The Higher Lower Tongariro

Prepared by:
Graeme Smart
(NIWA)

For:
Environment Waikato
PO Box 4010
HAMILTON EAST

**NIWA Client Report: CHC2005-002
January 2005**

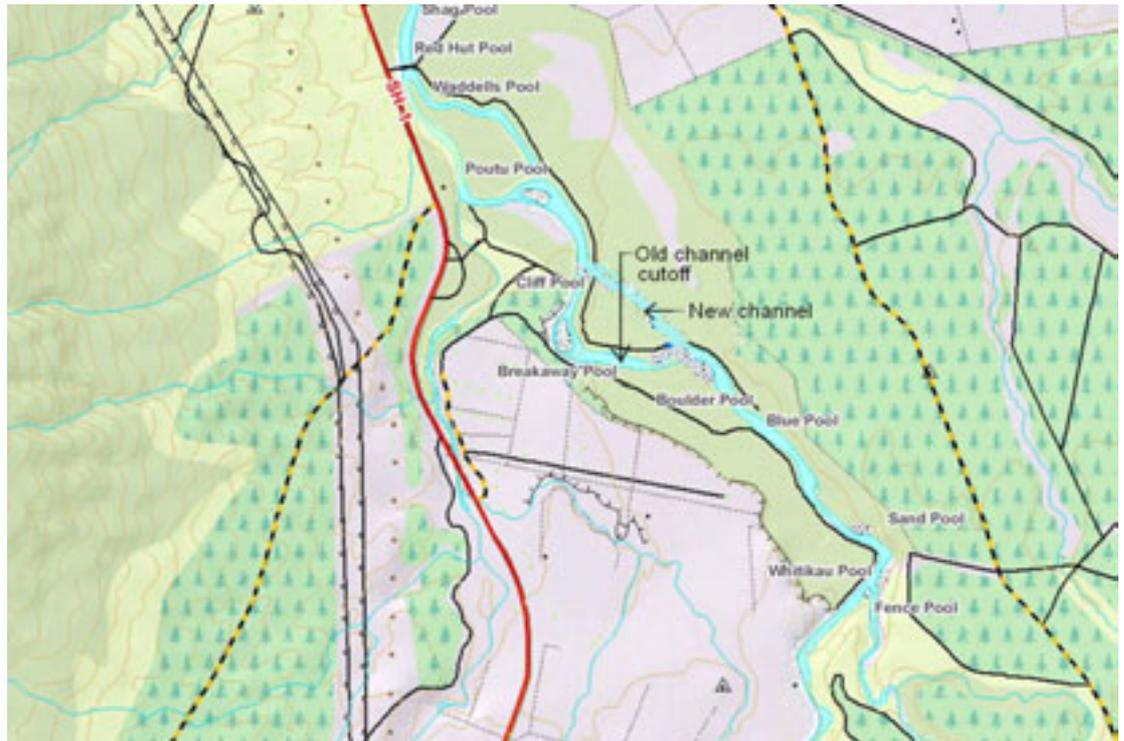
From 1993 to the present there were frequent floods including the February 2004 flood which caused significant changes. The island just downstream of the Rangipo Prison Road Bridge (at bottom of Fig. 1) was split in two by a new channel which the 2004 flood cut through the island's centre. At Breakaway Pool the river created a shortcut (similar to the one it had formed 1 km further downstream, some 40 years earlier). This enlarged a minor channel through a heavily vegetated island into a new main channel lying 200 metres away from the previous main channel (Fig. 4). Downstream of this "cutoff" the river eroded 50 metres from its west bank over a distance of 300 metres towards Poutu Pool. The river abandoned the previous shortcut from Poutu Pool to Red Hut Pool and scoured 60 metres from the western side of the island that previously existed at this location. From here to Barlows Pool the channel eroded large stretches by around 50 metres into the west bank. The flood increased the large braided area in an upstream direction towards Stag Pool. From Kamahi Pool to Major Jones Pool the left bank was severely eroded and the main channel moved up to 40 metres westwards.

Figure 4: Breakaway Pool before and after the Feb. 2004 flood.

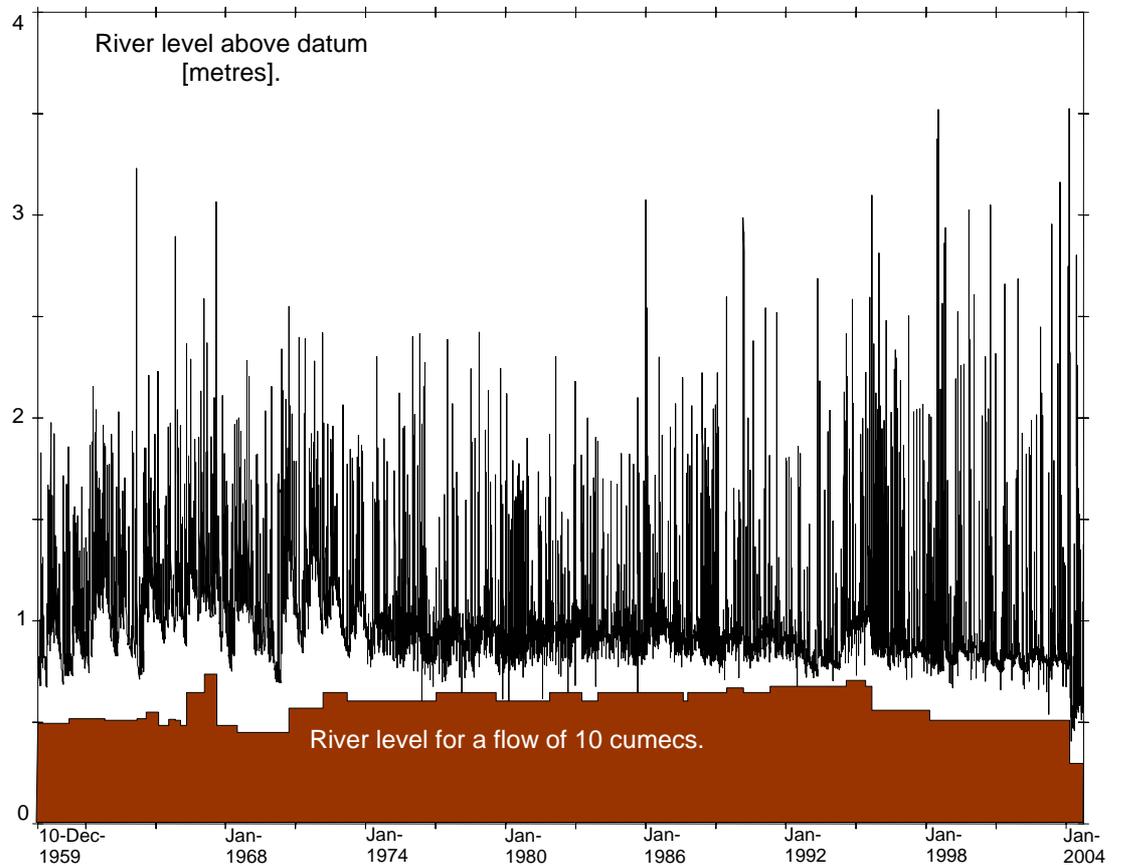
Figure 5: Changes in water level at Puketarata gauging station.

The upper trace in Fig. 5 shows water levels at Puketarata over the past 45 years. Changes in the level of the 10 cumec flow give a good indication of changes in the average level of the river bed (shown as the shaded area at the bottom of the figure). Figure 5 shows that there are often step changes in bed level occurring when there are high water levels (i.e. floods). Up until 1994 the bed level at Puketarata was fluctuating but slowly rising. Since 1995 the bed level has fallen by 40 centimetres, half of this fall occurring during the February 2004 flood. This situation illustrates how floods can change bed levels and how bed levels affect the water level. The figure shows that water levels at Puketarata were higher in the January 1998 flood than in the February 2004 flood, even though the 2004 flood was a larger flood.

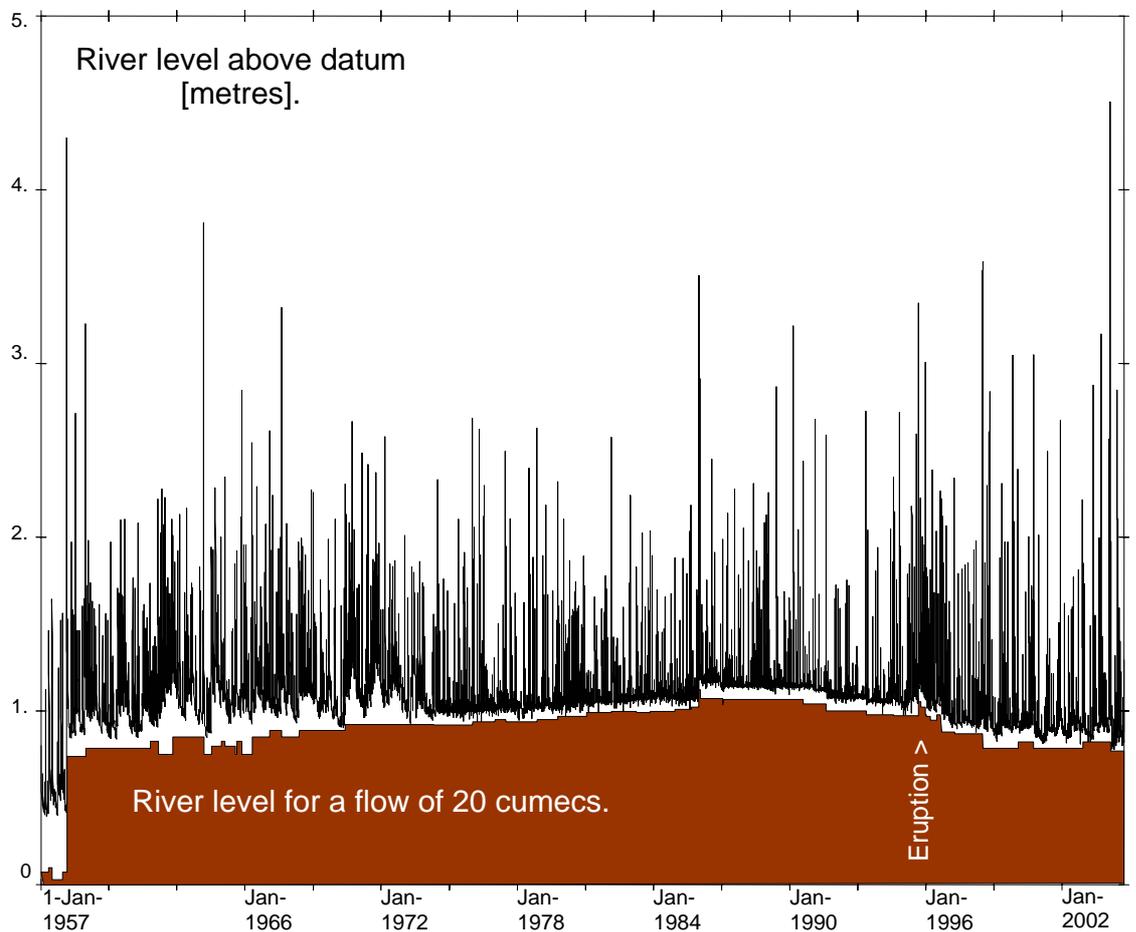
Figure 6: Changes in water level at Turangi gauging station.

Figure 6 shows a similar graph for the Turangi gauging site near Major Jones Pool at the downstream end of this section of river. Changes in the level of the 20 cumec flow give a good indication of changes in the average level of the river bed. The graph covers 46 years of record and includes the February 1958 flood, the largest flood on record. The 1958 flood is shown to have caused a sudden increase in bed level and the bed then continued to rise slowly until the late 1980's. The period of rising bed levels corresponds to the lull in floods from 1968 to 1985. Since the 1990's the bed level at the Turangi gauging site has been falling with the exception of minor rises caused by sand deposits from the 1995-96 eruptions. The fall in bed level of the gauging site indicates that gravel has been moved downstream. The fall in bed level corresponds to the period characterised by the return of frequent floods. The February 2004 flood caused little change in level at the gauging site but transported a large amount of gravel through this site and deposited it further downstream on the head of the delta.

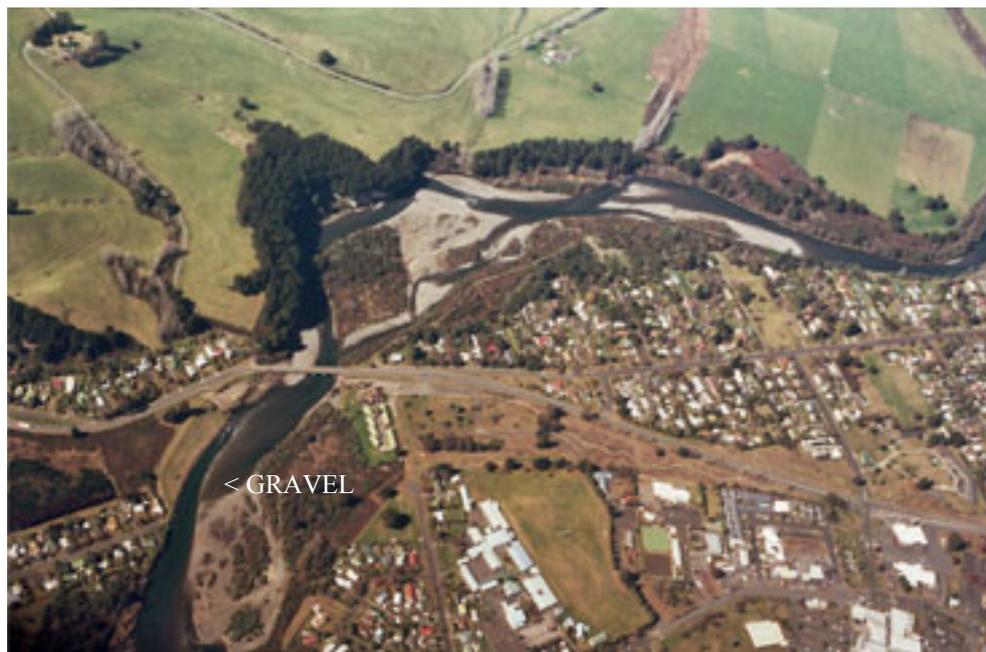
Figure 8: Aerial view of the Tongariro River and SH1 at Turangi taken on 5/5/2004.

A large underwater tongue of gravel formed just downstream of the SH1 Bridge as shown in Figure 8. This “slug” of gravel near the State Highway bridge is exacerbating bank erosion and will increase future flood levels in this part of the river. Stopbank protection has been improved following the flood as shown in Fig. 11.

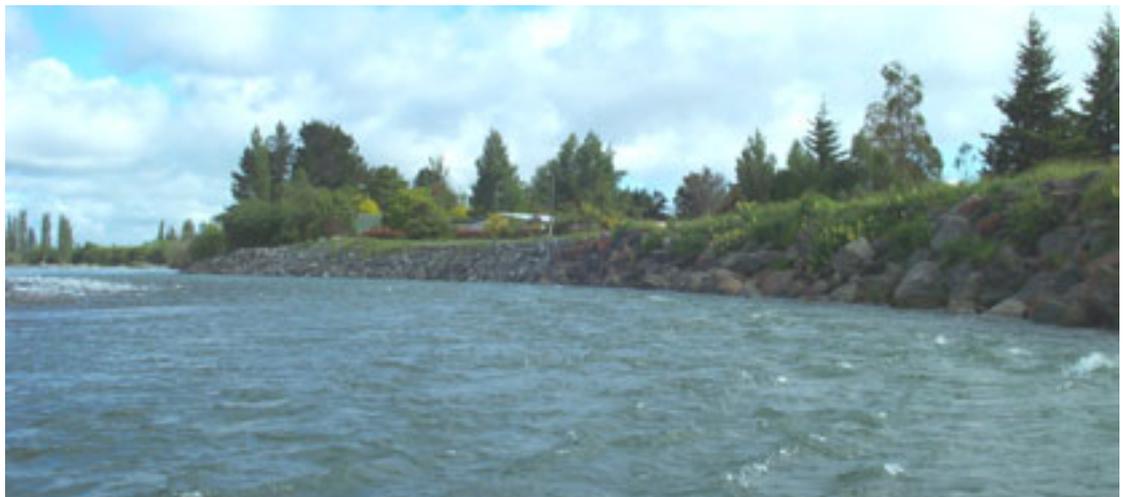
Figure 11: Rock to protect Herekieke St Stopbank from river attack.

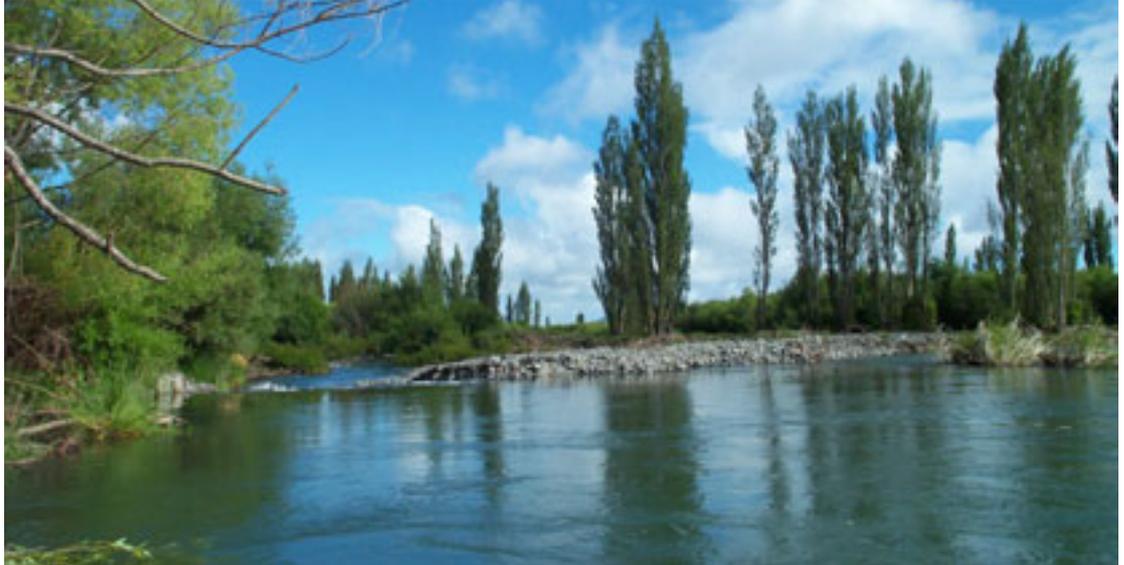
The increase in bed level is also evident at Swirl Pool where water spills out of the main channel during everyday flows as shown in Fig. 12.

Figure 12: Water spills from the main river channel towards the west from Swirl Pool.

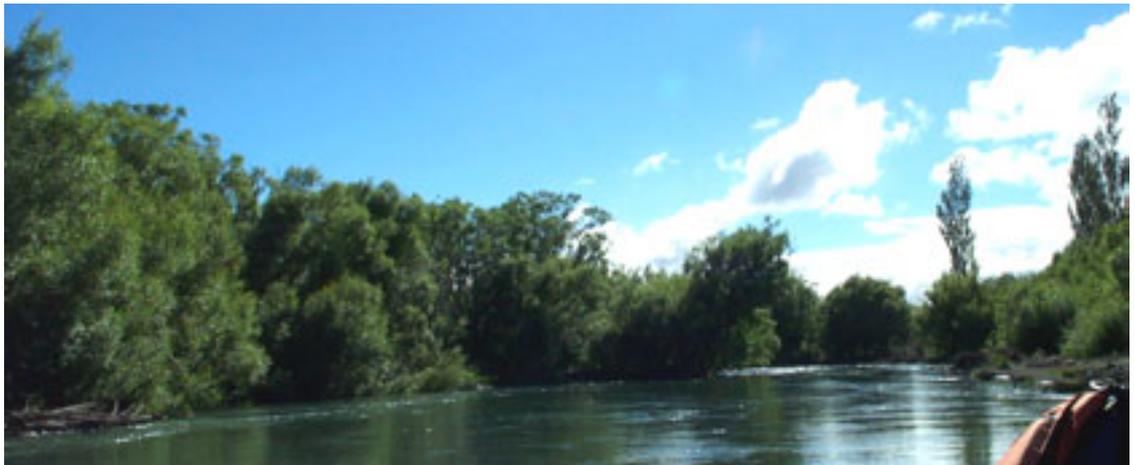
Below this point the river channel is constrained by willows (Fig. 13). These decrease bank erosion and increase out-of-channel sedimentation during floods.

Figure 13: Willows confine the main channel over much of the delta.

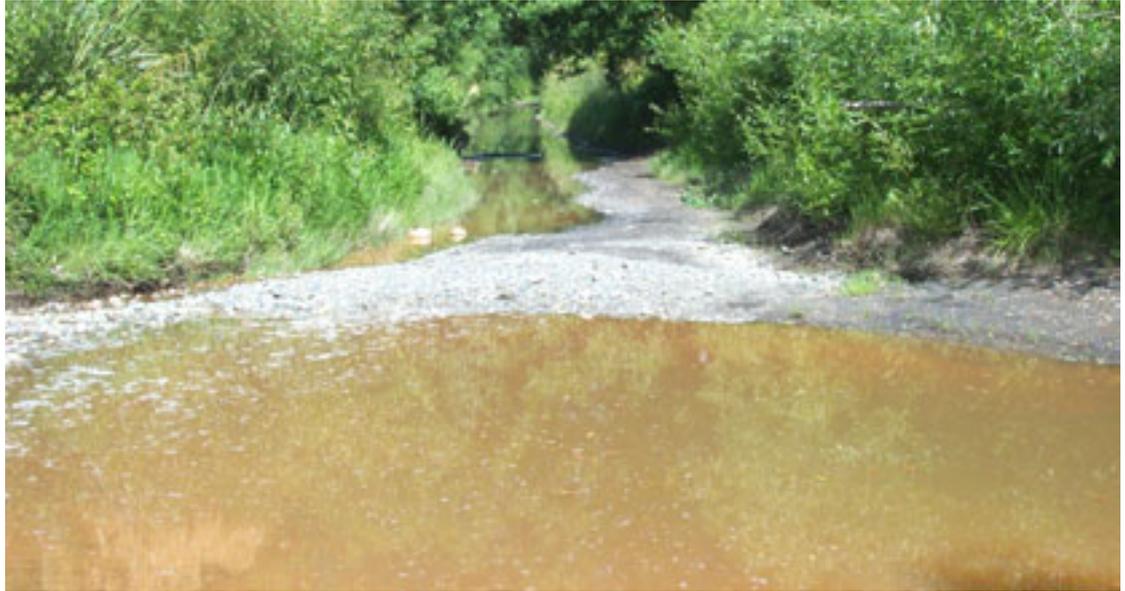
Even minor freshes overtop the low riverbanks and deposit suspended sediment adjacent to the river. An area at the end of Grace's Road is almost permanently under water as shown in Fig. 14.

Figure 14: The lower end of Grace's Rd is overgrown and underwater when there is a flow of 60 cumecs in the river.

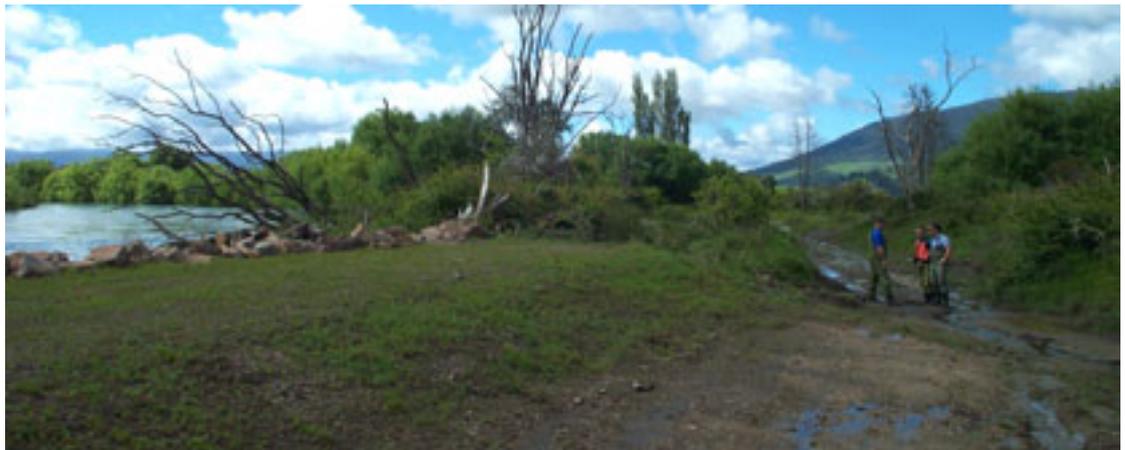
The high level of the river bed is evident in Figures 15 and 16 which show that land beside the river is lower than the level of water in the river. Here, water that seeps from the river during everyday flows or spills during freshes, flows into Deep Stream. There is a strong likelihood that the main river channel will divert towards Deep Stream in a future flood.

Figure 15: A low stopbank contains the Tongariro on the West side of Downs Pool. The river level is higher than ground level at the end of Awamate Rd.

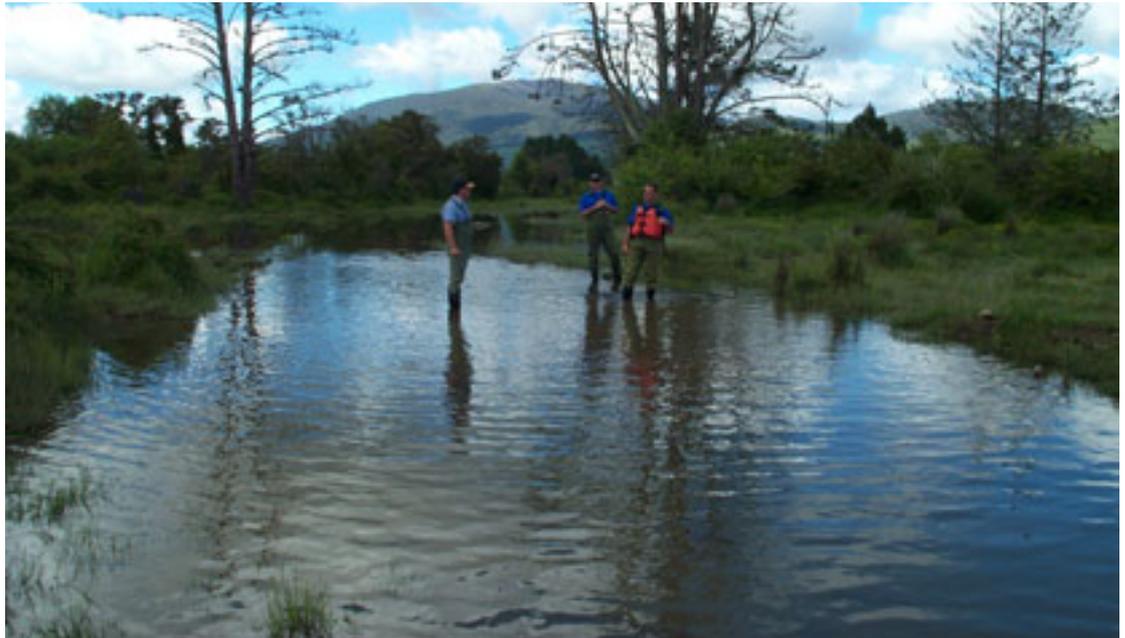
Figure 16: The extension of Awamate Rd is submerged with seepage from the Tongariro River when there is around 60 cumecs in the river.

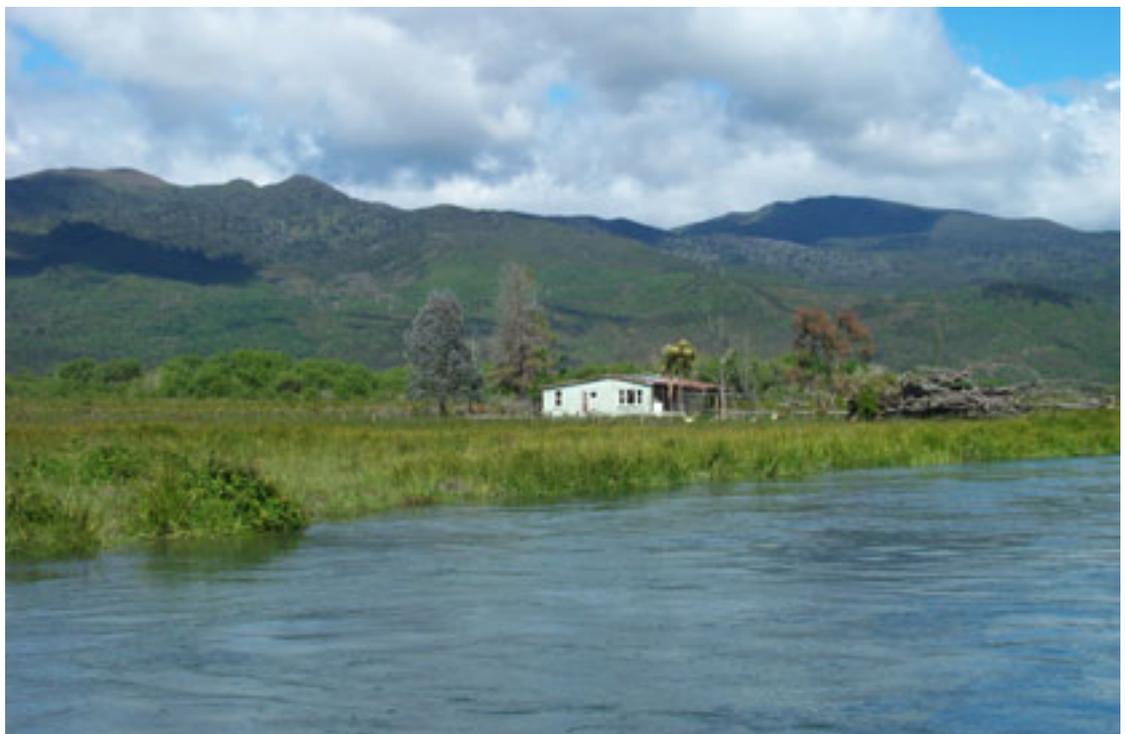
Downstream of this point much of the delta that was previously dry is now semi-permanently under water, as shown by the situation at Church's house in Fig. 17.

Figure 17: Church's old house has water to near floor level with a 60 cumecs flow in the river.
