**FISH PASSAGE PROBLEMS
AND OPTIONS FOR FISH PASSAGE AT MARAROA WEIR**

REPORT PREPARED FOR THE ELECTRICITY CORPORATION OF NEW
ZEALAND

CHARLES MITCHELL & ASSOCIATES

August 1994

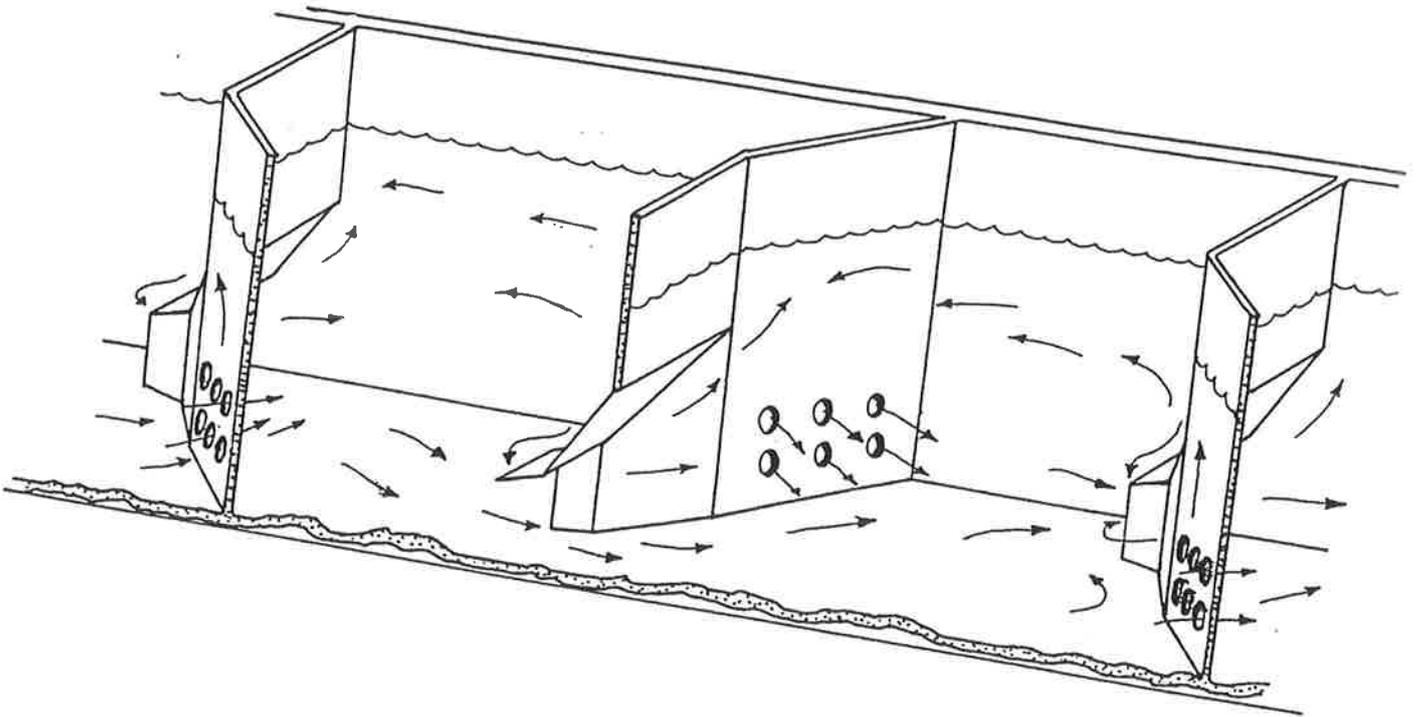
Despite this lack of popularity , the Borda Orifice proved a good design. Velocities within the fish pass were low enough to allow small native fishes such as smelt and bullies through the pass (Field Dodgson 1981). The functional parts of the fish pass are a series of 16 borda orifices (Fig 1). There is a head loss of between 200-400 mm between each orifice owing to the resistance it provides to the water flow. Between each orifice the flow expands into chambers where fish can rest. The highest water velocities are at the mouthpiece of each orifice (Aspden 1972) where fish encounter velocities of 1.86 m/s (Jowett 1989). The fish pass required an average flow of 10 cusecs, an amount of water then considered sufficient to meet the energy needs of perhaps 6000 people (Field-Dodgson 1977).

Fig 1. shows the basic principles of the borda orifice design and the patterns of water flow which develop. Although the fish pass apparently functioned well, allowing even weak swimmers such as bullies, smelt, lampreys and elvers upstream, it was considered that brown trout appeared to find water velocities excessive at the entrance (S. Sutherland pers comm.). On the other hand, Jowett (1989) thought the water velocity of 0.12 m/s through the entrance was too low (?) to provide sufficient attraction for fish. Rainbow trout used the fish pass and were recaptured well upstream. Brown trout always seemed to be the species for which the fish pass presented the greatest difficulty (Field Dodgson 1981).

One of the major constraints on building a fish pass at this site was the requirement that it functioned over a range of water levels. At high water levels parts of the fish pass would become pressurised and accordingly the whole structure has been encased within a concrete tunnel. This step alone has made the fish pass impracticable. Maintenance is virtually impossible as the interior of the fish pass is almost inaccessible.

Fig 1. Borda orifice pass, showing baffle design and water flow patterns.
