WATER QUALITY PROBLEMS IN KINLOCH MARINA,
LAKE TAUPO

Clive Howard-Williams, John Davies and Stuart
Pickmere

ECOLOGY DIVISION FILE REPORT

September 1982

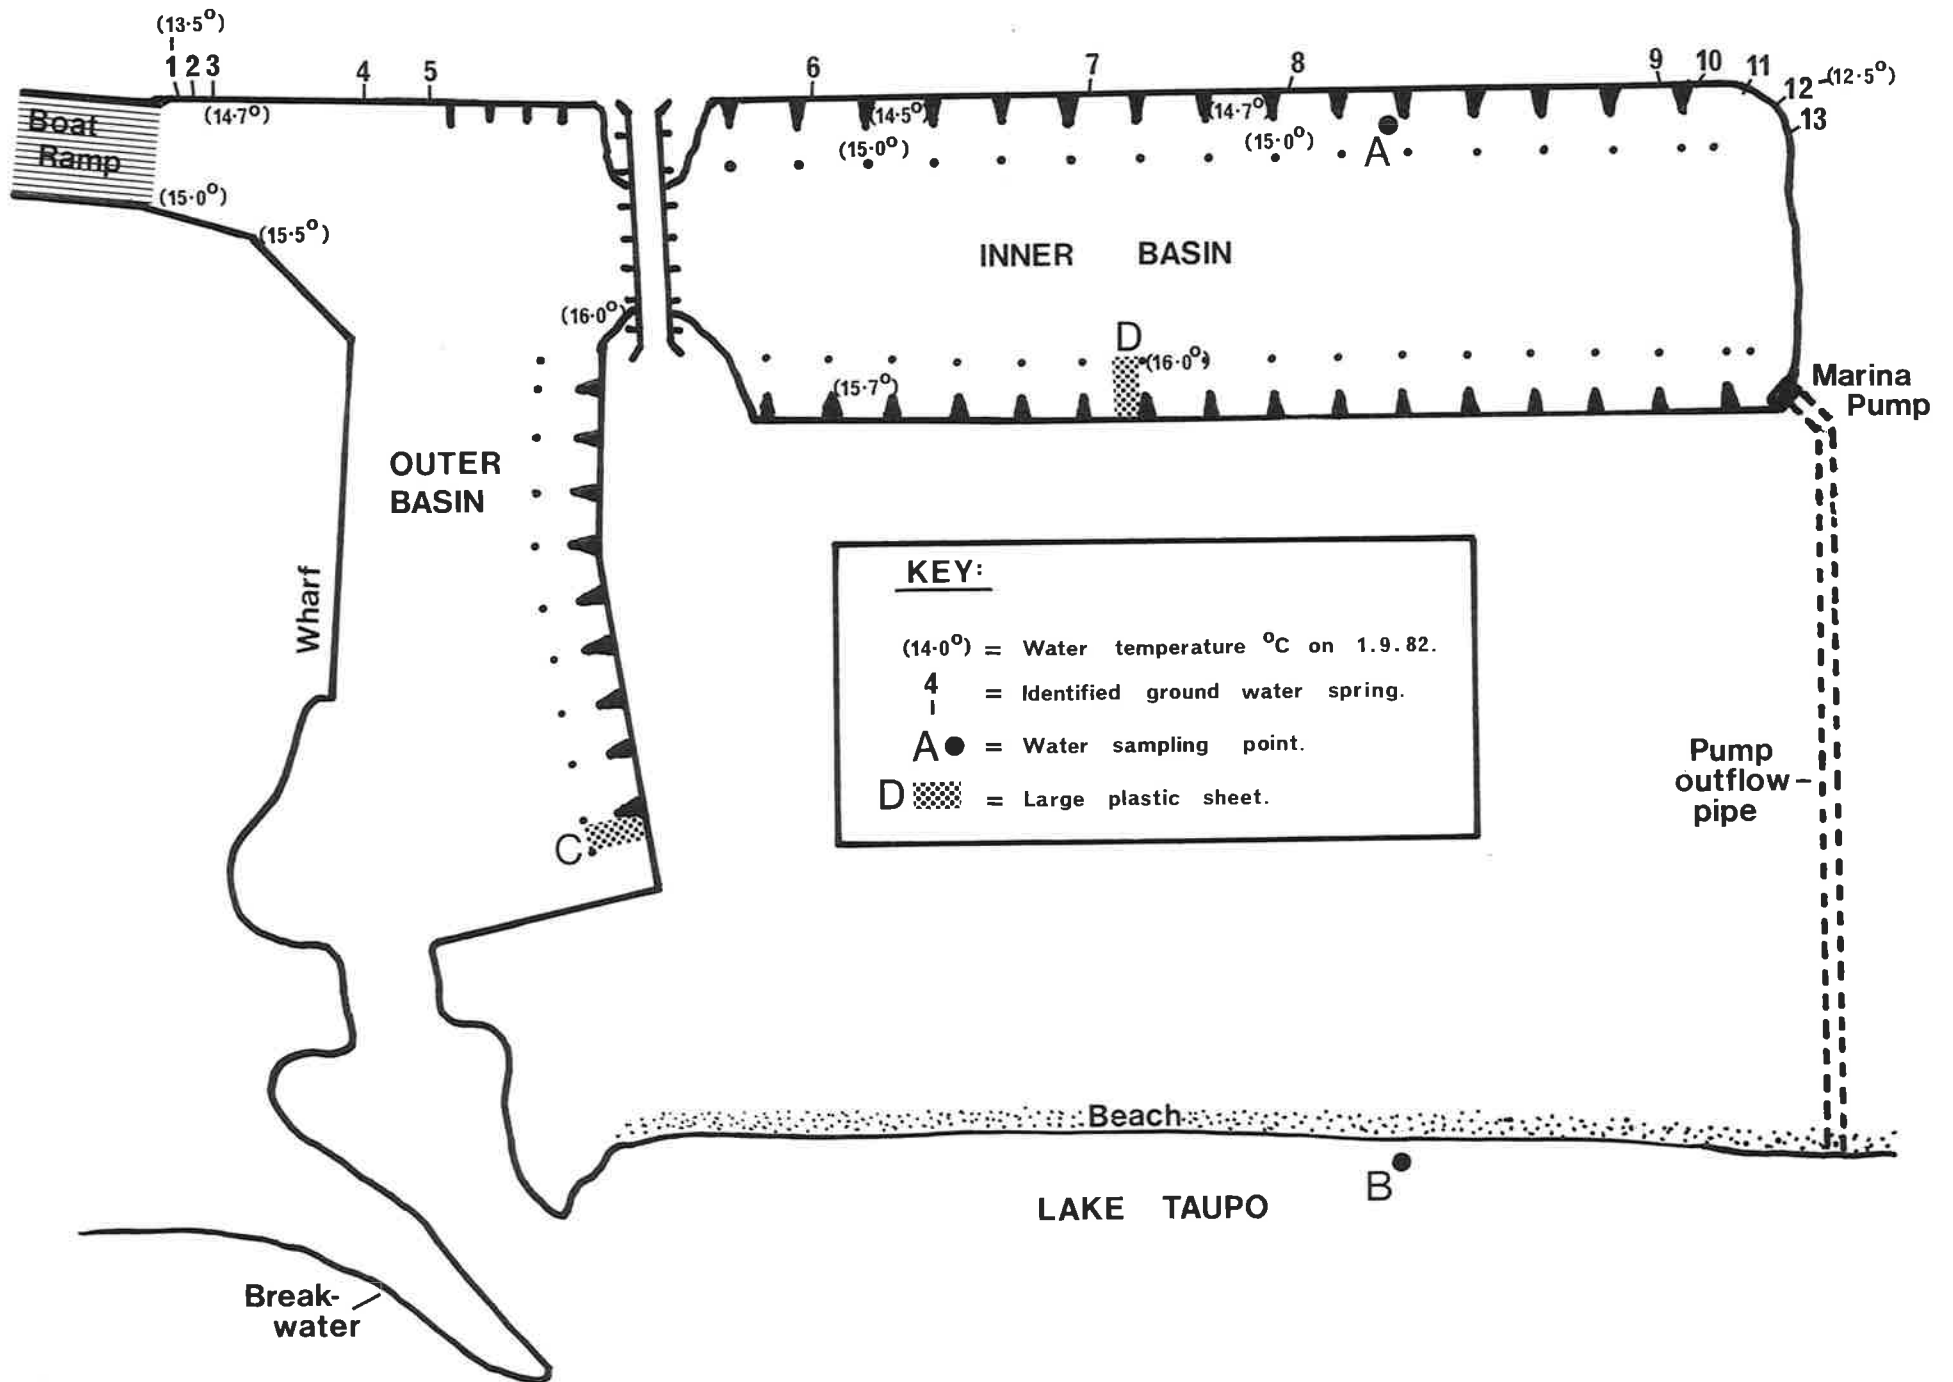
Fig.1 Plan of Kinloch Marina with features mentioned in the text.

The plan of Kinloch marina is depicted in Fig.1. Features relevant to the text of this report are illustrated in the figure. The marina consists of two basins, an inner and an outer basin. At a lake water level of 357 m above mean sea level the central areas of the basins are up to 4.5 m deep. Water depths at the berths are generally from 3 m sloping to 1 m at the breastwork. The boat ramp is at the northwest corner of the outer basin. In the southeast corner of the inner basin there is a large electrically

The marina is not lined, and the sediments are pumice overlain with a fine organic ooze up to 30-40 cm deep in places. Ground water from the catchment enters the marina along the northern edge. On 1 September 1982 when the lake level was very low, thirteen identifiable ground water flows were counted along this edge (Fig.1), and presumably water is seeping all along here. In February 1974 when the lake level was also low Richmond (1974) found that the seepage of cold ground water was sufficient to cause cooler water temperatures along the north side as opposed to elsewhere in the marina. Temperatures we measured on 1 September 1982 in the marina confirm Richmond's findings. The temperatures we recorded are shown in Fig.1.

The algal scum problem is very noticeable at the boat launching ramp (Fig.1). Boat owners object to algae sticking to their trailers when these are pulled from the water, and they object to wading in these scums particularly having paid a launch ramp fee.

(b) Plastic bottom seals: Large opaque plastic sheets laid on the bottom sediments can be used to prevent plant growth. Even permeable mesh screens have been used effectively for this purpose (Perkins et al. 1979). As a complementary control method to the rake, which cannot be used in the berths we attempted to control plant growth in two contrasting marina berths (sites C, D in Fig.1) with plastic sheets.

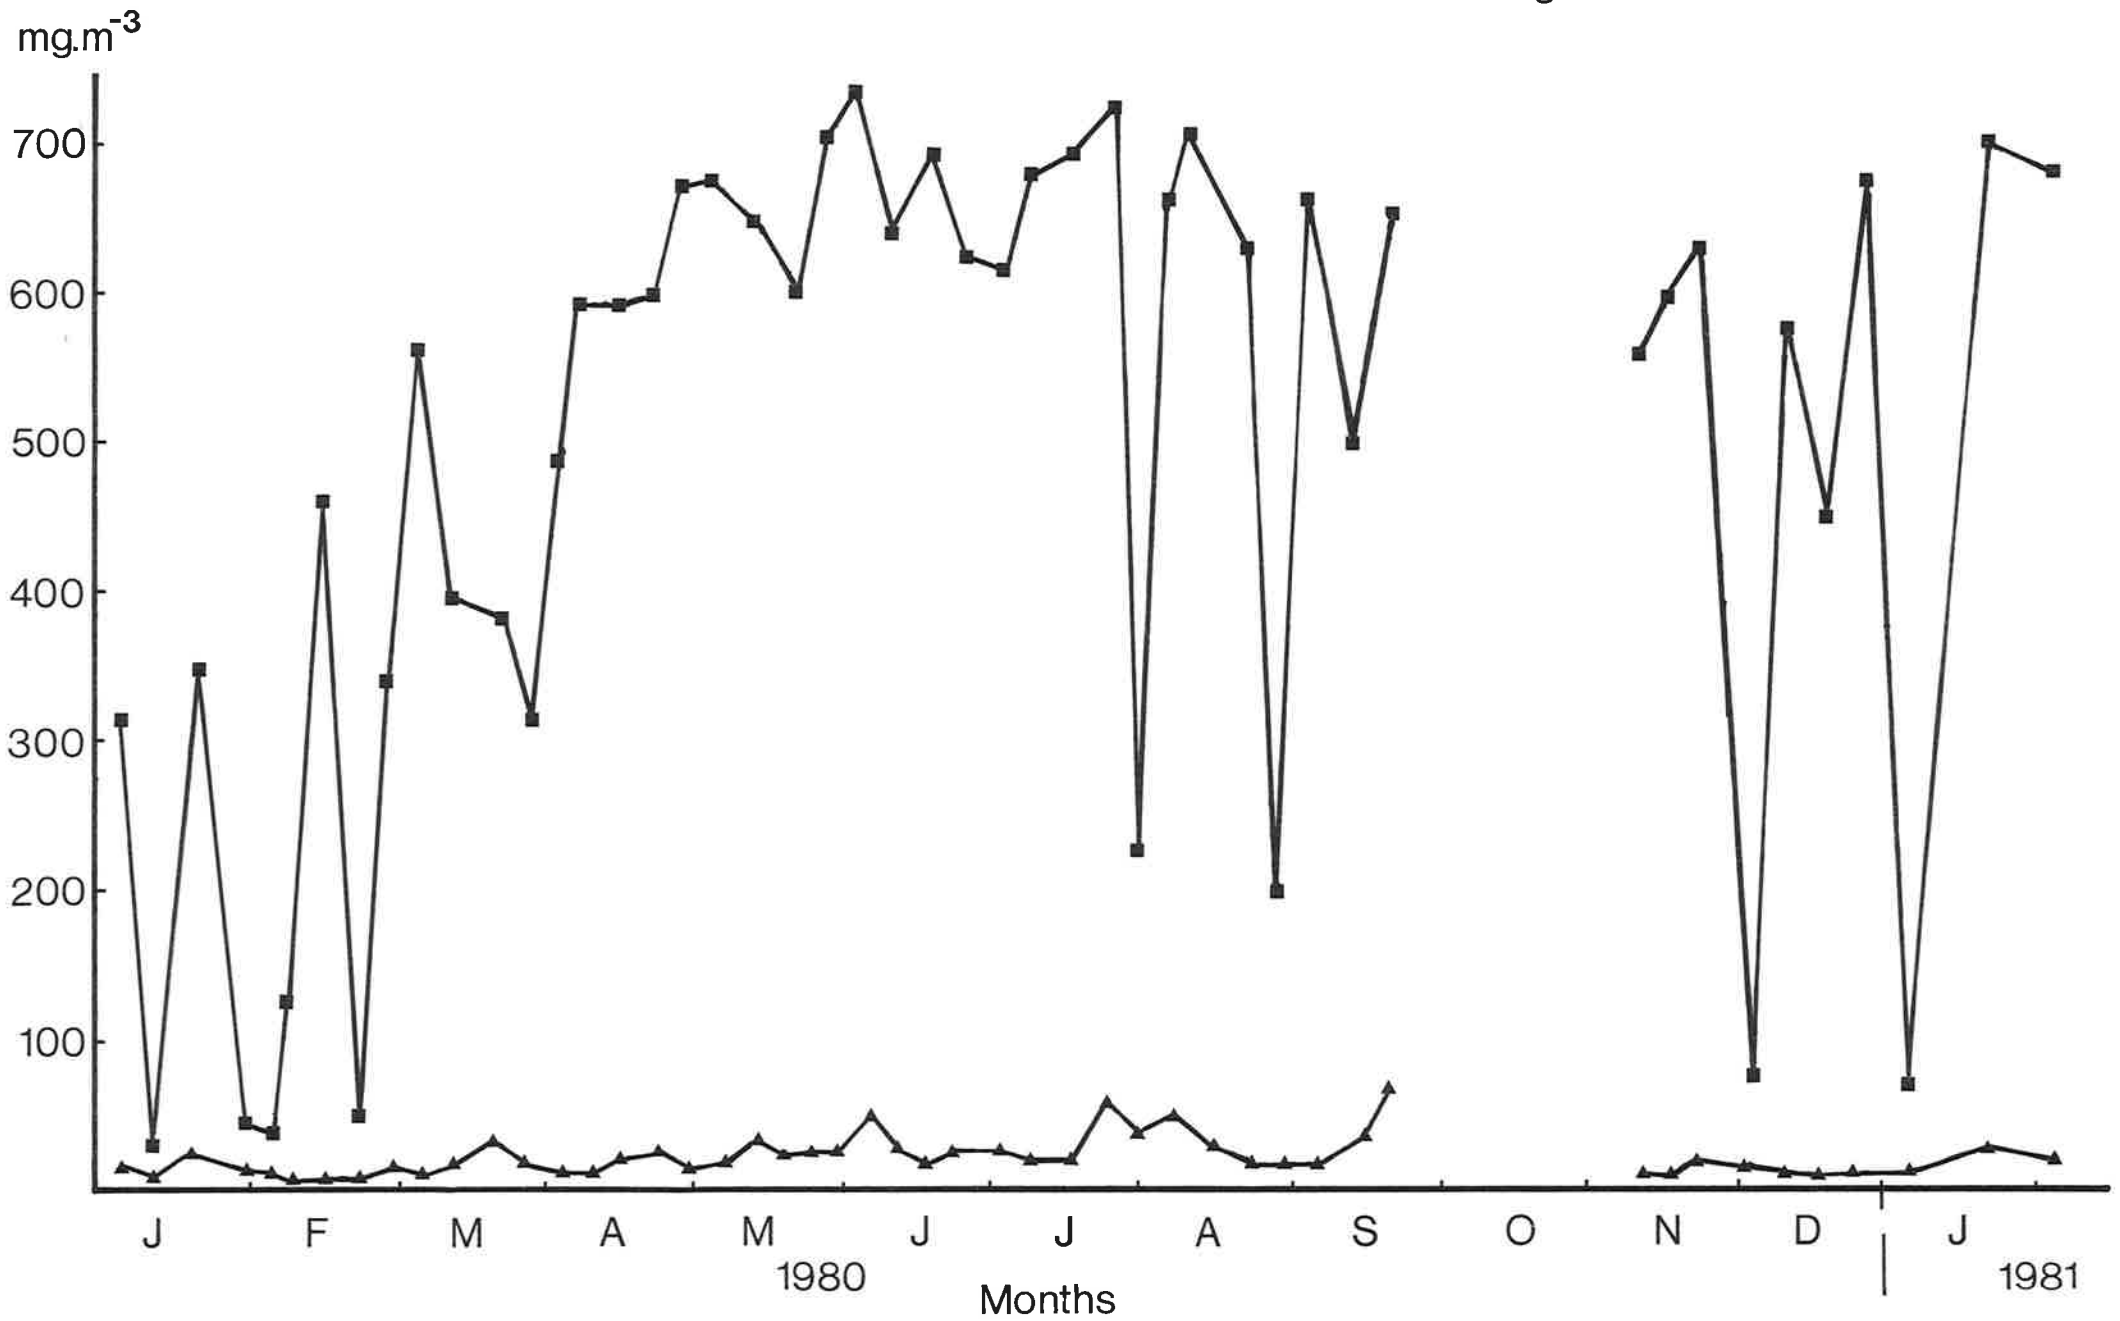
Fig. 2

Nitrate-nitrogen (Fig.2) reached high concentrations in the marina relative to those in the adjacent lake water. It is interesting to note that the $\text{NO}_3\text{-N}$ concentrations in the inshore lake water are themselves several times higher than $\text{NO}_3\text{-N}$ reported for the surface waters of the open lake where values range from not detectable to 2.0 mg m^{-3} . This is indicative of inshore enrichment of $\text{NO}_3\text{-N}$. The very irregular pattern of $\text{NO}_3\text{-N}$ in the marina during the two summer periods (Fig.2) reflects the use of the marina pump. When the pump is operating, marina water is replaced with lake water. The pump operates frequently in summer to remove the surface algal scums

during the holiday period. We collected samples on two days in winter when the pump was operating (20 July, 1980 and 23 August, 1980) and on these occasions, nitrate levels had dropped considerably.

Nitrate-Nitrogen: Variation with time in Marina (■) and lake edge (▲)

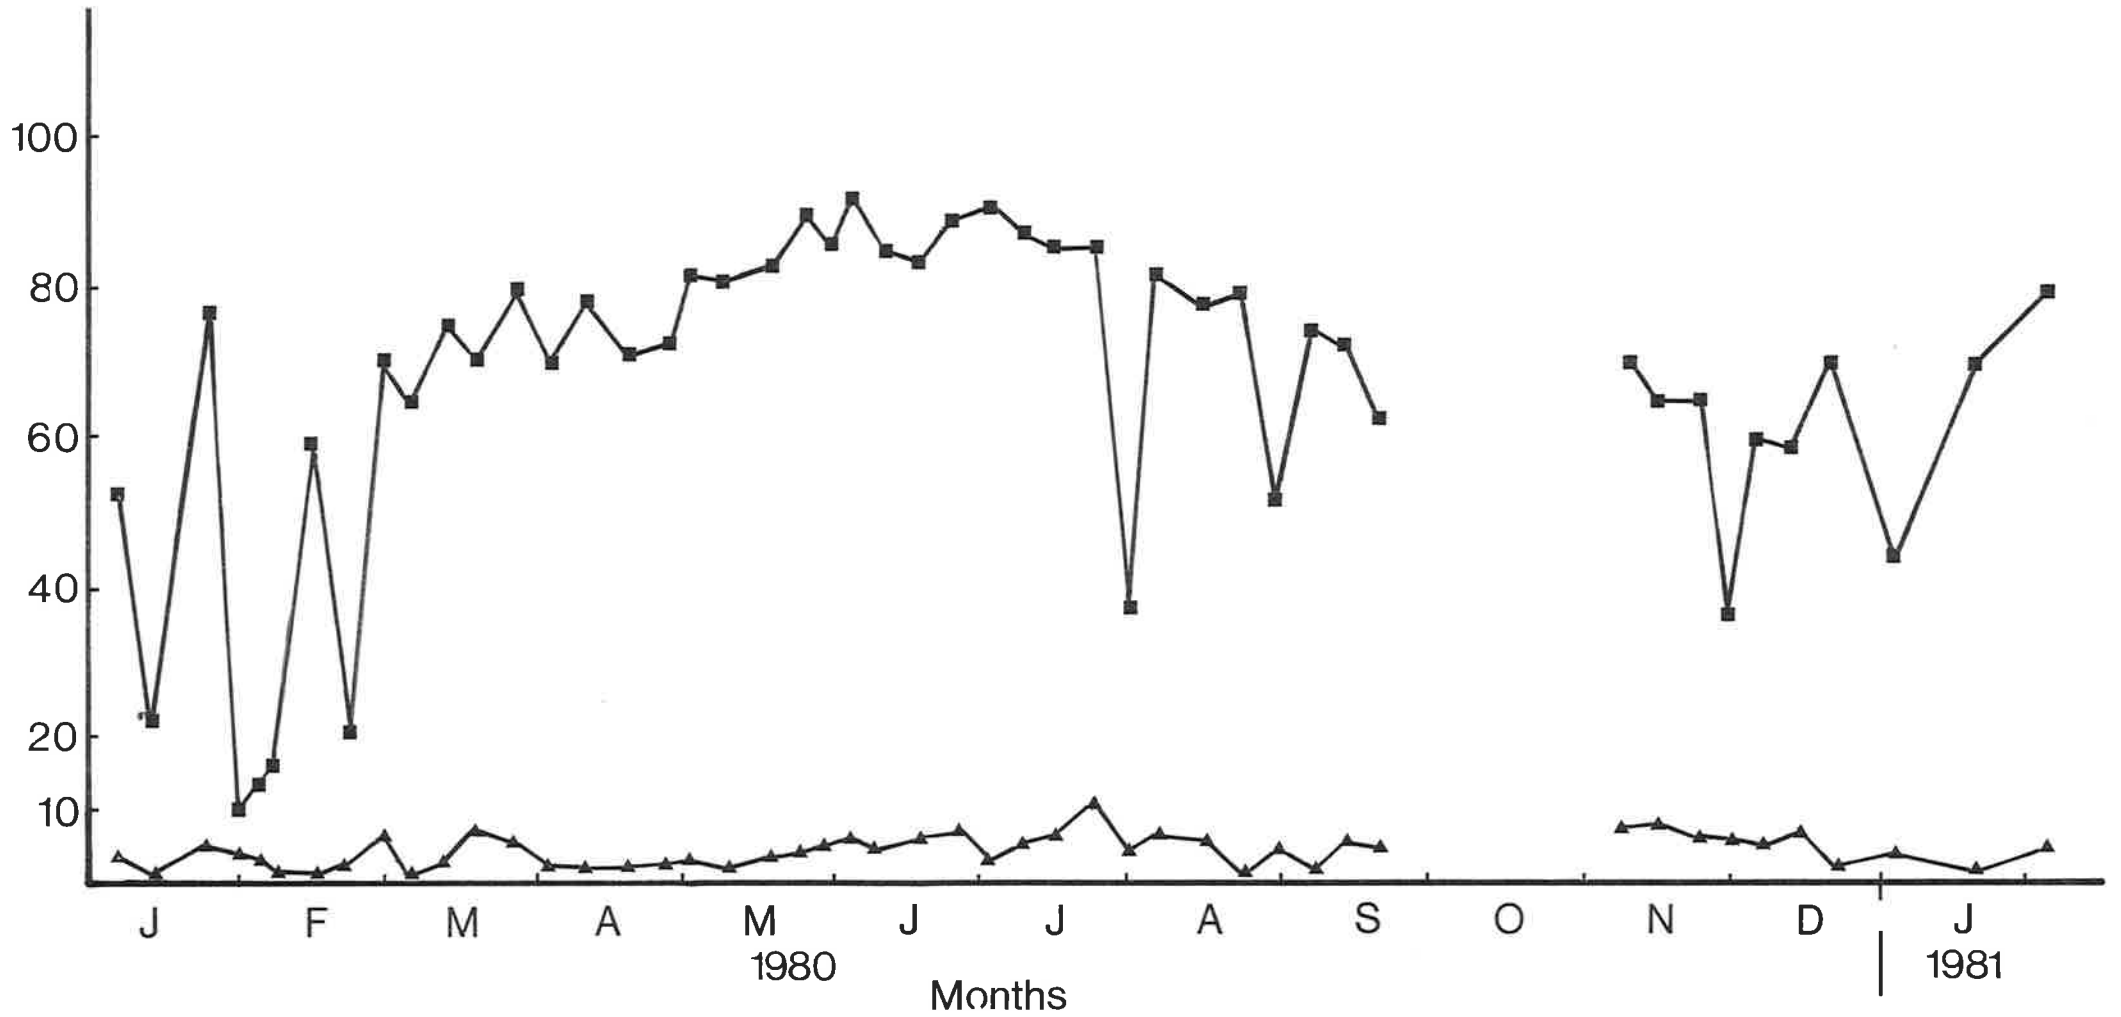
Fig. 3

Dissolved reactive phosphorus (Fig.3) follows the same pattern as nitrate. Of particular importance is the large concentration in the marina relative to that in the lake.

Reactive Phosphorus: Variation with time in Marina (■) and lake edge (▲)
