**MARLBOROUGH
CATCHMENT
BOARD**

REPORT
on the
10th JULY 1983
FLOOD

SEPTEMBER 1983

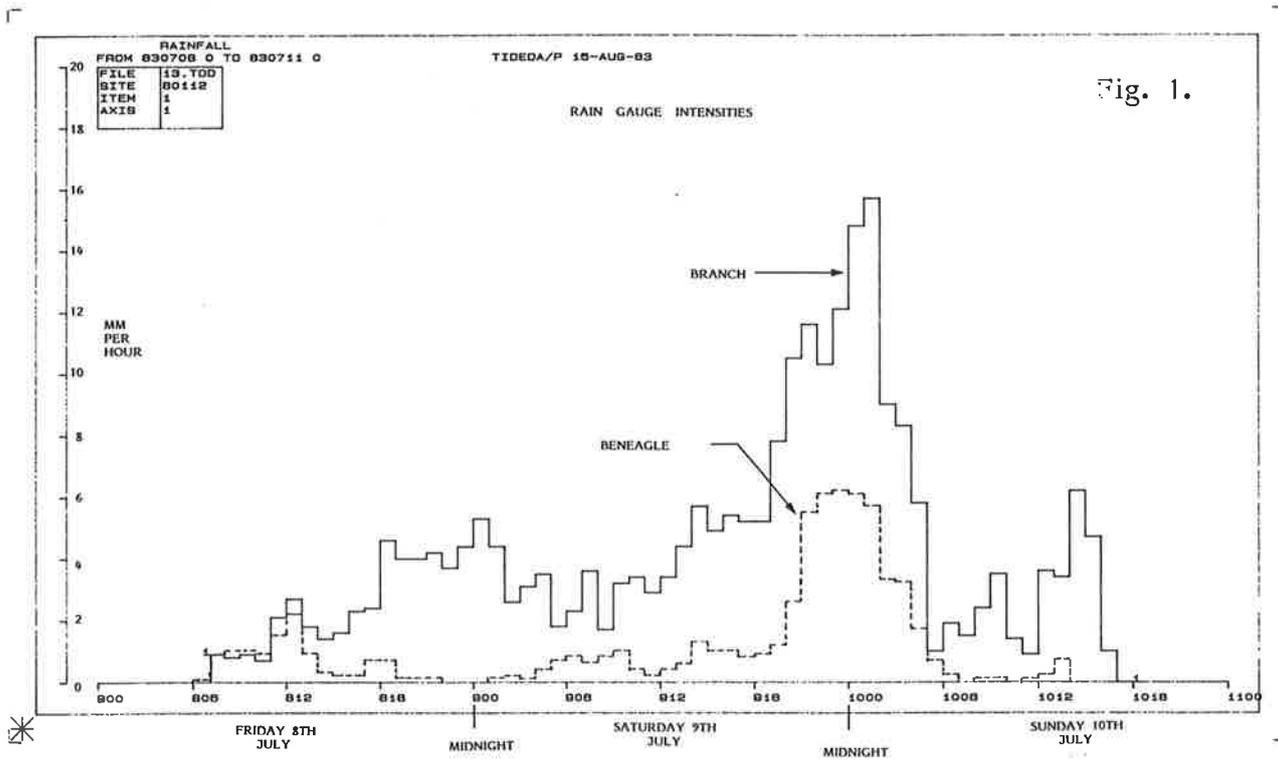
These higher intensities must have a relatively rare return period, but further study is needed to complete this part of the flood assessment.

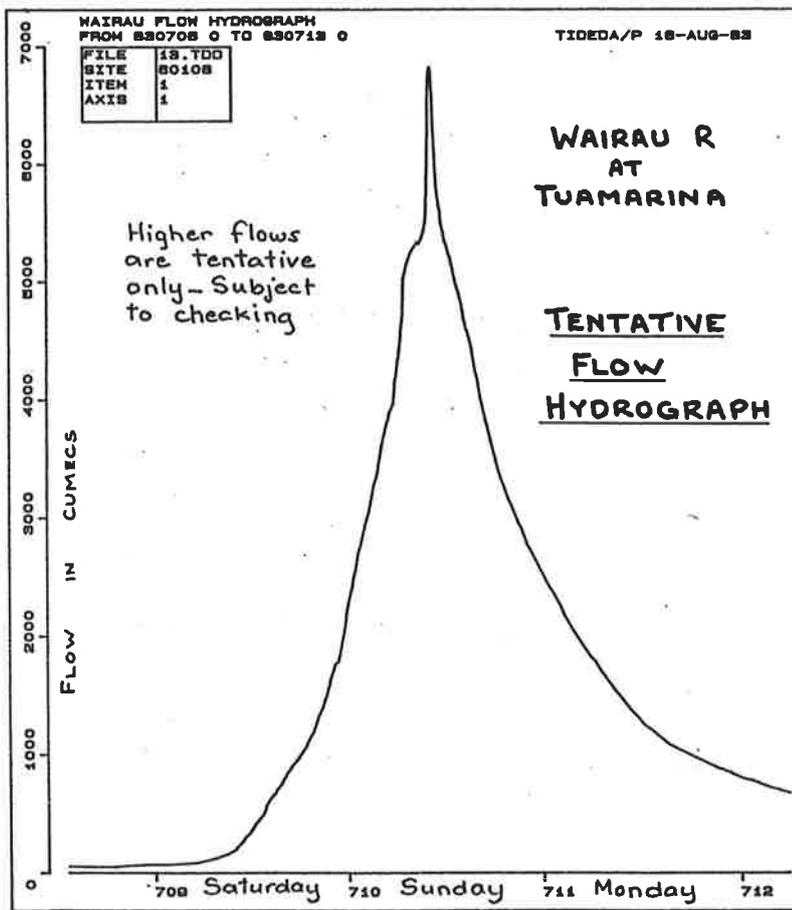
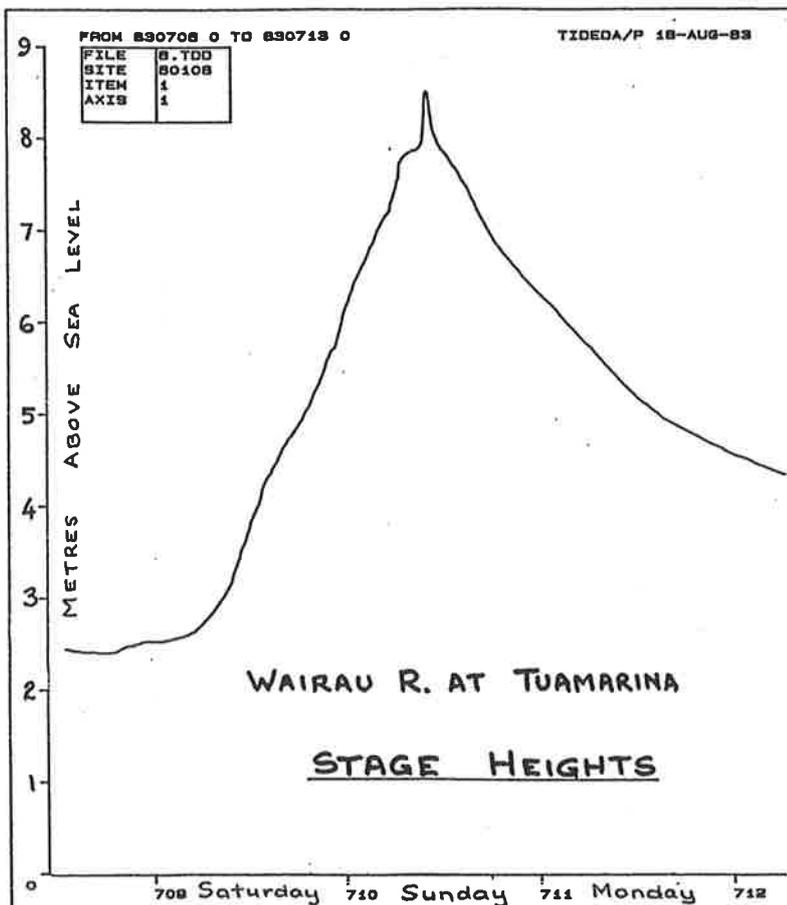
Fig. 3.

The shape of the flood hydrograph is unusual for the Wairau River. After a study of rainfall and other flow records, it is apparent that three separate hydrographs were superimposed. These were due to :-

- a) The long rainfall period of about 36 hours from before midday on Friday until 1900 hours on Saturday which included the effect of warm conditions and rain on snow.

- b) The more intense rain during Saturday evening which continued in most areas until about 2 a.m.
- c) A period of intense rain which fell from midnight to 2 a.m. over the middle of the catchment creating very large peak flows in the Northbank above Bartletts Creek and from the Wairau Valley-Hillersden-Branch foothill areas. The resulting hydrograph at Tuamarina shows a relatively slow rising flood until 6 a.m. on Sunday (See Fig. 3) when there was a short rapid rise, followed by an apparent peak. This was followed by a further rapid rise from 9 a.m. to 10.30 a.m. when nearly a 30% increase in flow appears to have occurred at the Tuamarina bridge. At first sight, the false peak between 6 a.m. and 9.30 a.m. was thought to have been caused by upstream overflows. While these may be partly responsible it is more likely that this peak was caused by the intense two hour rain in the middle of the catchment early on Sunday morning. This is

perhaps verified by a similar shape on the Wye Recorder chart, but does not show on the Waihopai river record. Unfortunately, there is no record of the peak at the Branch River, only a maximum flood level which is within the recorder house. Here the record is affected by the partly built Branch Hydro intake.
