MISCELLANEOUS PUBLICATION

LANDSLIP AND FLOODING HAZARDS IN EASTBOURNE BOROUGH

a guide for planning

**NATIONAL WATER AND SOIL
CONSERVATION ORGANISATION**

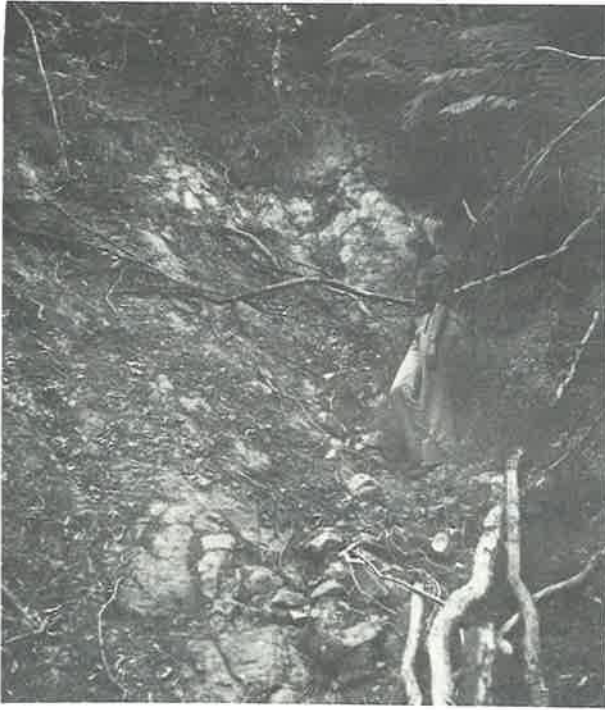
Photo 1—Natural slip in gully head situation with shear plane along contact between bedrock and regolith.

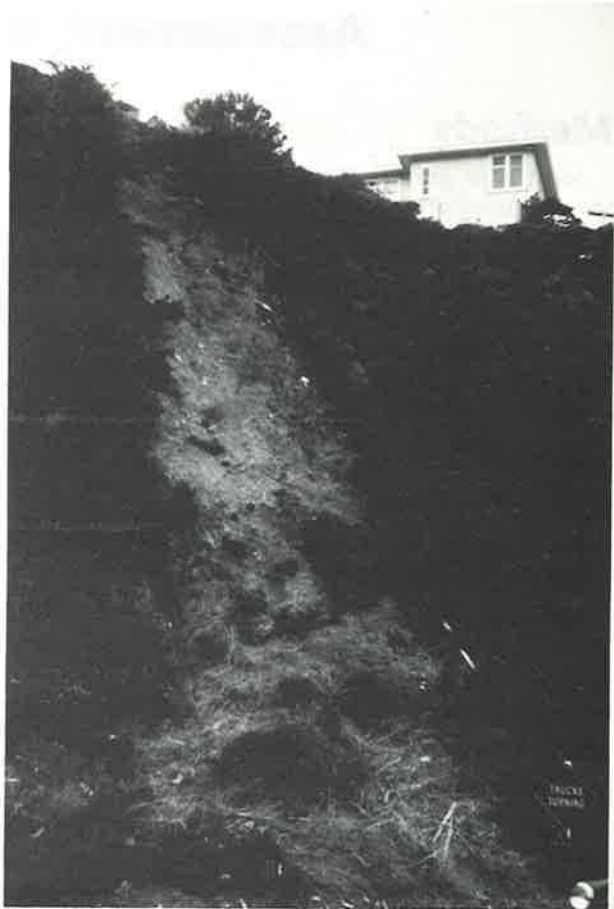
Photo 2—Slip on coastal cliff involving colluvial material and vegetation.

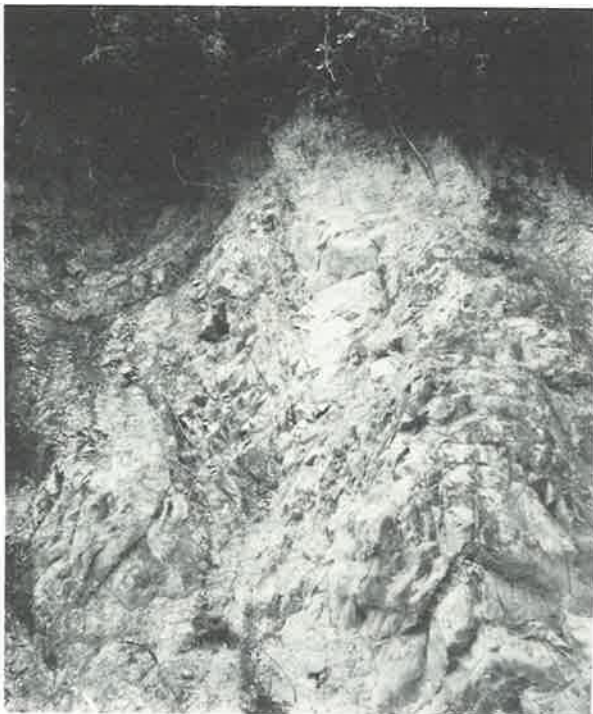
Photo 3—Bedrock failure among joint planes in a cut slope—note range of jointing.

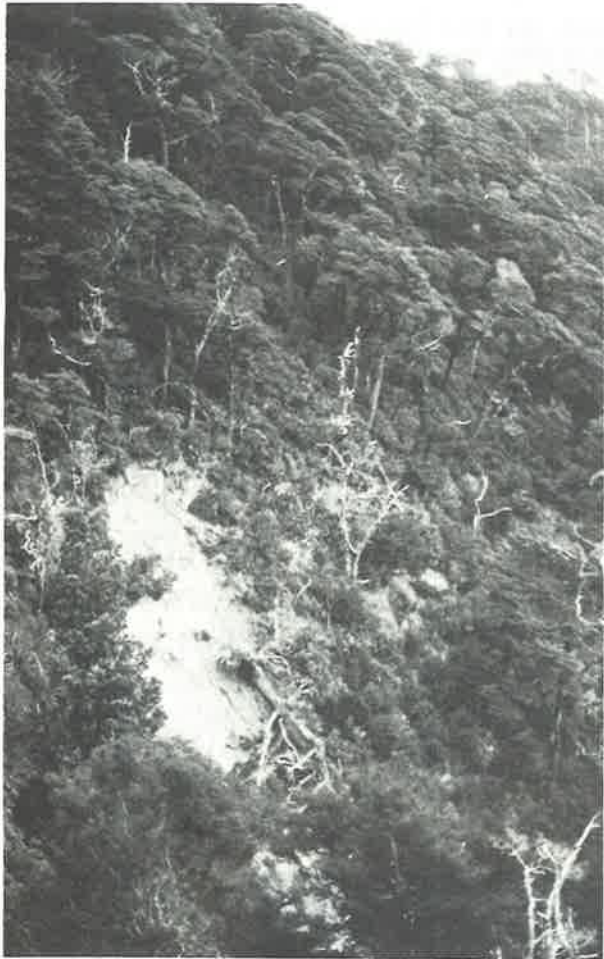
Photos 5 a and b—Slips associated with uprooting of dead beech trees on slopes in excess of 50°.

Seventeen slips on natural slopes were associated with old dead beech trees. (Photo 5). These trees had been burnt, damaged in the Wahine storm of 1968, or had succumbed in the 1972–73 drought.

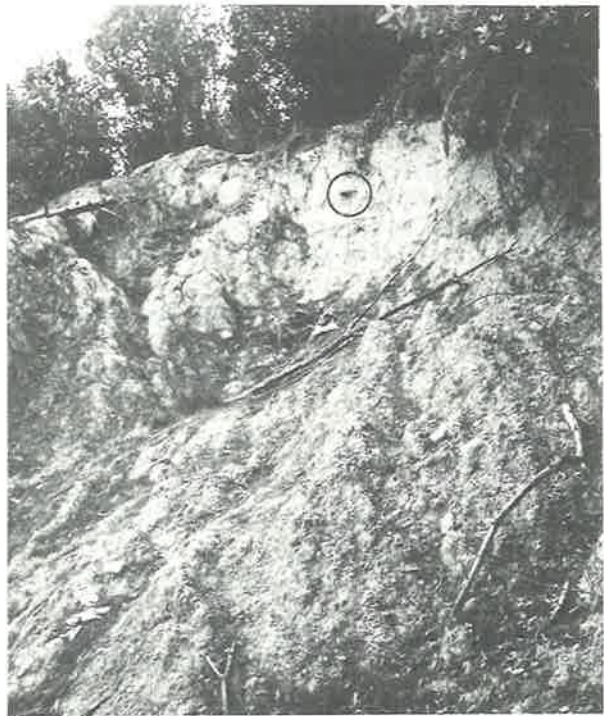
Photo 4—Slip face showing fill material on original soil surface (marked by hammer).

In the face of several slips old buried soils (see Photo 4) were found, in some cases indicating prior movement. This was confirmed by the presence of bent trees that had previously been moved to a horizontal position and then grown upright again.

Unnecessary overburden on steep slopes, such as felled trees, general rubbish (old car parts, timber, bricks, scrap iron, etc.) and soil was a contributory factor in 24 slope failures (see Photos 4 and 6).

Excavated material and other general rubbish and waste should not be pushed on to existing slopes. This unconsolidated mass adds weight to the slope, interrupts percolation of water, and can fail readily or contribute to the failure of the material beneath.

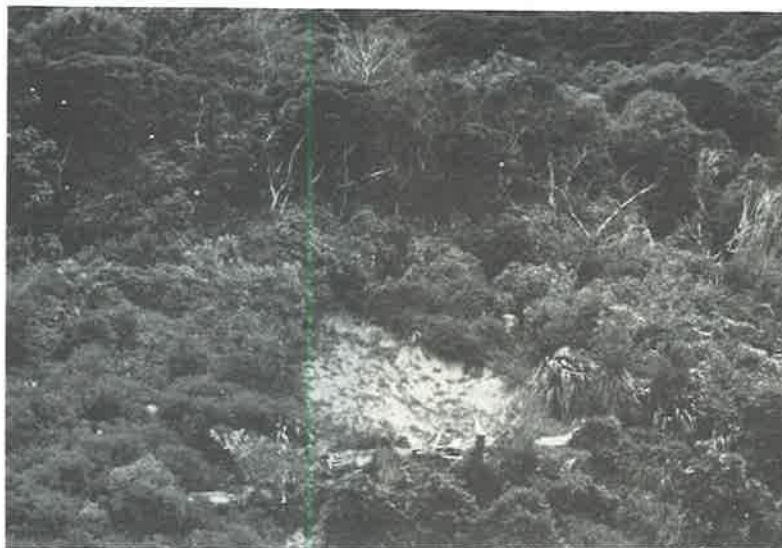
Eight slips occurred after pine trees had been felled. In 6 of these cases, trees were left on the ground adding weight to the slope and enabling water to collect on it. (Photo 6).

Photo 6—Trees left on slope after felling adding weight to slope, and enabling water to collect on it.

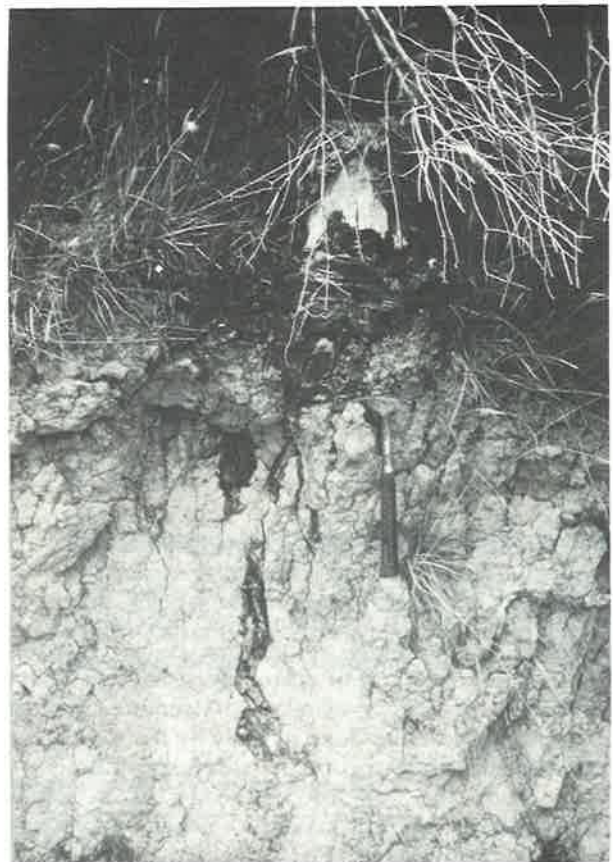
O'Loughlin (1974) found in Canada that 3–5 years after tree felling, small tree roots had lost over half their original tensile strength (Photo 7).

Photo 7—Old pine root from felled tree showing decay. Note root shrinkage which would allow water penetration to some depth into the ground.
