# Estuarine Vegetation Survey : Inner Firth of Thames

Prepared by:  
Meg Graeme M.Sc,  
Natural Solutions  
Marine & Terrestrial Ecologists Ltd

For:  
Environment Waikato  
PO Box 4010  
HAMILTON EAST

June 2006

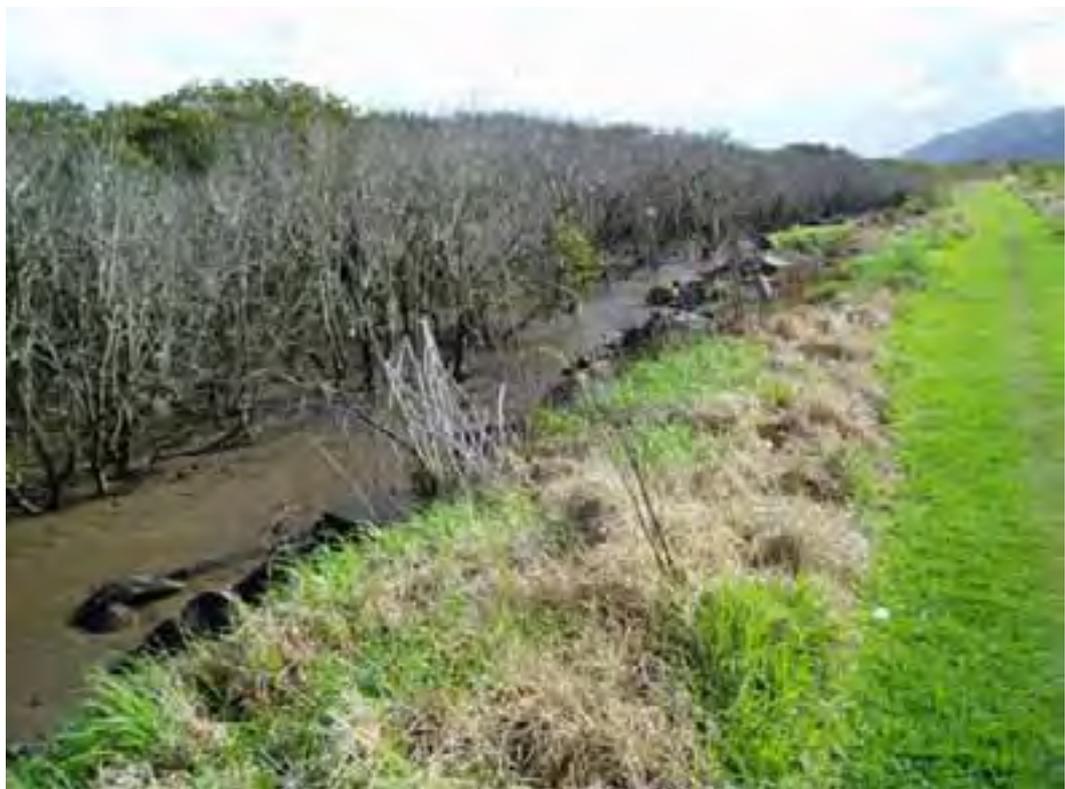
**Figure 3:** Dead mangroves and 'hard fill' edge backing mangrove band along Thames township foreshore – new subdivision at mouth of Kauaeranga River.

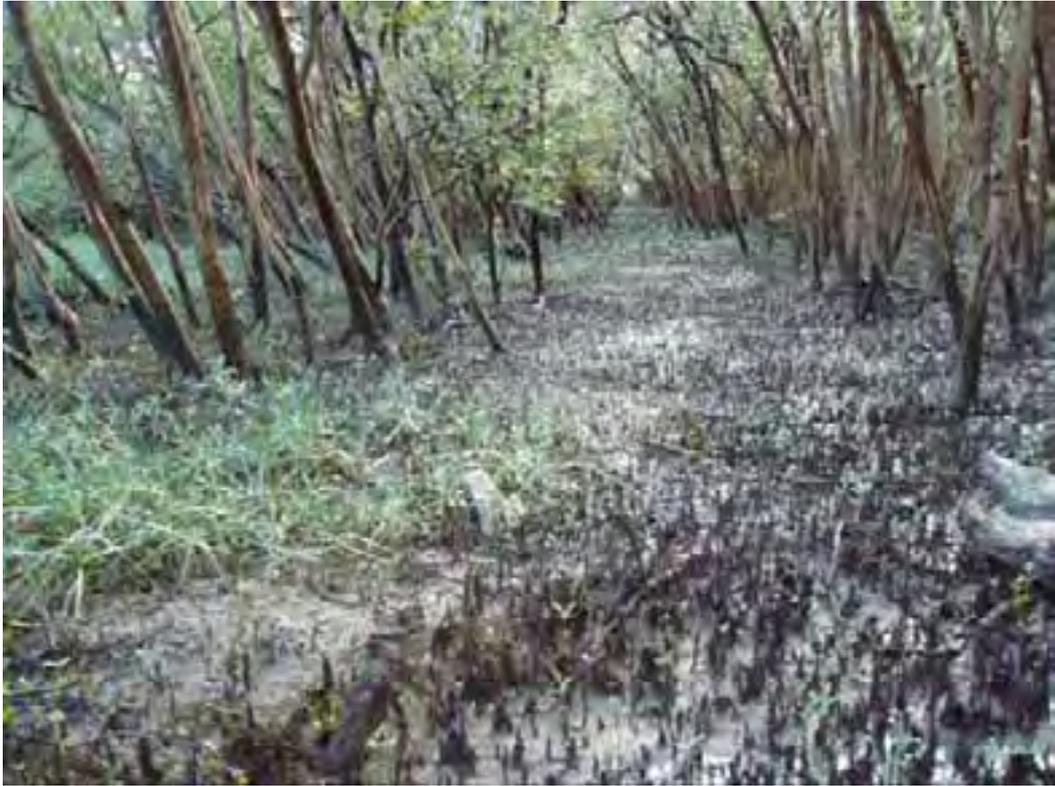
**Figure 6:** An old track cut through the mangroves and patches of spartina in the mangal beside the Thames Toyota factory on the true right bank of the lower Kauaeranga River.

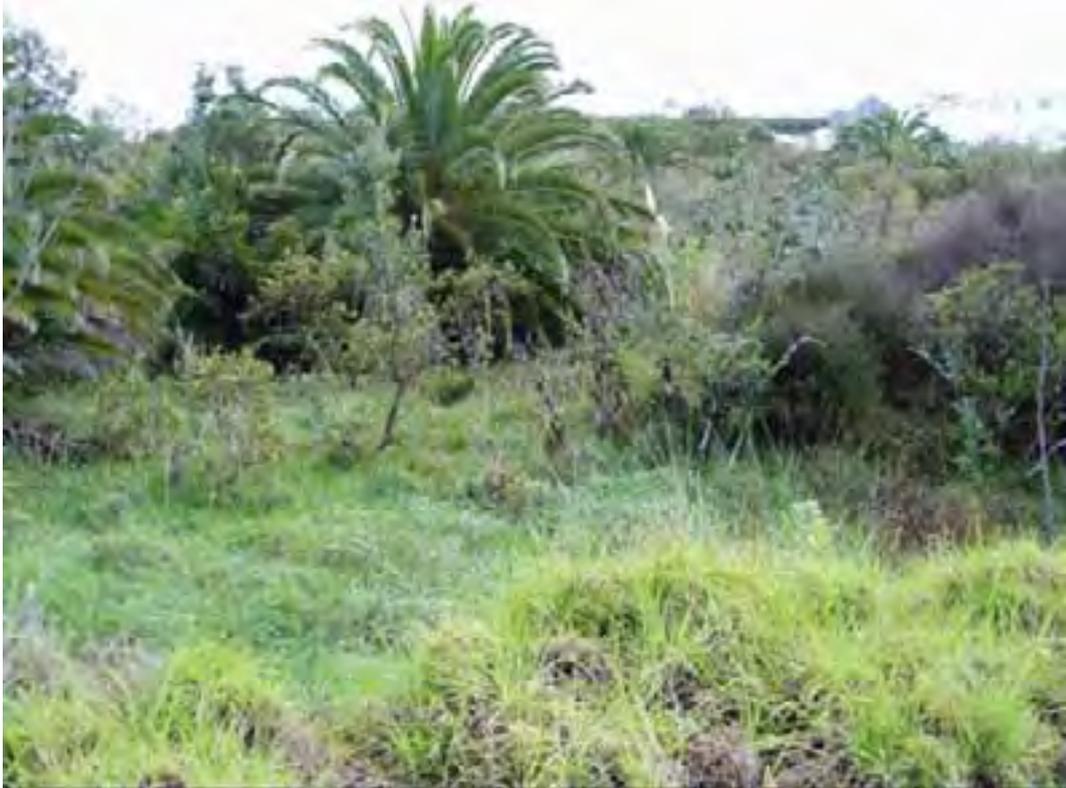
**Figure 8: Saltmarsh ribbonwood, mangroves and karo competing with introduced weeds (phoenix palms, tall fescue, honeysuckle, wattle and smilax between the SH 25 bridge and the Toyota factory).**

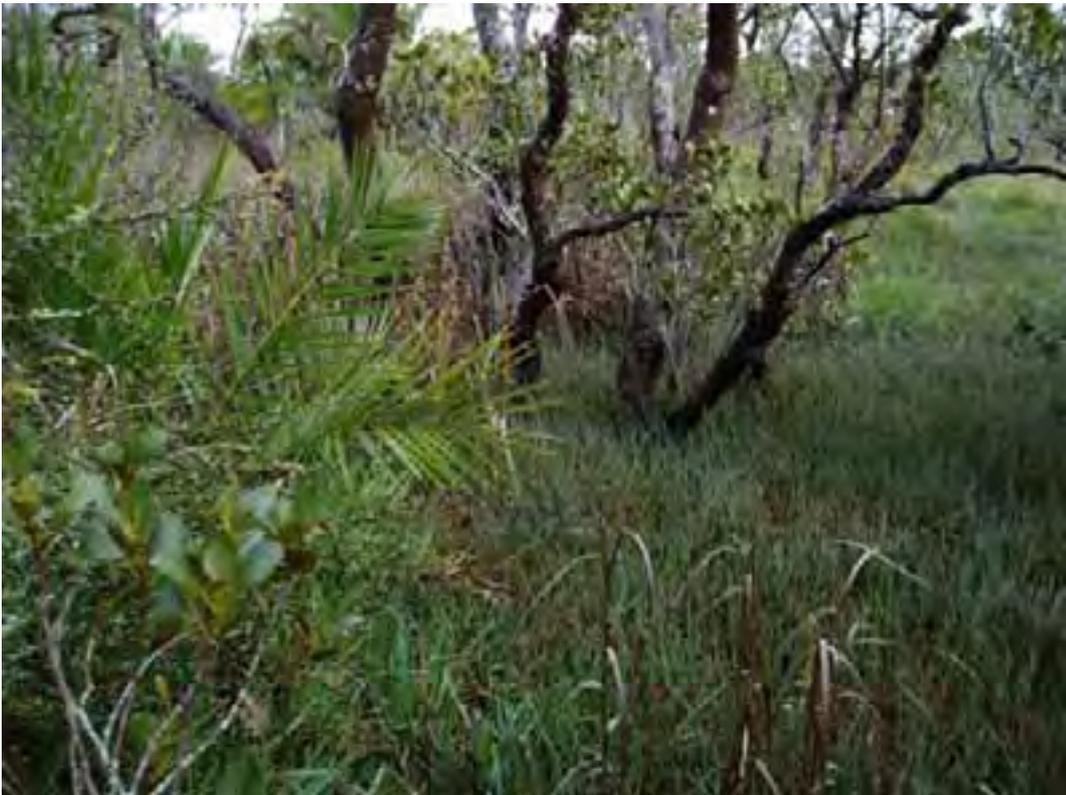
**Figure 9: A phoenix palm seedling and buffalo grass growing amongst glasswort, mangroves and marsh clubbrush (between SH 25 bridge and the Thames Toyota factory).**

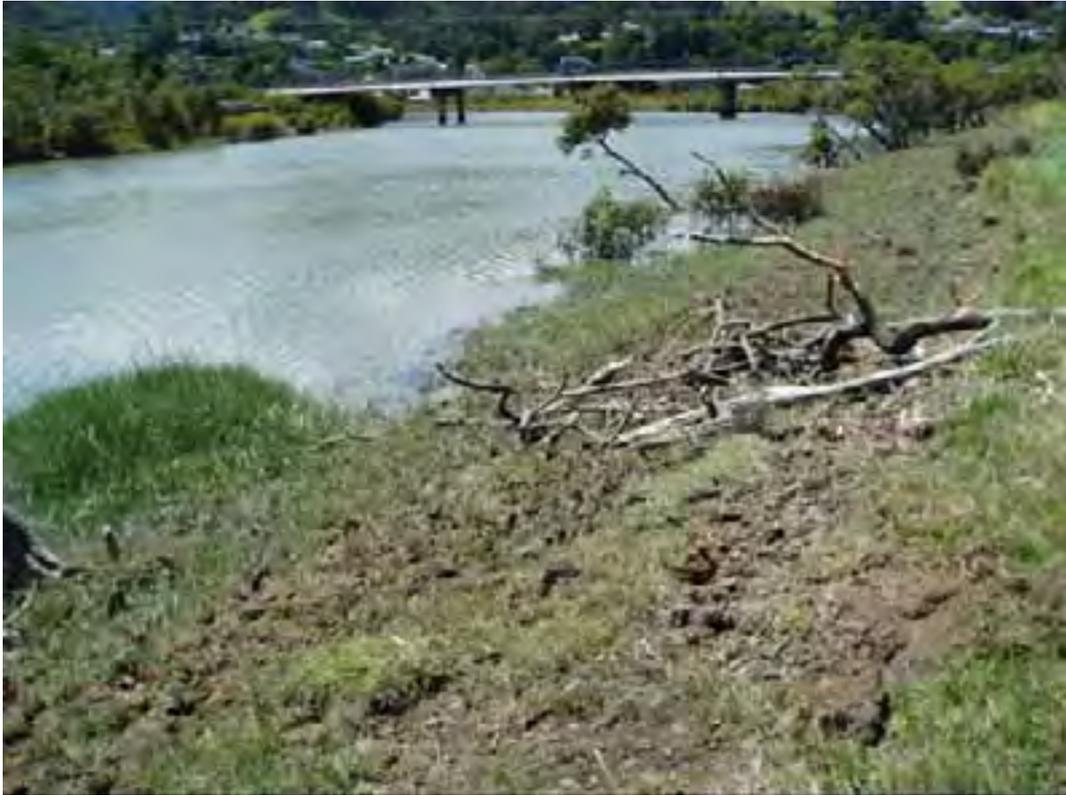
**Figure 10: Pugged spartina on the lower true left bank of the Kauaeranga River.**

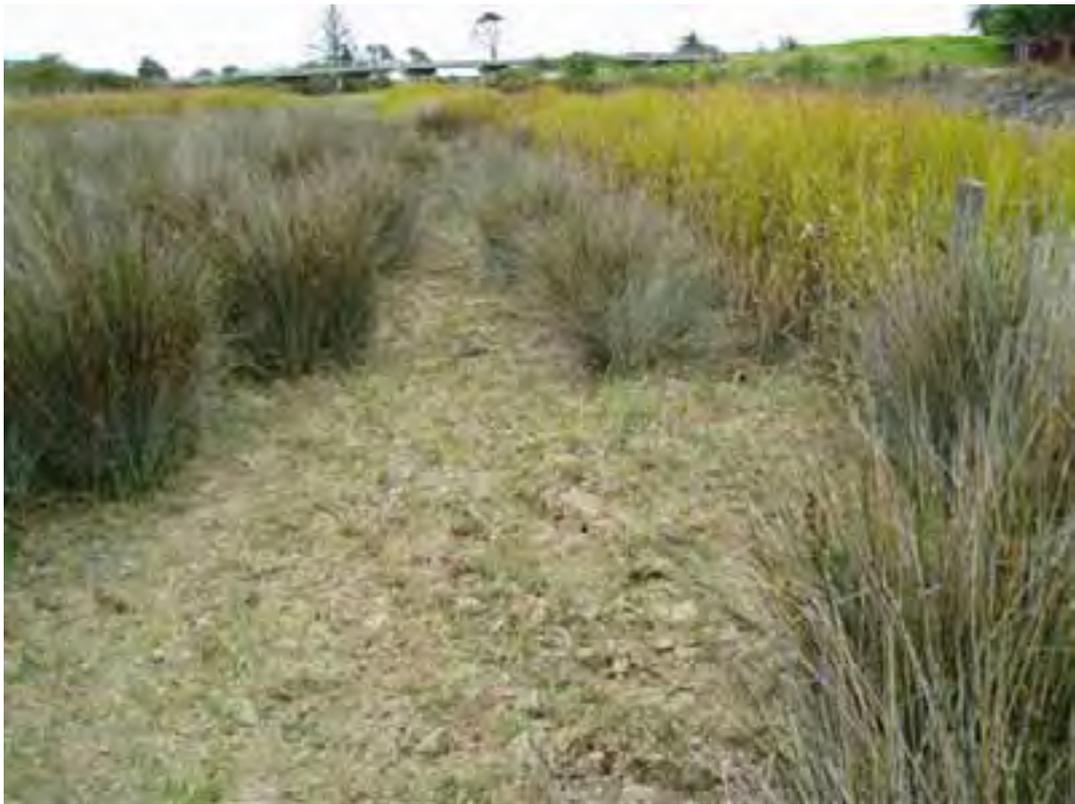
**Figure 11: A grazed area of the lower Kauaeranga floodplain upstream of the SH 25 bridge. The swamp clubrush has been preferentially grazed out leaving patches of sea rush and heavily grazed spartina.**

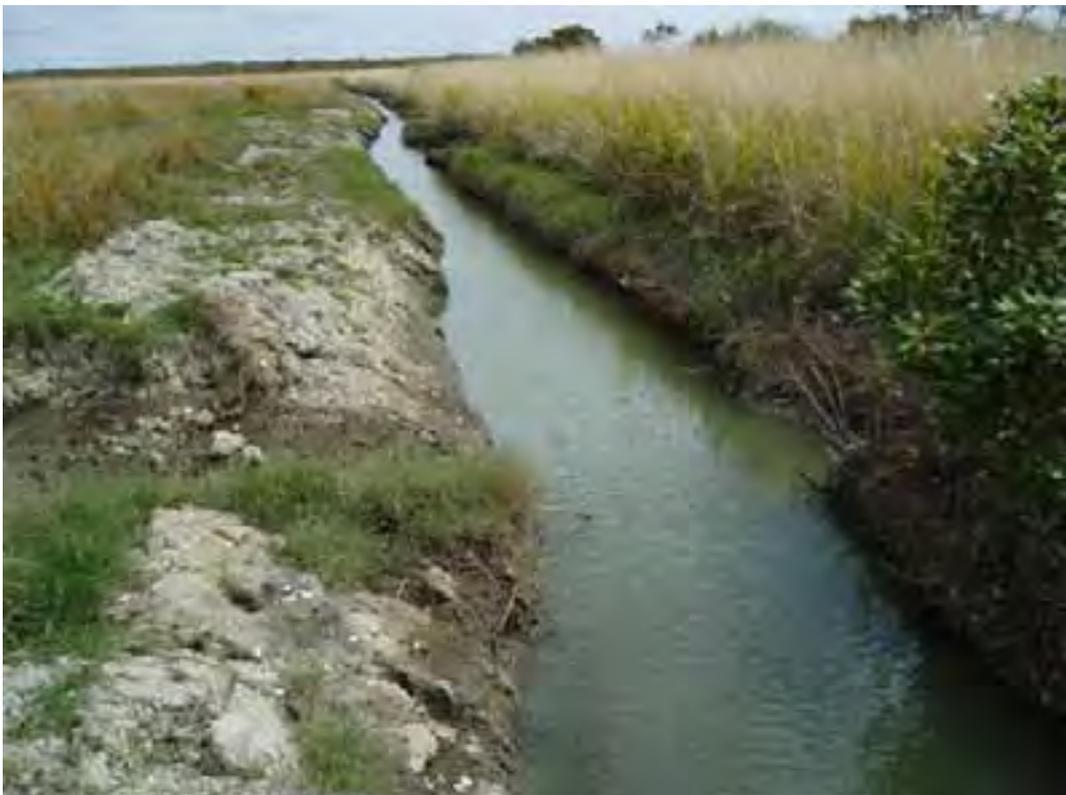
**Figure 13:** Saltwater paspalum (grey green in foreground and middle ground) lined a newly dug drain near the motor cross field, Kauaeranga River.

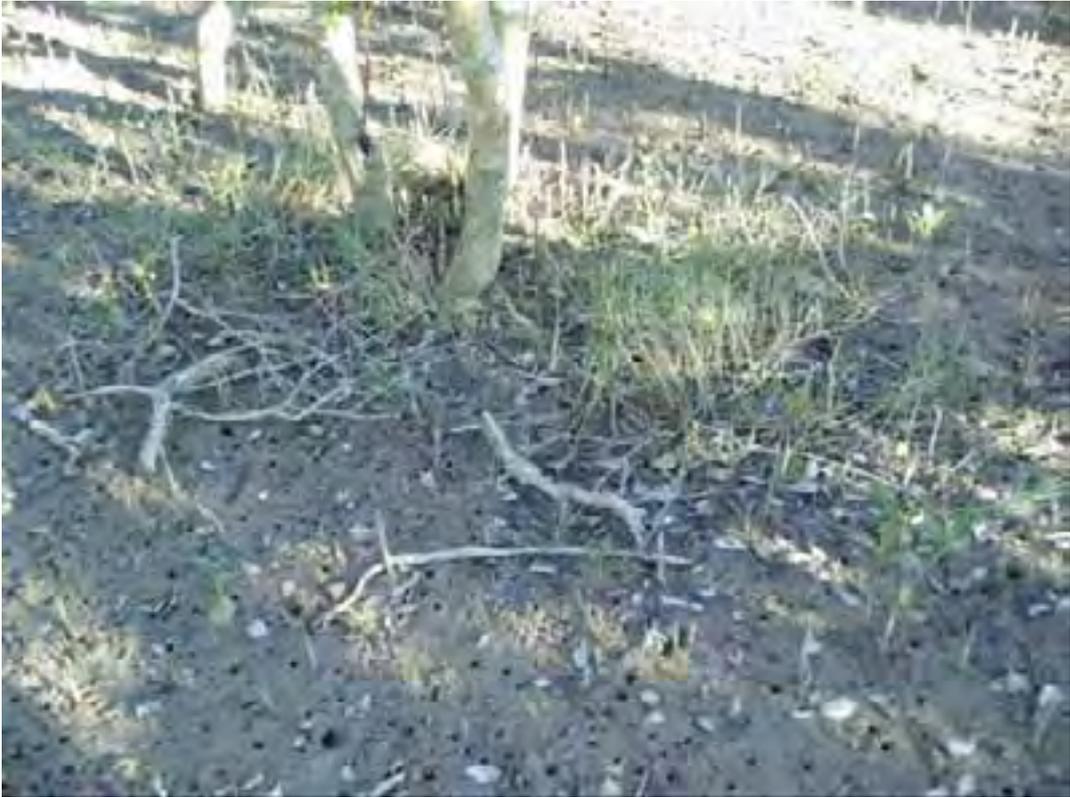
**Figure 18:** A small patch of saltwater paspalum found under open mangal canopy (opposite treatment ponds).

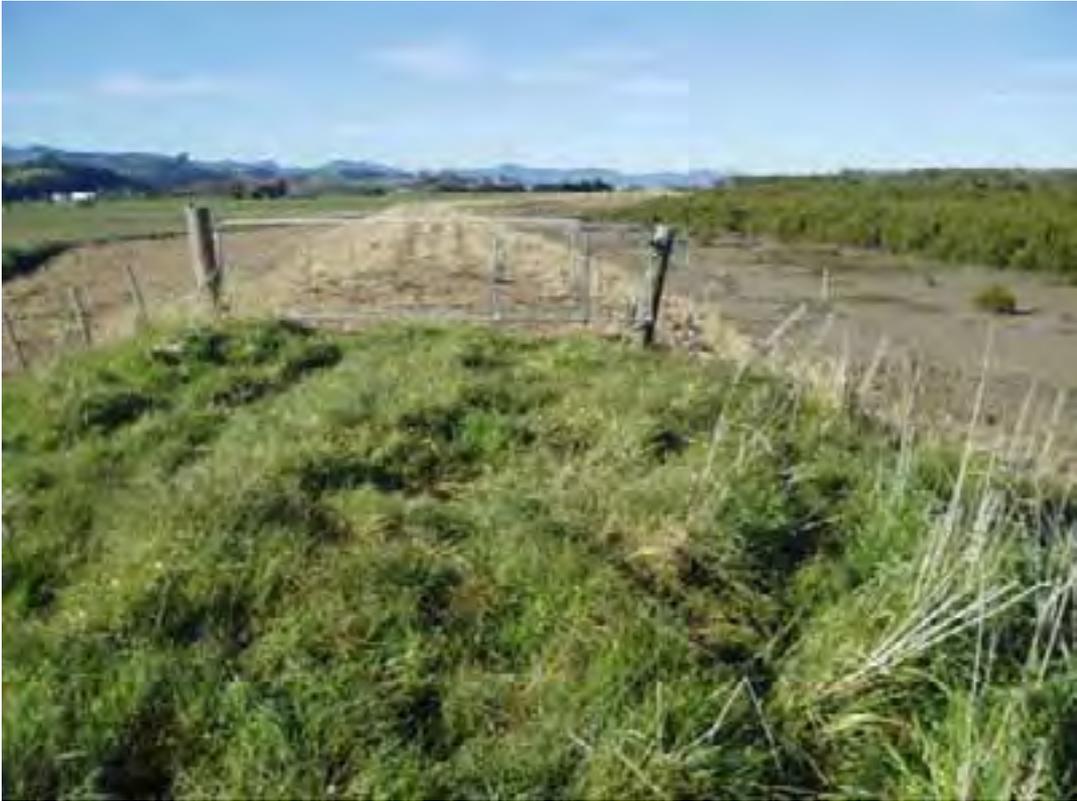
**Figure 20:** Heavy stock grazing of the stopbank and stock pugging and grazing of the open flats, sea meadow and mangrove edge (south of the treatment ponds). A thick bank of young mangroves is visible in front of the mature mangrove boundary.

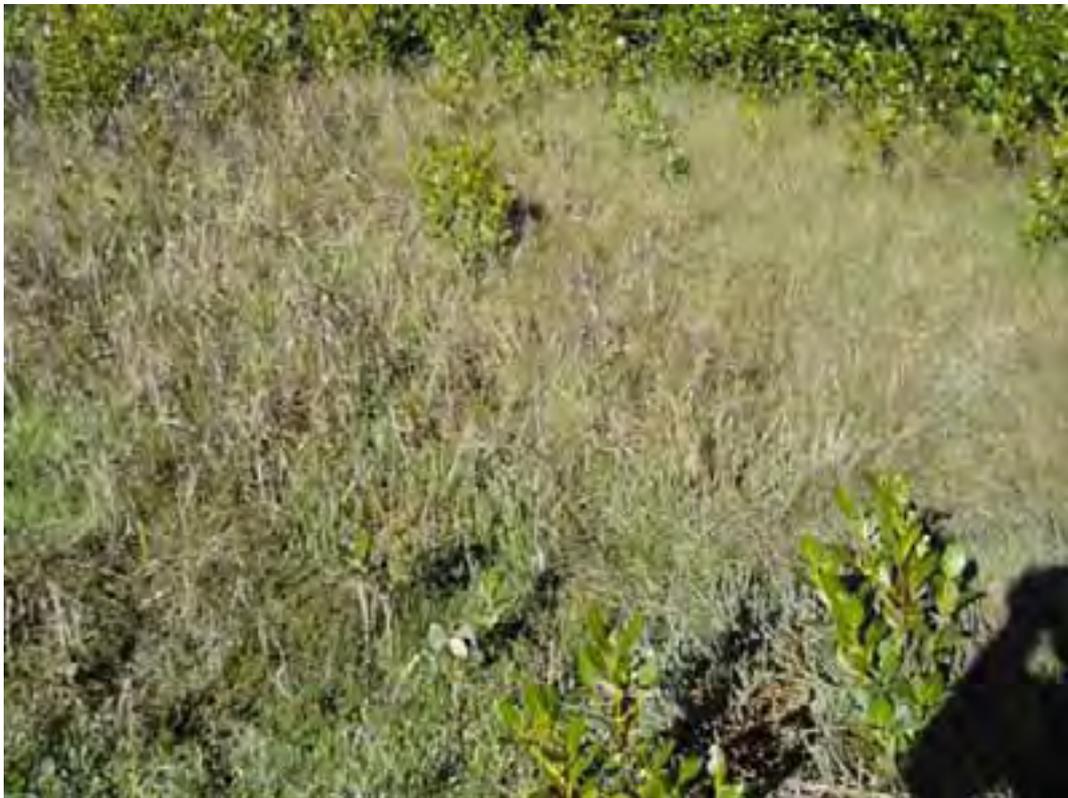
**Figure 21:** A patch of saltwater paspalum upstream of the Waipapa River mouth. Mangroves and sea primrose were present around the edges.

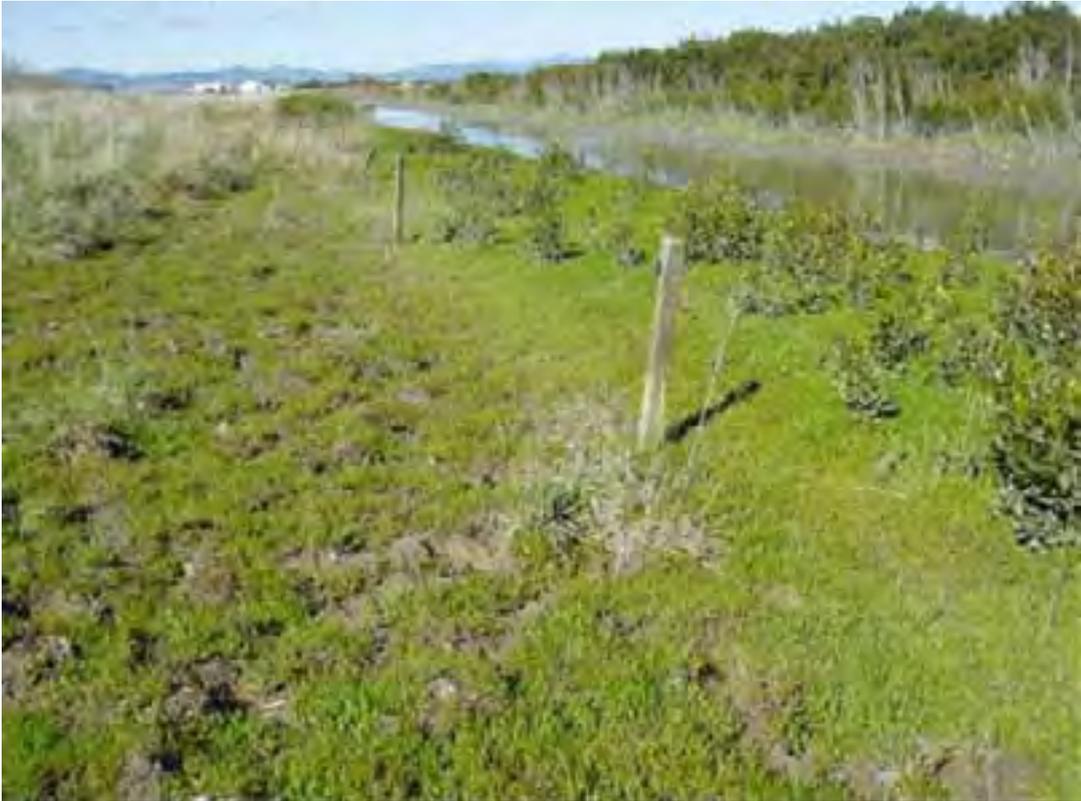
**Figure 22: Pugged and un-pugged Bachelor's button along a drain looking south toward Kopu boat ramp. A small plant of Maori musk was also found here.**

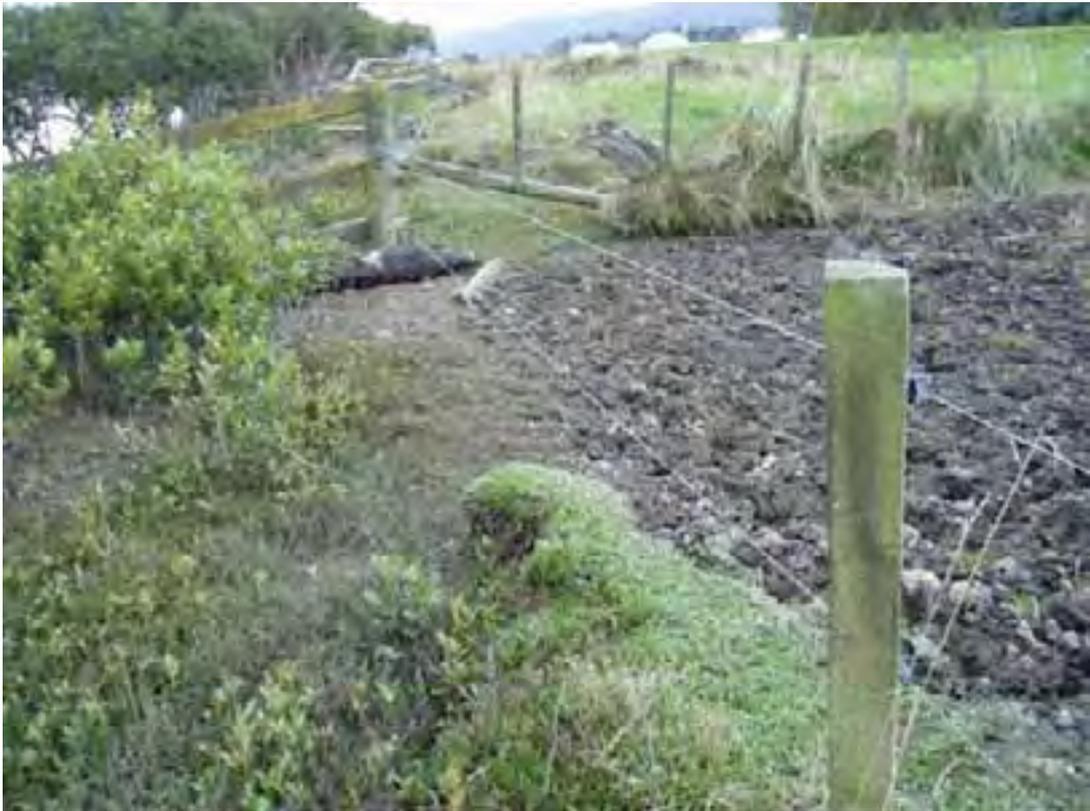
**Figure 23: Severe pugging of the Waihou River bank. Saltwater paspalum and sea meadow were present on the un-pugged banks.**

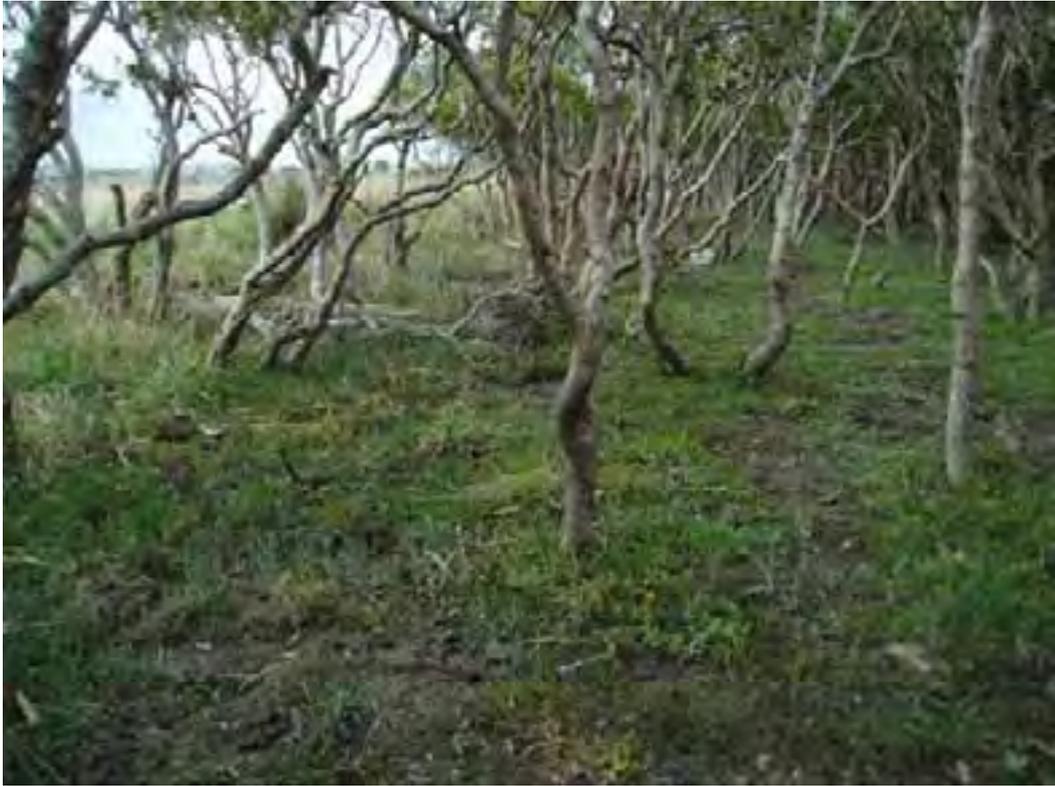
**Figure 24:** South of the Kopu bridge this mangal edge with a subcanopy of sea meadow was unfenced and hence pugged and grazed. True right bank Waihou River.

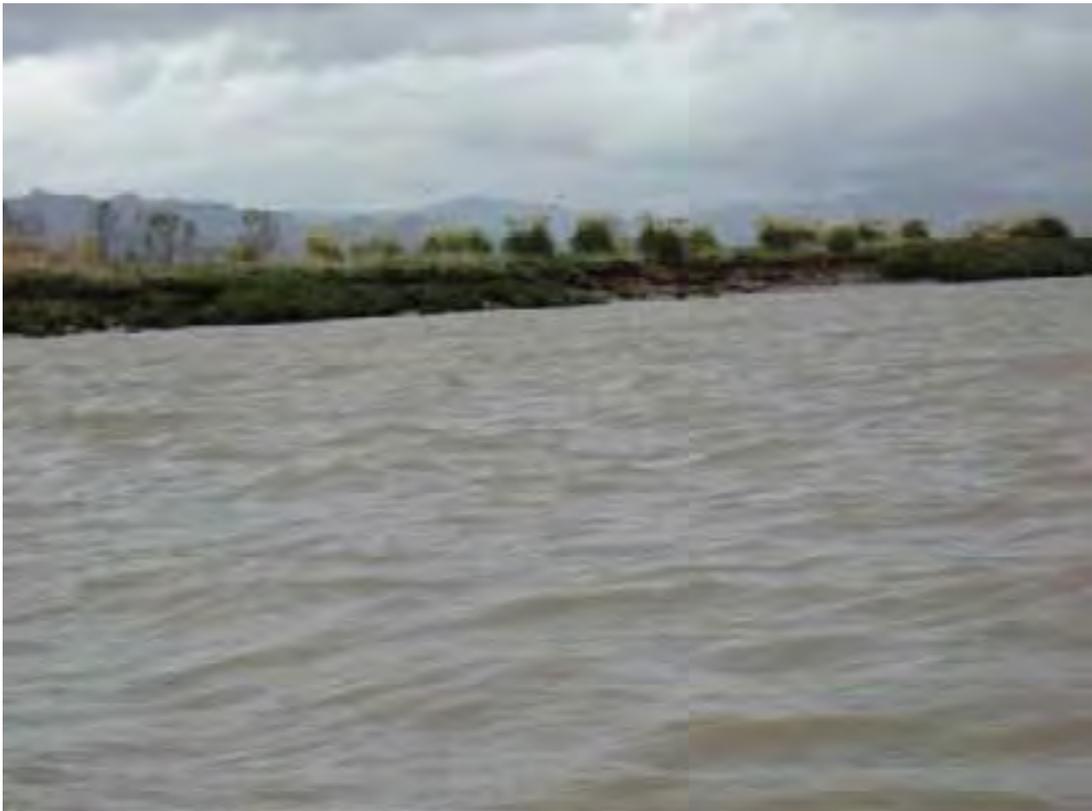
**Figure 29:** Thick banks of spartina are eroding into the Waihou River downstream of the Matatoki Canal.

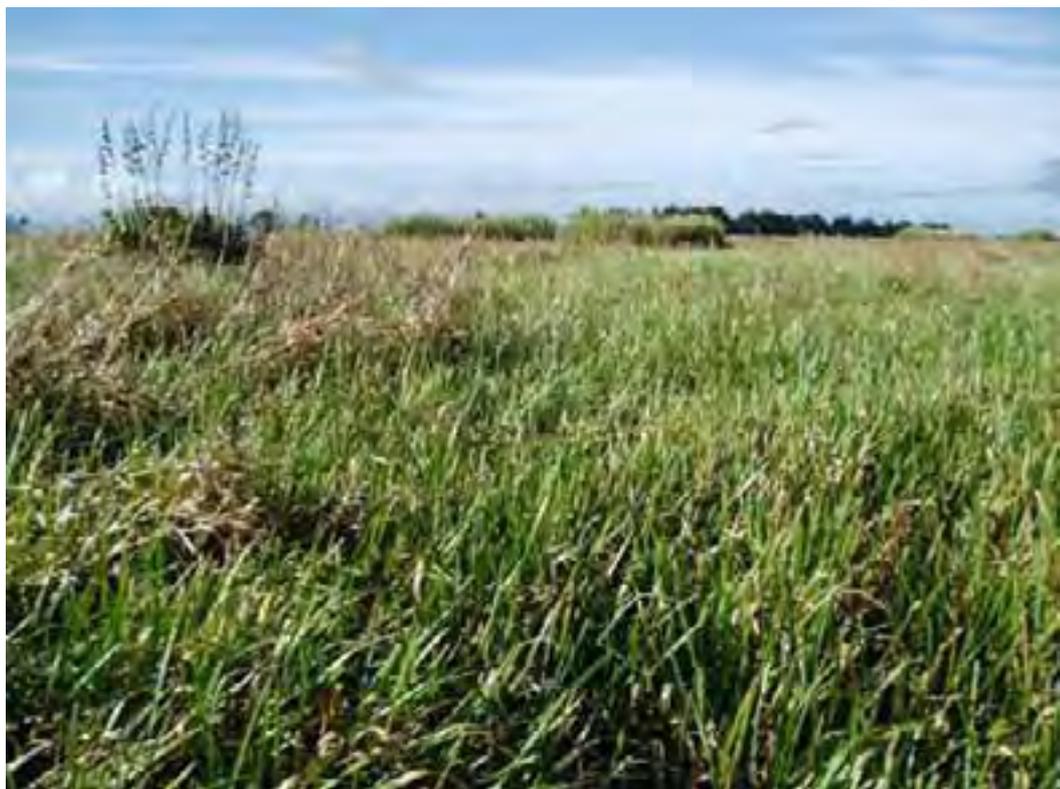
**Figure 31: Sweet reedgrass dominating swamp clubrush, flax and raupo behind mangroves on the Waihou River bank near the Matatoki Canal.**

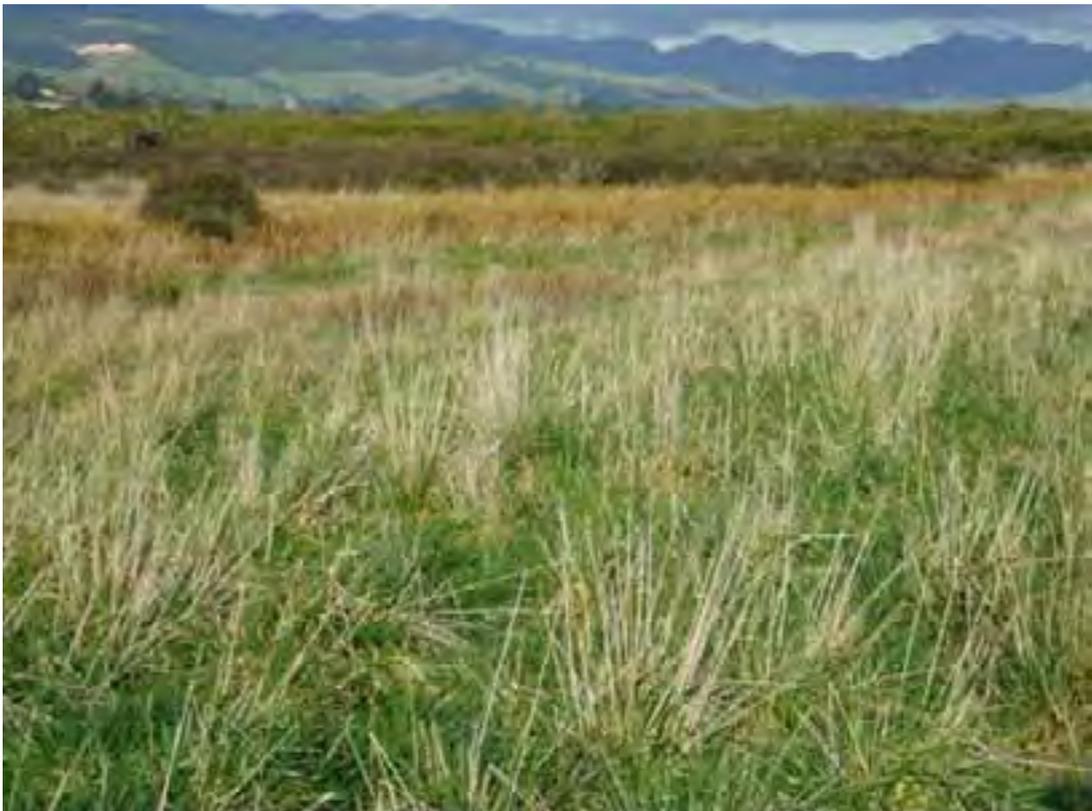
**Figure 38: Saltwater paspalum (light green in centre) invading a glasswort bed under the mangal canopy downstream of the Kopu Bridge (true left bank).**
