Estuarine Vegetation Survey – Tairua Harbour

June 2008

Prepared by:
Meg Graeme M.Sc (Marine Science)
Natural Solutions – Marine and Terrestrial Ecologists Ltd

For:
Environment Waikato
PO Box 4010
HAMILTON EAST

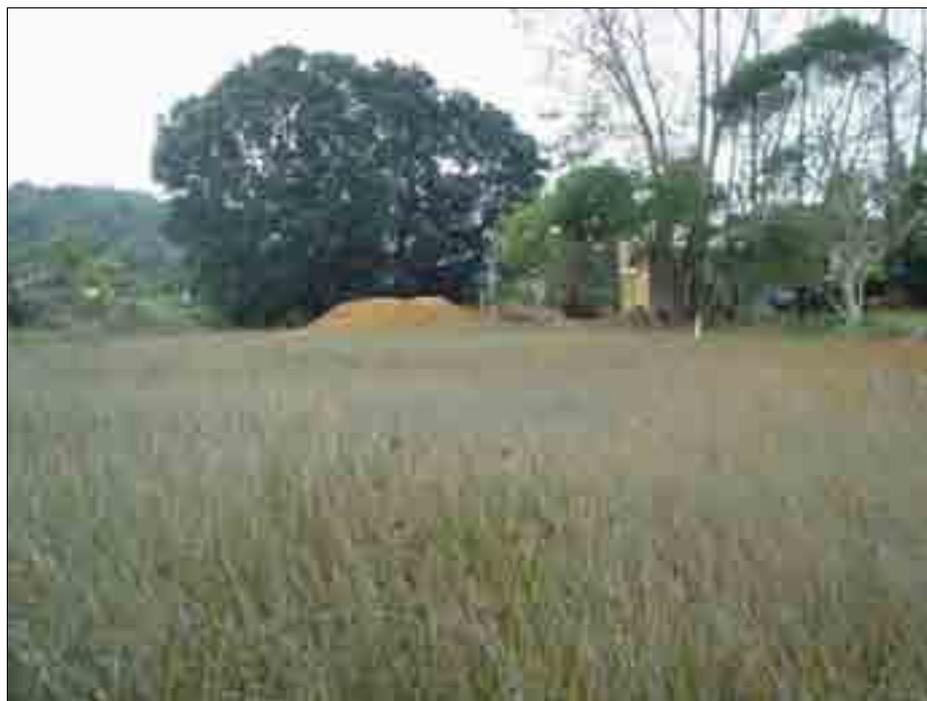
Figure 3: Infilling for housing has encroached on the Grahams Stream wetland in places. In this photo spoil is being dumped along the north-eastern side of the wetland (next to the beginning of the boardwalk path).

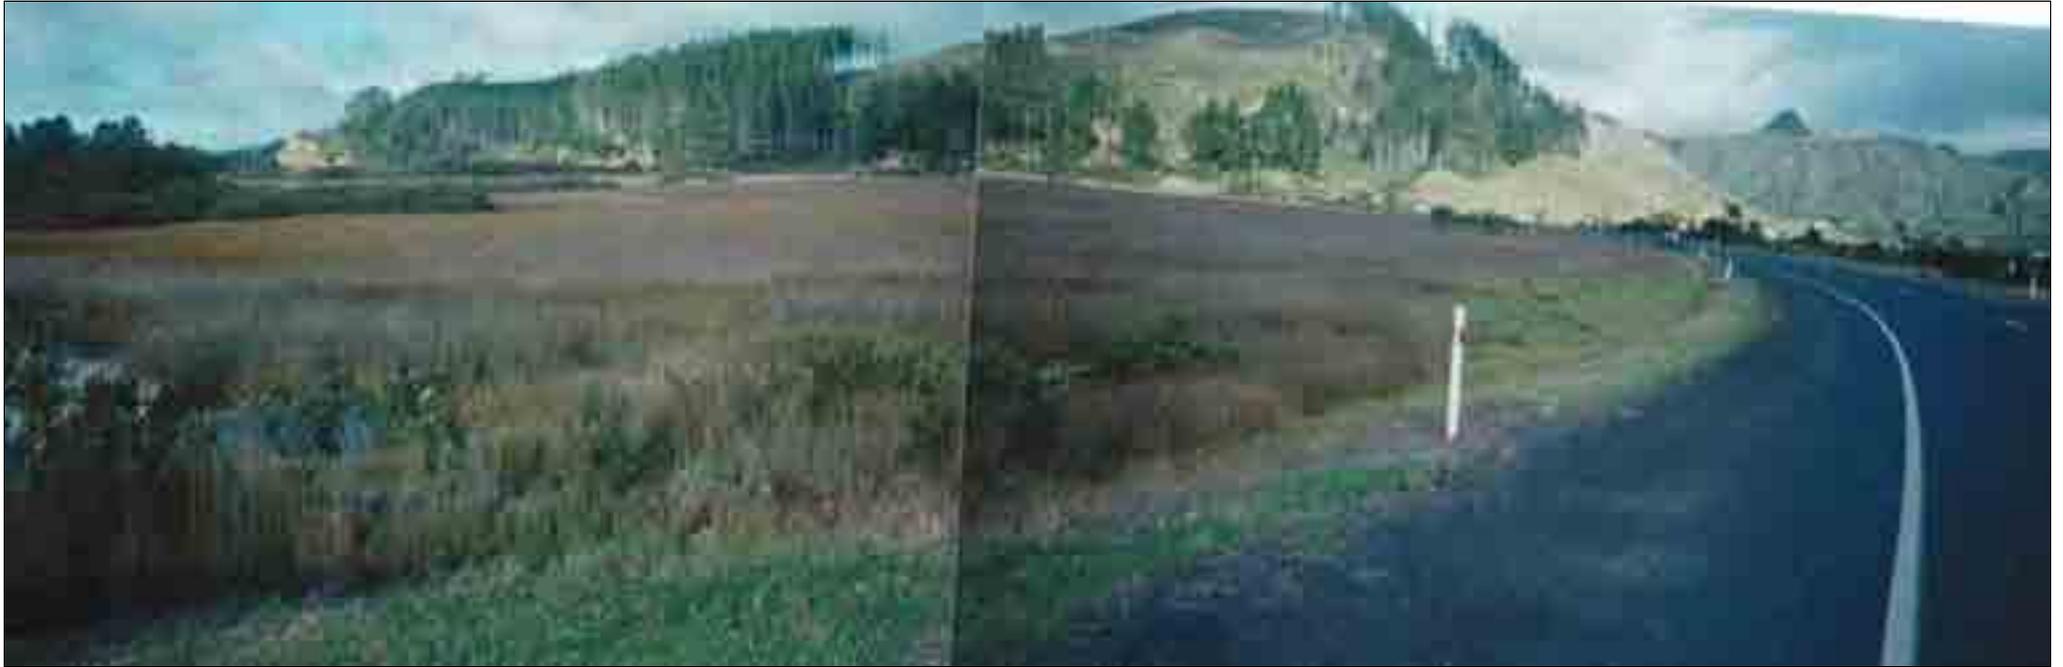
Figure 10: This photo is a repeat of the 1998 photo [41] showing the alignment of the new road and expanding patch of saltwater paspalum. The undisturbed saltmarsh remains unchanged.

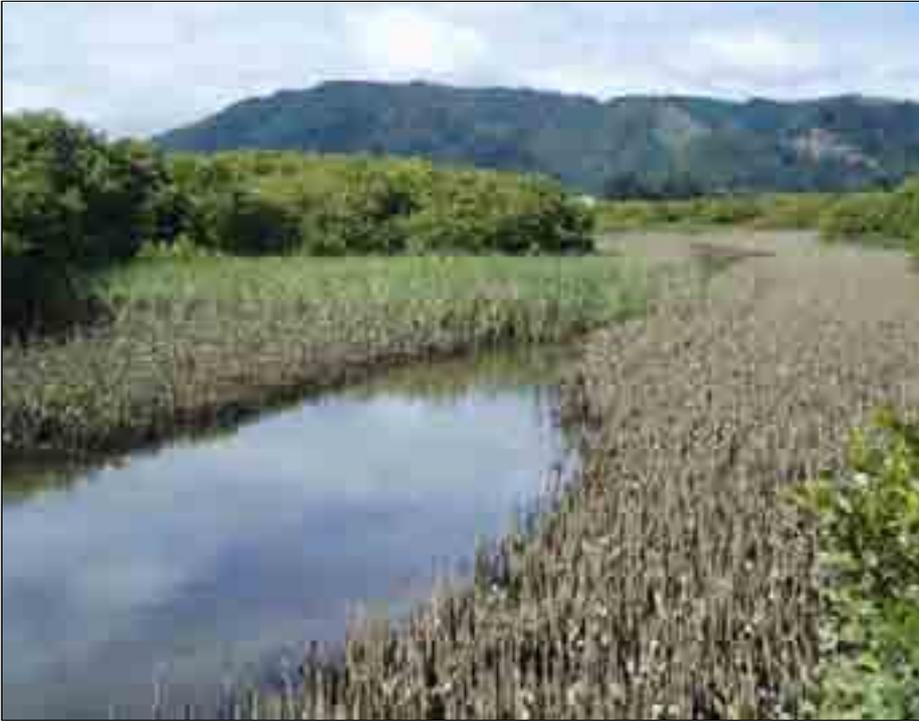
oioi. A patch of healthy spartina was found along the northernmost mangrove-lined channel in the Oturu embayment (Figure 11). Figure 12 shows a band of saltwater paspalum dominating the zone between the mangroves and rush/sedgeland. Figures 13 and 14 show a view of the Oturu Stream from the new road bridge and Figure 15 shows the re-aligned highway around the back of the Oturu embayment. Figure 16 shows a repeat view of the 1998 photo [46] from **Green Point** looking over the southern end of the Oturu embayment wetland. Vehicle tracks were noted coming from State Highway 25 near the TLB of the highway bridge through the sea rush and out to the high land on the TLB of the Oturu Stream mouth.

Figure 11: A healthy patch of spartina found growing along a mangrove creek immediately north of Oturu Stream (NZMG 2762419.0, 6459713.4).

- **Spartina** – The Department of Conservation has been controlling spartina with herbicide in the harbour since the early 2000's. During the current survey, a few surviving plants were found at the sprayed sites (see Figures 18 and 34) and a new uncontrolled site was found within the Oturu Stream embayment (see Figure 11).

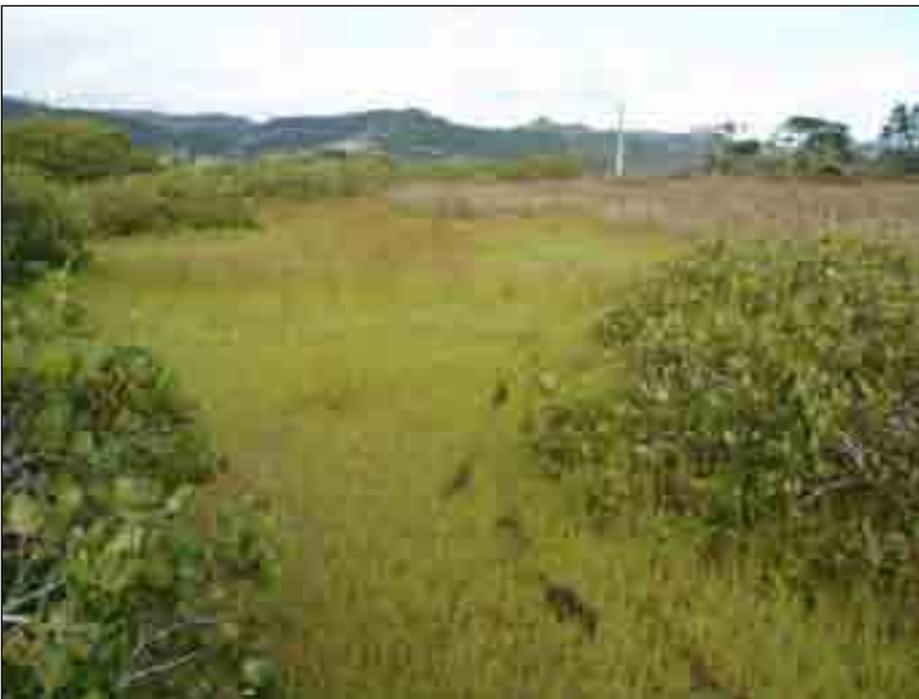
Figure 12: Saltwater paspalum forms a band between the landward edge of mangroves and seaward sea rush community in the Oturu Stream embayment. Sparse oioi can be seen scattered amongst the saltwater paspalum.

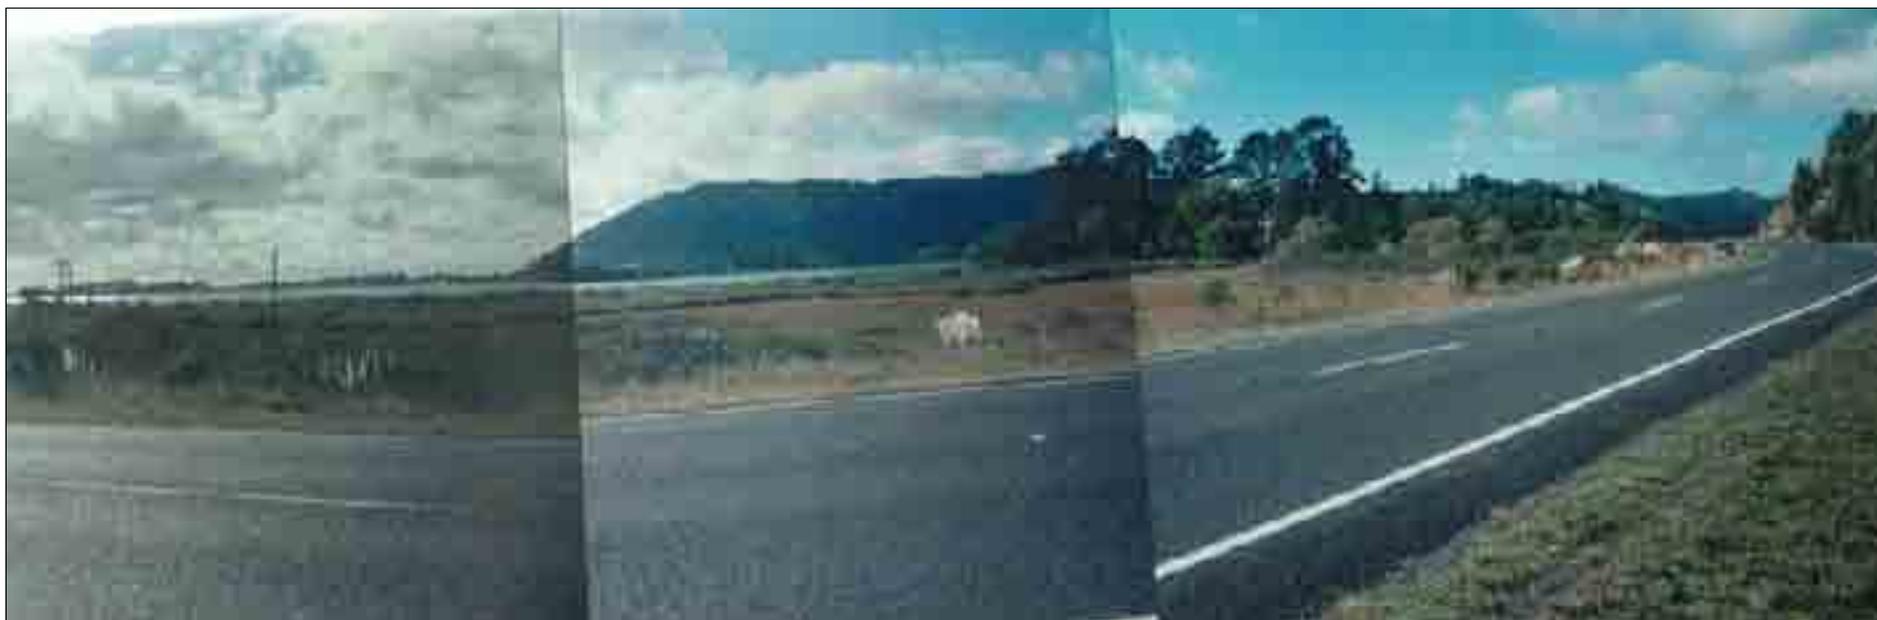
Figure 15: A view of the realigned SH25 and neighbouring saltmarsh. The new road line has resulted in the loss of large areas of manuka/tangle fern wetland that formed part of a natural sequence of estuarine to freshwater wetland communities as was pictured in the 1998 photo [44].

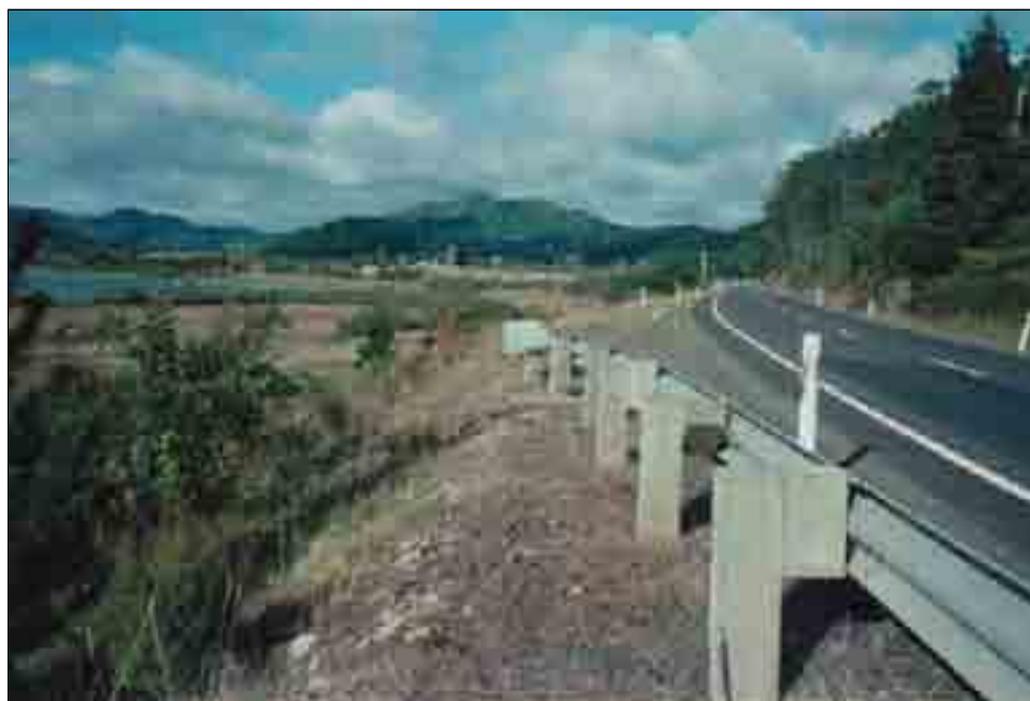
Figure 17: A repeat of 1998 photo [47] showing the newly aligned SH25 that has encroached out into the saltmarsh. The roading disturbance has also allowed a band of weeds to establish out from the road earthworks.

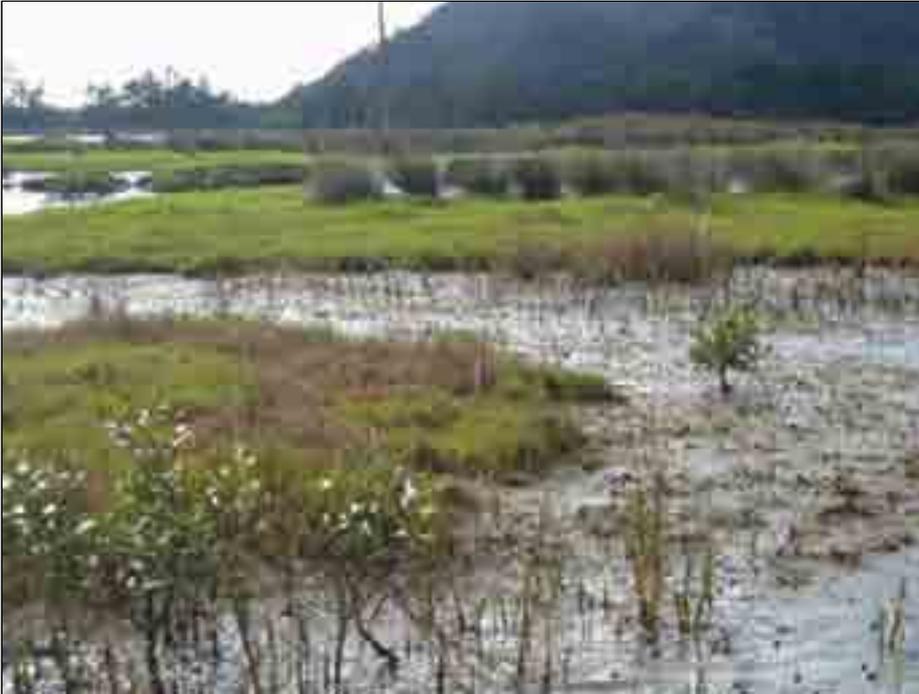
Figure 18: Spartina has been sprayed in the Swamy Stream embayment (dead patches in green mat and scattered stalks on open flats) but the saltwater paspalum has been left to continue encroaching over the open mud flats.

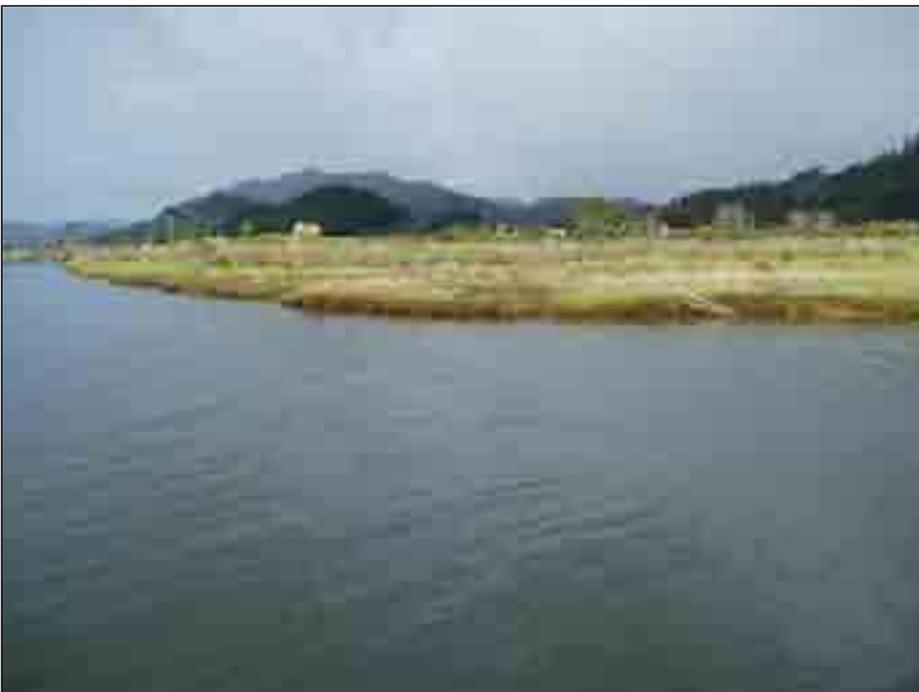
Figure 19: Sprayed spartina amongst saltwater paspalum towards the southern end of the Swamy Stream embayment. The piled up logs in the left background have been purposefully placed to provide bank protection.

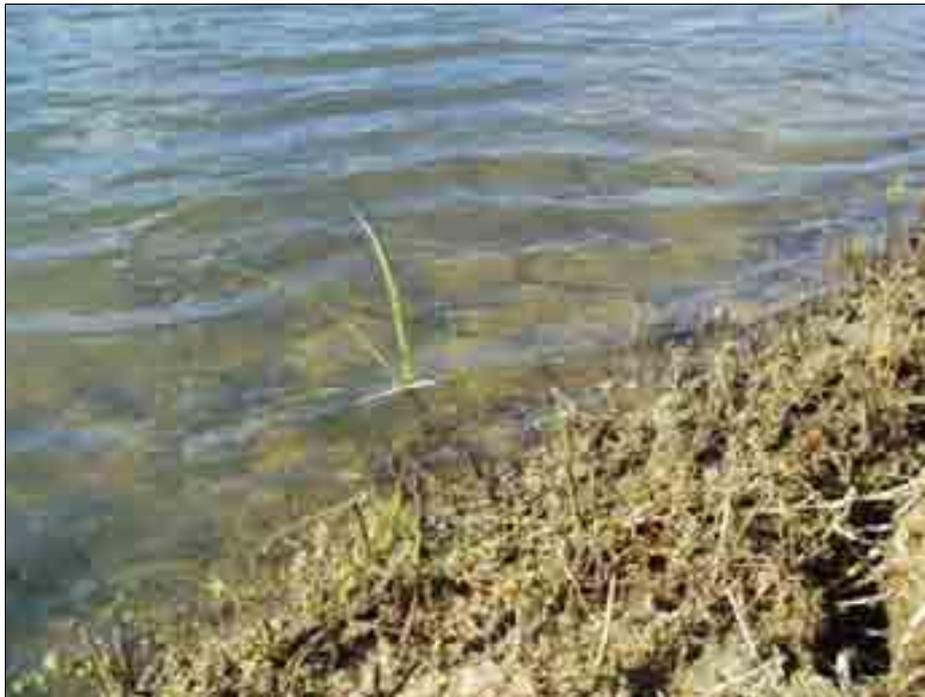
Figure 20: Occasional fragments of spartina survive and require follow-up spraying. Live sea primrose and a runner of saltwater paspalum can just be seen amongst the dead spartina root mat.

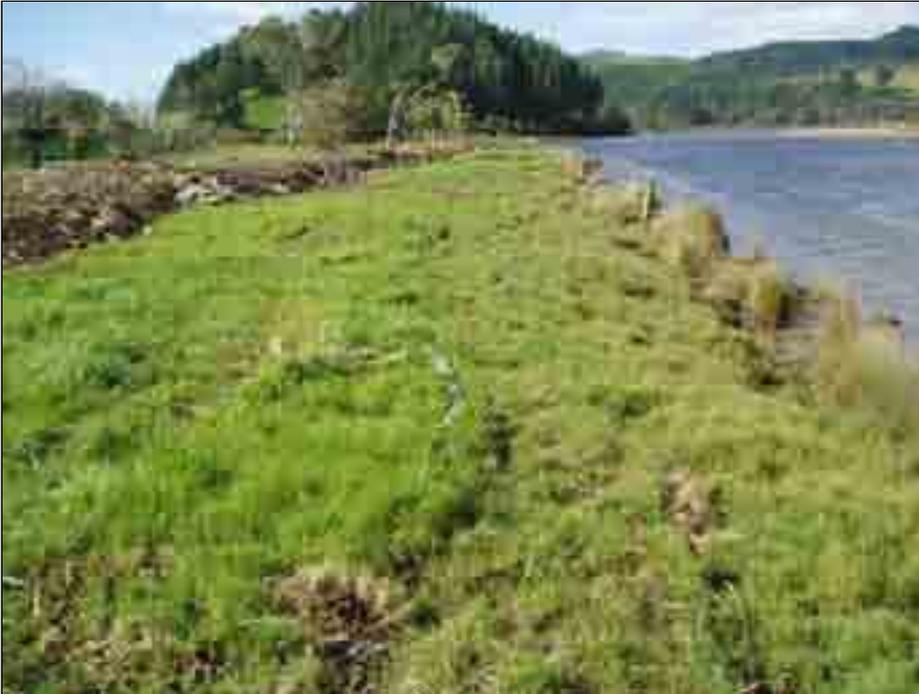
Figure 22: A view looking downstream from a fence line showing the embankment of the river edge. A thin patchy band of rushes exist along the eroding bank edge. A change in the colour and lushness of the grass indicates the inland boundary of saltwater paspalum with kikuyu grass.

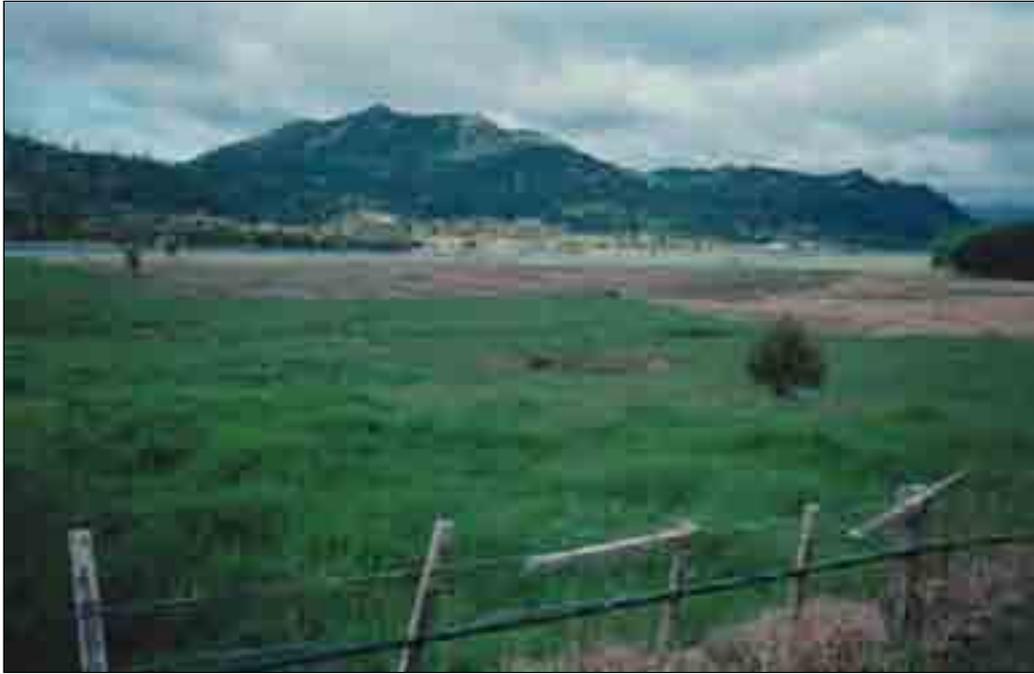
Figure 24: This photo shows a repeat view of the floodplain in the 1998 photo [48]. Note the recent earthworks to presumably form large ‘hollows’ to concentrate and drain the floodwaters that naturally accumulate on this floodplain. Figures 22 and 23 show the harbour margin of this area.

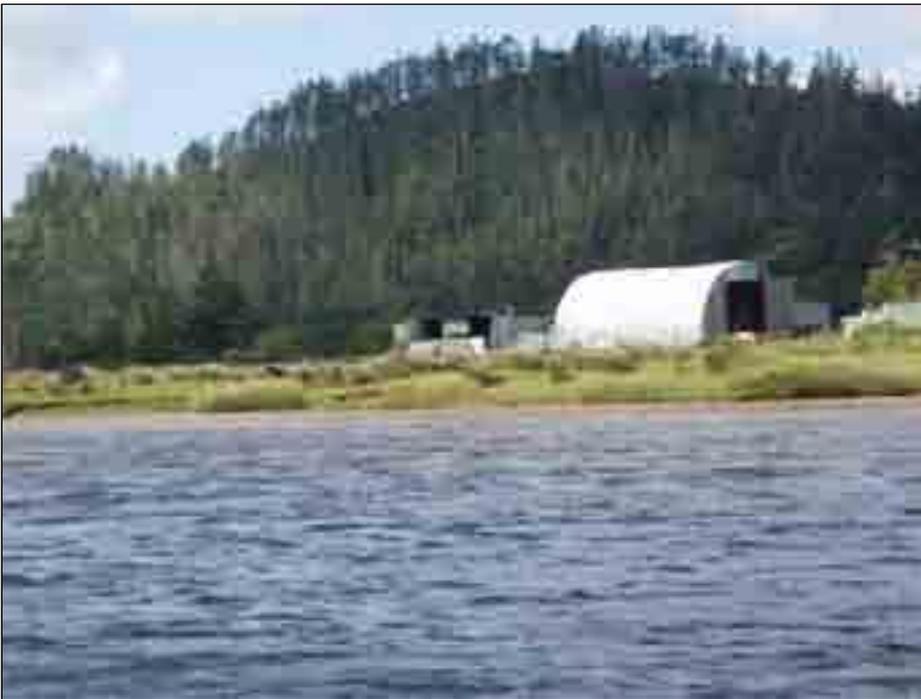
Figure 27: A view from the upper harbour looking over to cattle grazing amongst saltwater paspalum and rushes.

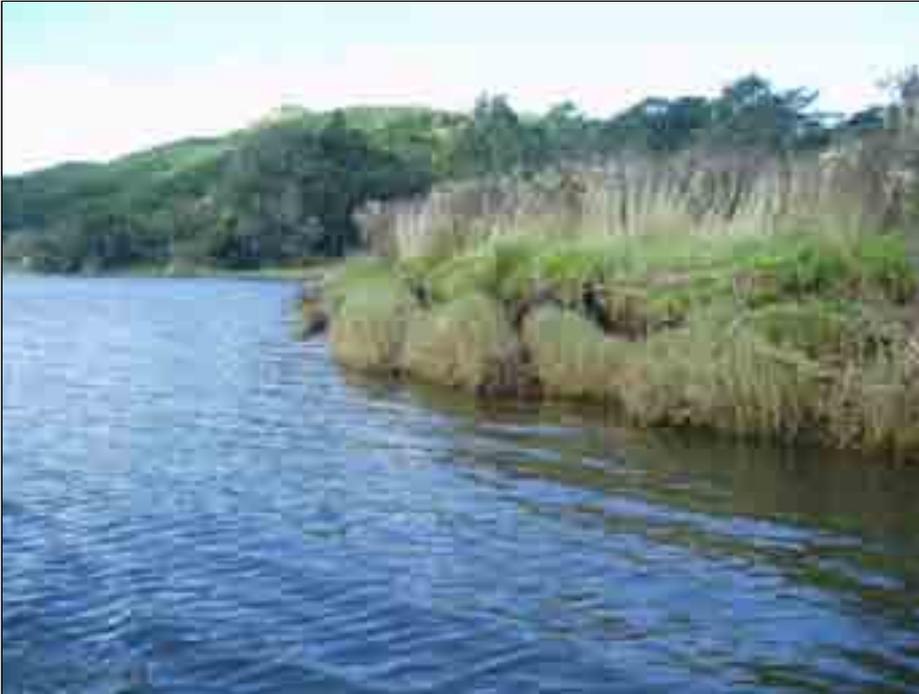
Figures 30 and 31 show eroding banks and saltwater paspalum at the mouth of **Duck Creek**. A bittern was disturbed at the stream mouth and further investigation found uprooted saltwater paspalum suggesting the bittern could have been feeding in/on this grass (Figure 32). Stock tracks are common in the saltmarsh on the TRB of Duck Creek. There is only a thin band of saltmarsh ribbonwood and oioi scattered amongst freshwater vegetation along the banks above the road bridge. Above the saltwater influence, manuka, freshwater rushes and flax dominate. Duck Creek is recognised as a highly significant freshwater wetland with a large fernbird population and other wetland bird species. Saltwater paspalum, reclamation and stock access are degrading the lower estuarine vegetation of this significant wetland sequence.

Figure 30: Slumping saltwater paspalum edge upstream of the mouth to Duck Creek

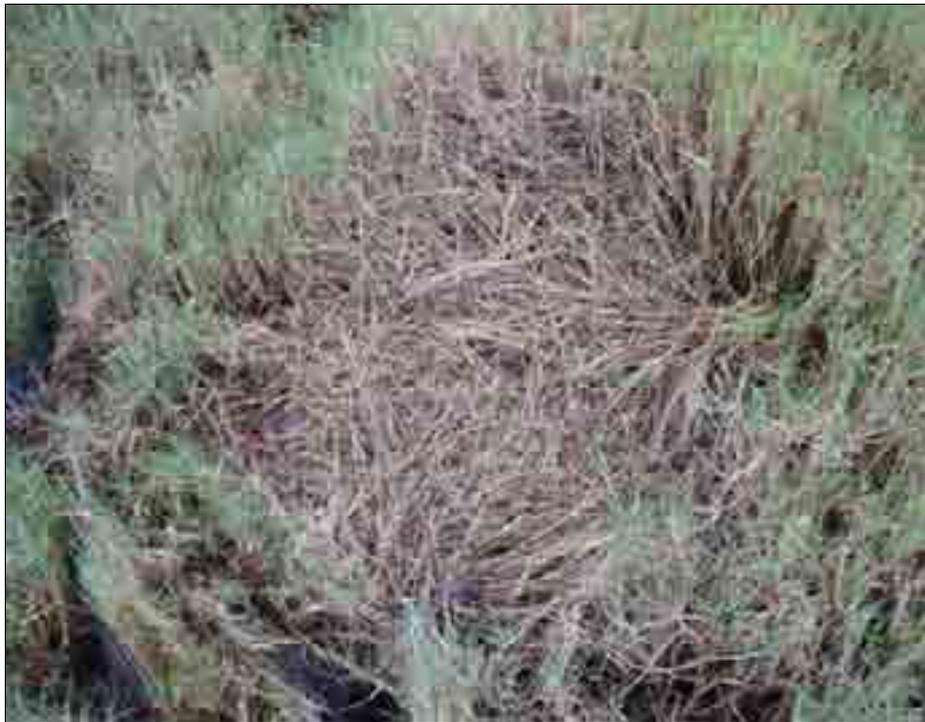
Figure 32: A number of areas of uprooted saltwater paspalum were found at the mouth of Duck Creek. A bittern was disturbed in the same area.

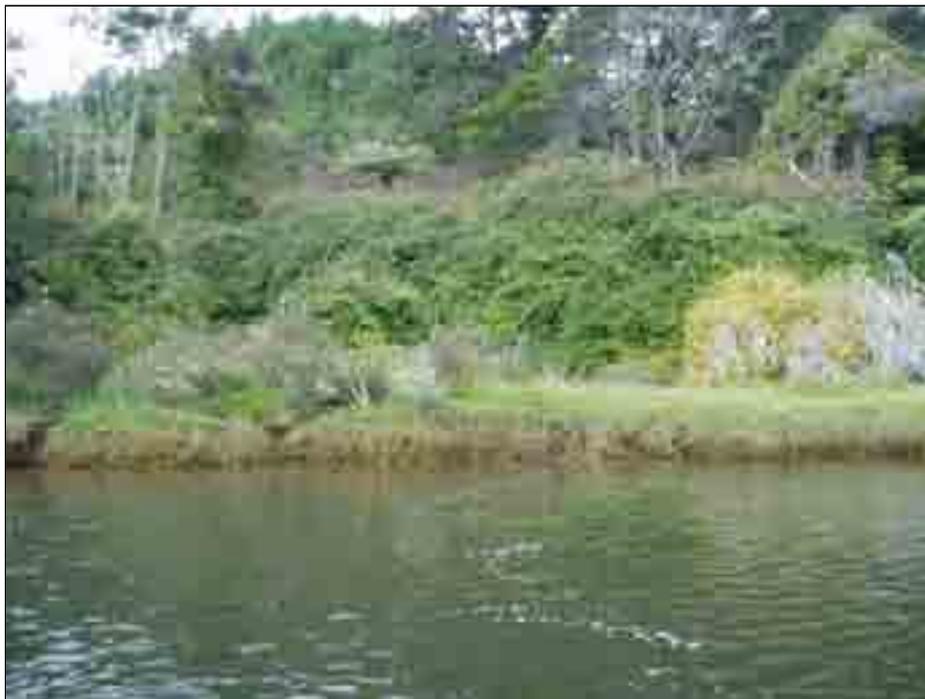
Figure 33 shows an un-natural coastal edge north of Duck Creek with *Eleagnus* dominating the landward bank and saltwater *Paspalum* dominating the tidal edge. The only native estuarine plants visible here are saltmarsh ribbonwood. Banded rail footprints were seen further north. Further north again, the saltwater *Paspalum* mats expand out to dominate the tidal flats immediately south of **Gumdigger Gully** stream mouth. A patch of sprayed *Spartina* was found along a *Paspalum*-lined creek (Figure 34). A few individual *Spartina* plants remain green. The saltwater *Paspalum* was generally over knee deep at this site. There were some small areas where sea primrose survives amongst lower-statured saltwater *Paspalum*. Saltwater *Paspalum* dominates at the stream mouth of Gumdigger Gully (Figure 35) while extensive rush/sedgeland is found further upstream. Saltwater *Paspalum* lines the creek edge and is backed by thick saltmarsh ribbonwood (Figure 36). Saltmarsh ribbonwood is also found in thin bands between the rush community and the forestry. Fernbird and banded rail are present in this wetland.

Figure 33: A repeat of the 1998 photo [53] showing saltwater paspalum still dominating the tidal flats with scattered saltmarsh ribbonwood. Note the eleagnus vine dominating the bank.

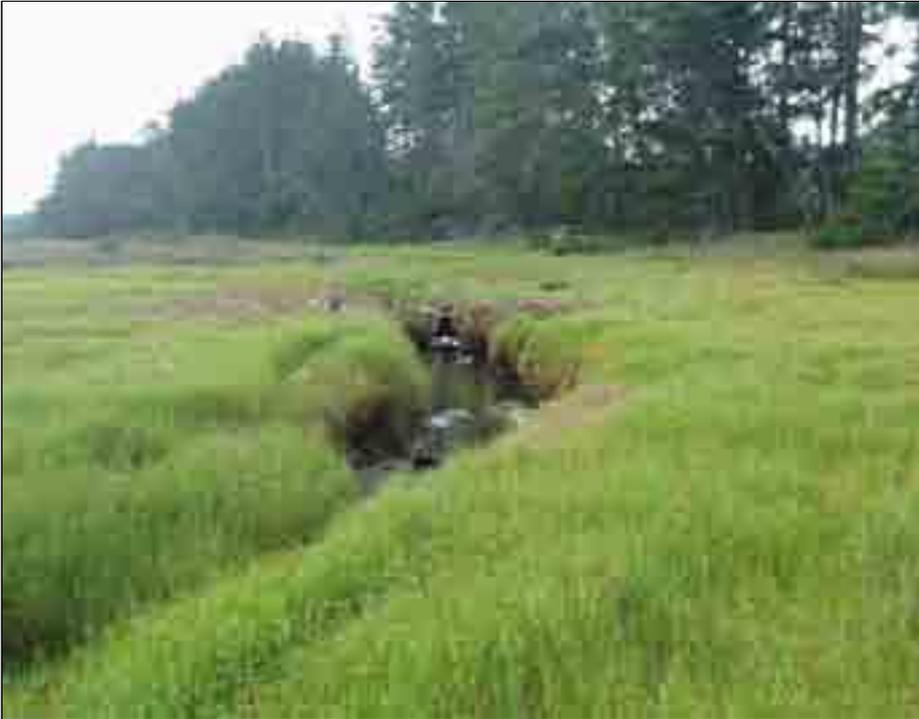
Figure 34: A sprayed patch of spartina (either side of creek) amongst dense saltwater paspalum. Sea rush can be seen in the left background and oioi along the landward edge on the right-hand side of the photo.

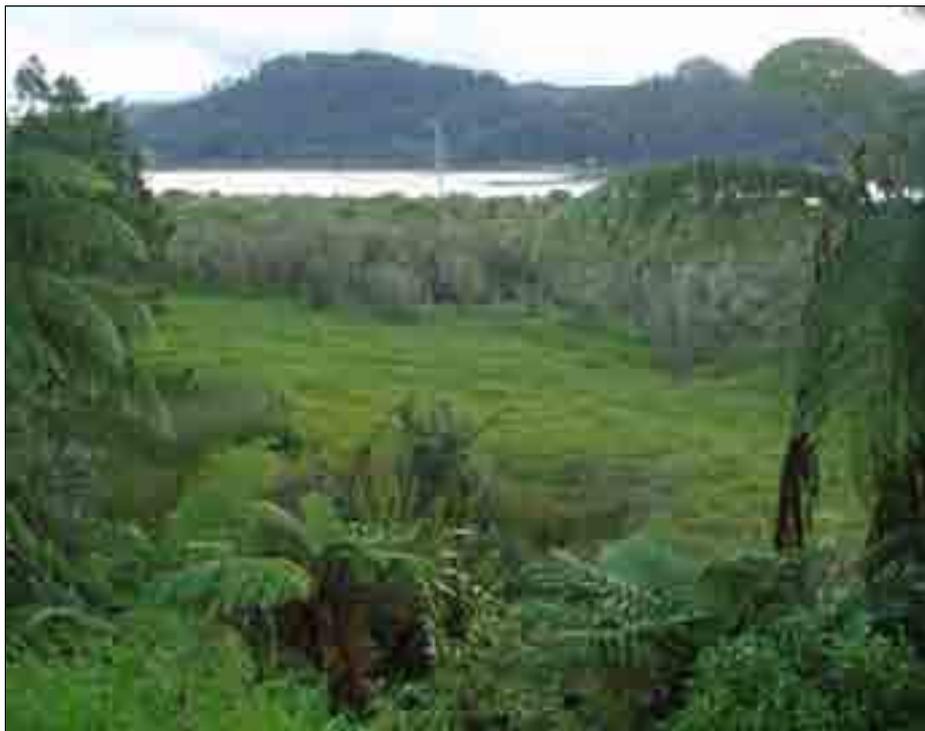
Figure 37: View (along a line of power poles) over a thick band of saltwater paspalum that has colonised between the landward rush edge and the mangroves.

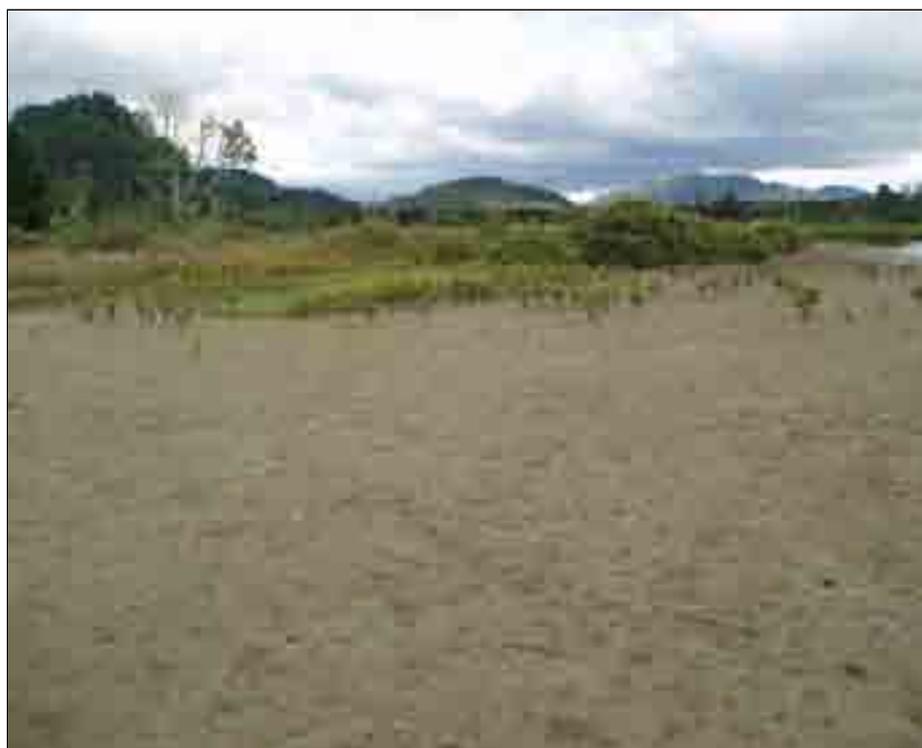
Figure 41: A view looking south over mud flats towards the natural mangrove edge. Mangroves have been cleared from the mud flats in the foreground of this photo. The board-walked Tangitarori wetland (Oxley gully) is in the background.

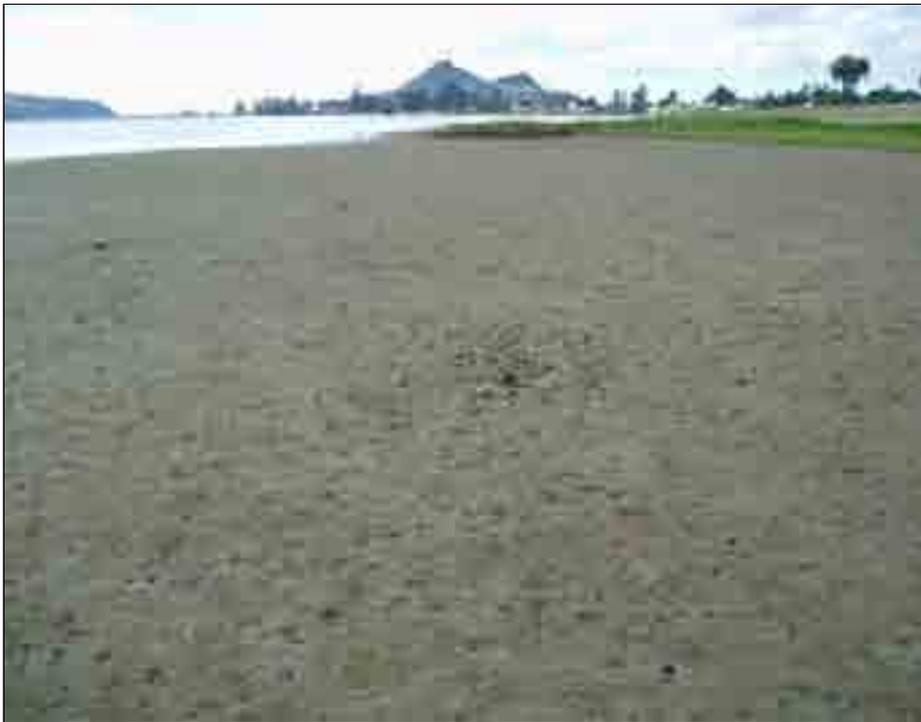
Figure 42: This is a view north from the photo point of Figure 41 above, looking over scattered mangrove stumps (note the oysters are concentrated around old stumps).

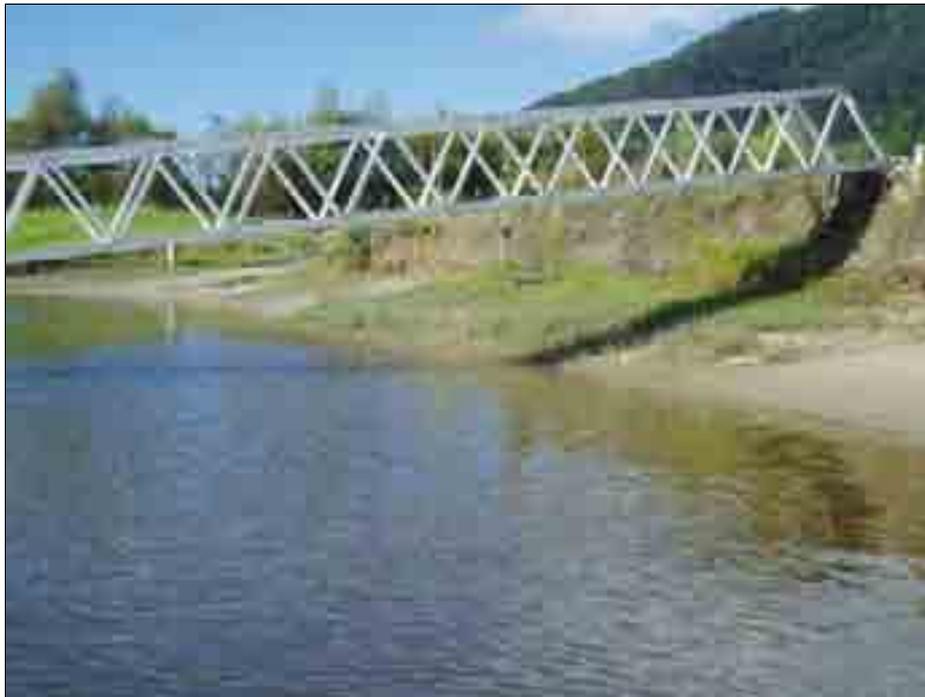
Figure 44: Saltwater paspalum has established at the head of this dead-end canal.

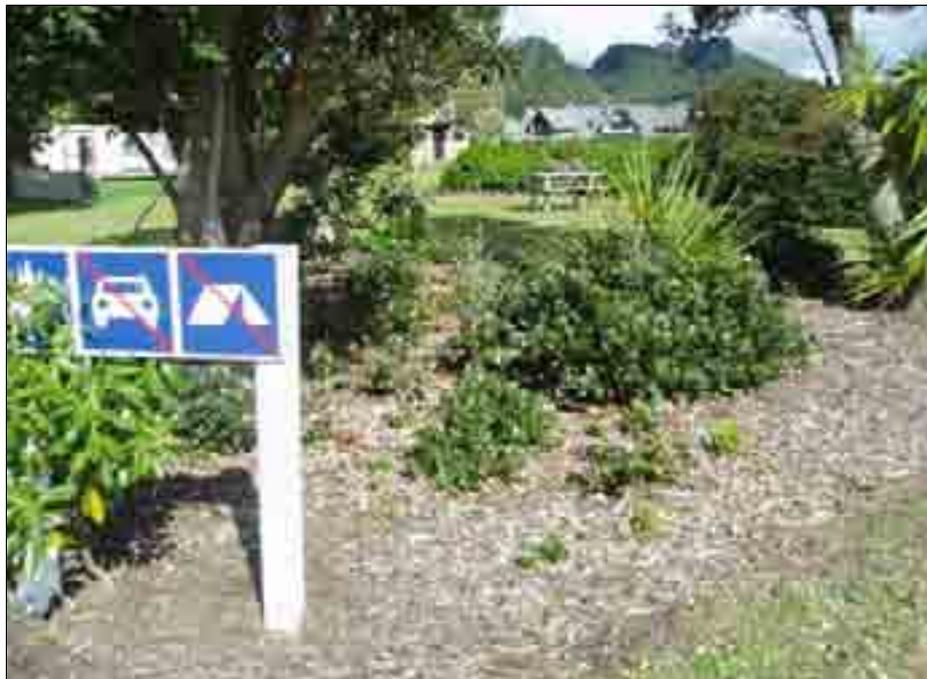
North of the Waterways entrance channel there are reserve plantings that incorporate Indian hawthorn (*Rhaphiolepis* sp.). This introduced coastal tree is of concern as it seeds prolifically (see Figures 45 and 49). In front of the northern end of Waterways Parade is a small wetland with mangroves, saltwater *Paspalum* and saltmarsh including sea rush, oioi and saltmarsh ribbonwood (Figure 46). Further north, the landward zone of the wetland has a thin band of saltmarsh ribbonwood intermingled with coastal shrub daisy, manuka and flax which have survived the effects of residential development (Figure 47). Figure 48 shows the northern edge of this wetland, which is the downstream limit of the saltmarsh and mangrove community on the eastern side of the Tairua Harbour. A banded rail was seen amongst the mangroves. Some of the seaward mangroves have been cut down.

Figure 45: Indian hawthorn (*Rhaphiolepis* sp.) has been planted in reserve gardens near the Waterways entrance canal (dark green bush in right background). Birds are freely dispersing the seed of this exotic coastal species as indicated by the proliferation of seedlings in the middle foreground of this photo.

It is also recommended that Indian hawthorn (*Rhaphiolepis* sp.) is removed from TCDC reserve plantings (noted near Waterways) as this exotic coastal species shows clear signs of becoming a serious weed (see Figures 45 and 49).

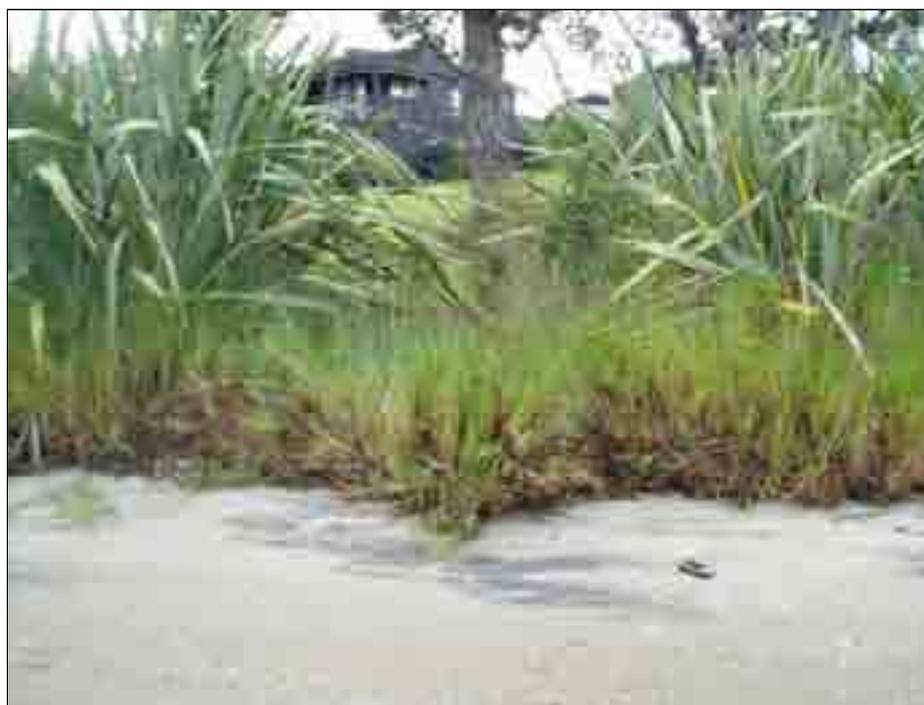
Figure 49: Indian hawthorn (*Rhaphiolepis* sp.) in amongst saltwater paspalum, flax and *Baumea juncea*.
