### Chile Tsunami Event Impacts in Hawke's Bay February 2010

## **Chile Tsunami Event Impacts in Hawke's Bay February 2010**

**April 2010  
AM 10/07  
HBRC Plan Number 4195**

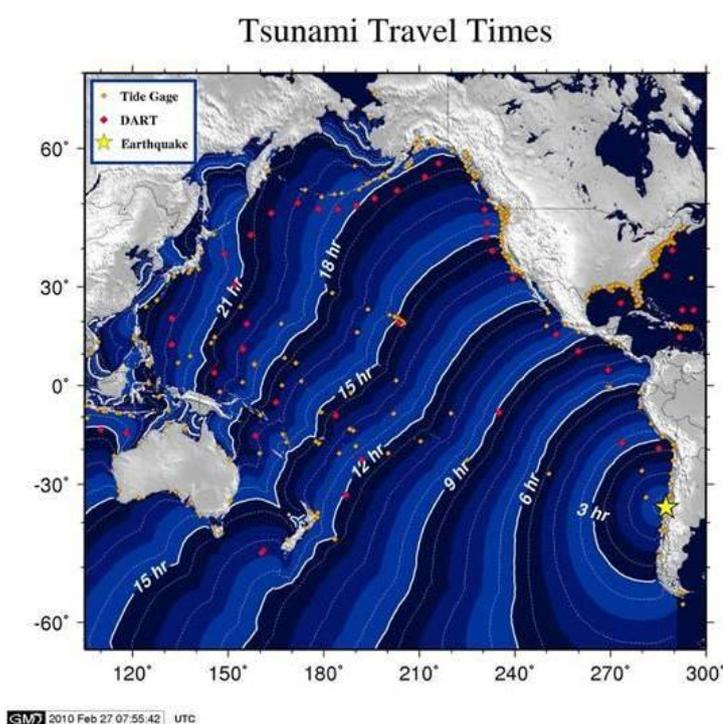
The Pacific Tsunami Warning Centre issued a map showing the estimated tsunami travel times (Figure 2).

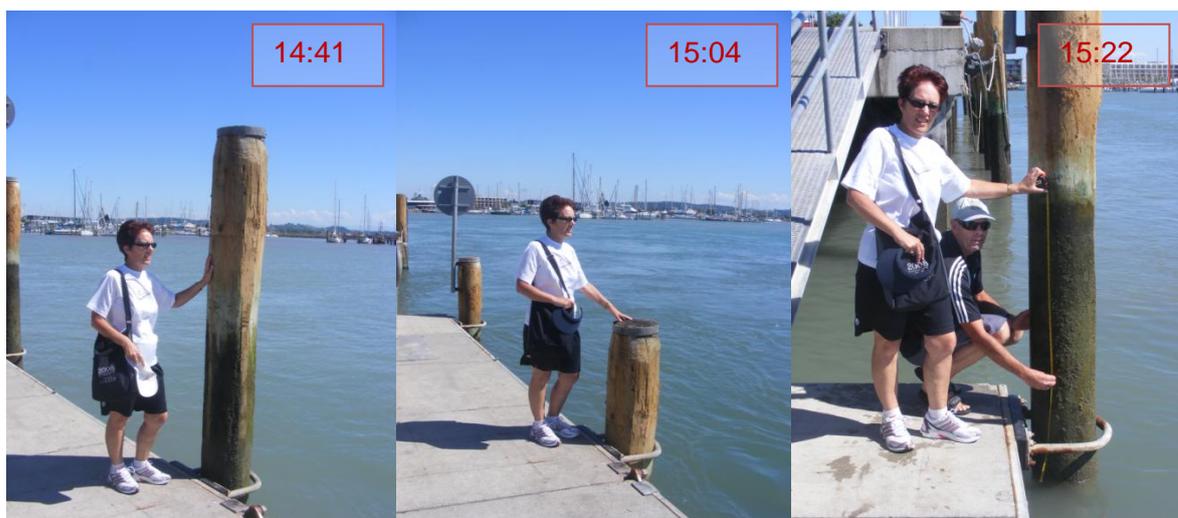
**Figure 3: Changes in water levels graphically shown in the Inner Harbour at Napier on a floating pontoon.**

The tsunami was seen in Hawke's Bay with changes in water levels around the coast and in harbours of around 1 metre. Wave surges were seen around Ahuriri Harbour as were abnormal water level and wave patterns along the coast. A member of the Napier Sailing Club, Jeff Lynex took pictures showing the changes in water level (Figure 3). The 1<sup>st</sup> picture taken at 14:41 hours compares with the 2<sup>nd</sup> taken at 15:04 (23 minutes later). The 3<sup>rd</sup> picture taken at 15:22 shows a subsequent drop 18 minutes later which he measured at 1.42 metres.

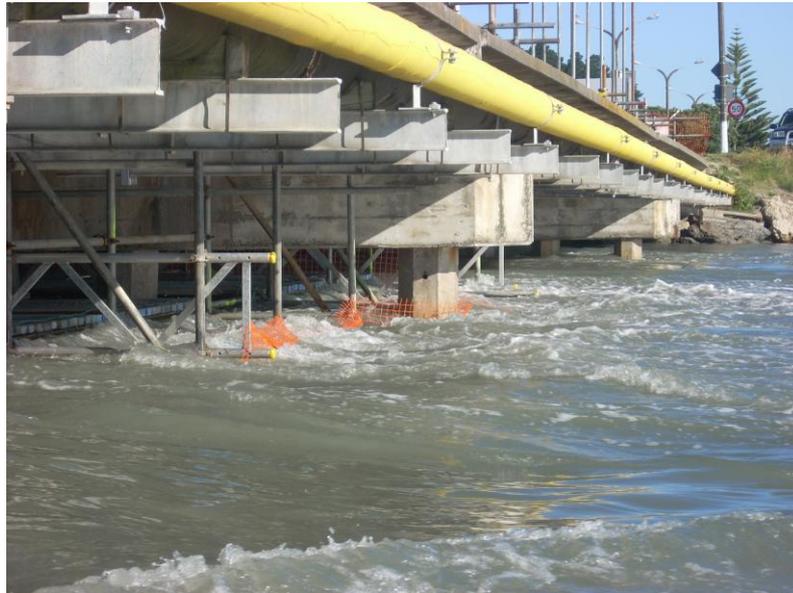
*Figure 4 Strong currents from the tsunami move under the Westshore Bridge, Napier.*

There was no reported damage to bridges or culverts. There were reports of strong currents under the Westshore Bridge in Napier (Figure 4).

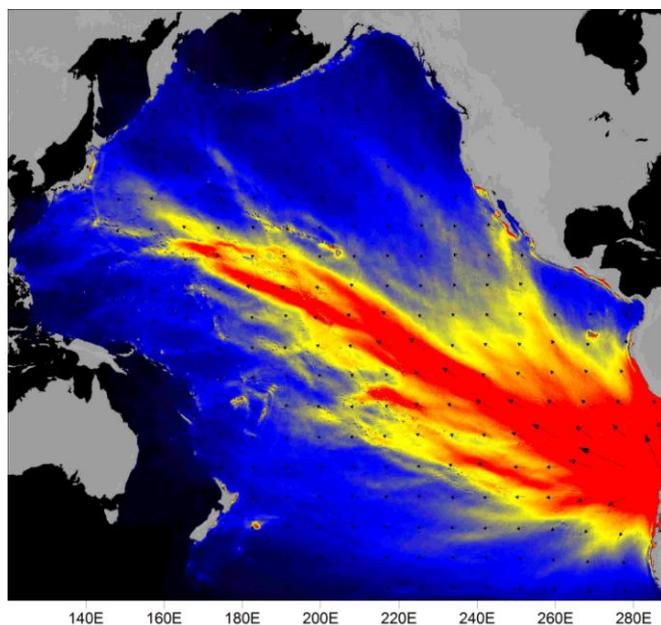
**Figure 6: Tsunami Energy Flux by Isaac Fine (IOS) Chilean tsunami Feb 27 2010**

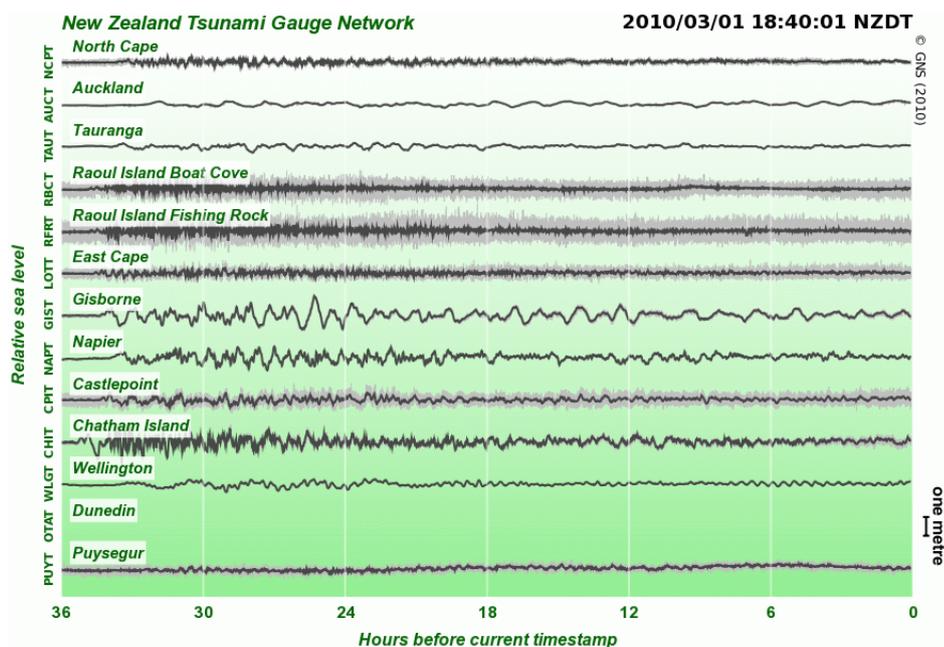
**Figure 7: Recordings of New Zealand Tsunami Gauge Network on 1 March 2010 showing the changes in relative sea level for the 36 hours previous.**

Recordings on the New Zealand Tsunami Gauge Network showed fluctuations around 1 metre (Figure 7), while the Port of Napier Wave Buoy showed surges up to 1.2 metres (Figure 8).

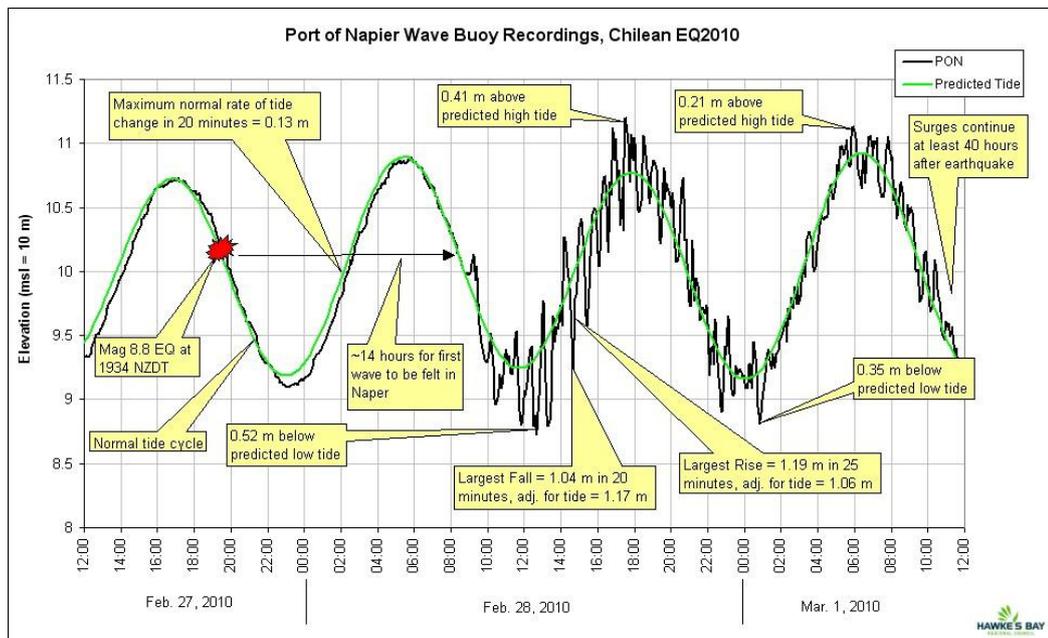
**Figure 8: Port of Napier Wave Buoy Recordings**

At 09:37 a regional warning confirmed the first wave had arrived at Napier at a height of 0.2metres and by 12:59 Regional Warning No. 14 confirmed significant surges were still occurring at the Port of Napier with up to 0.7 metre variance within one hour. The recordings taken at the Port of Napier Wave Buoy are shown in Figure 7.

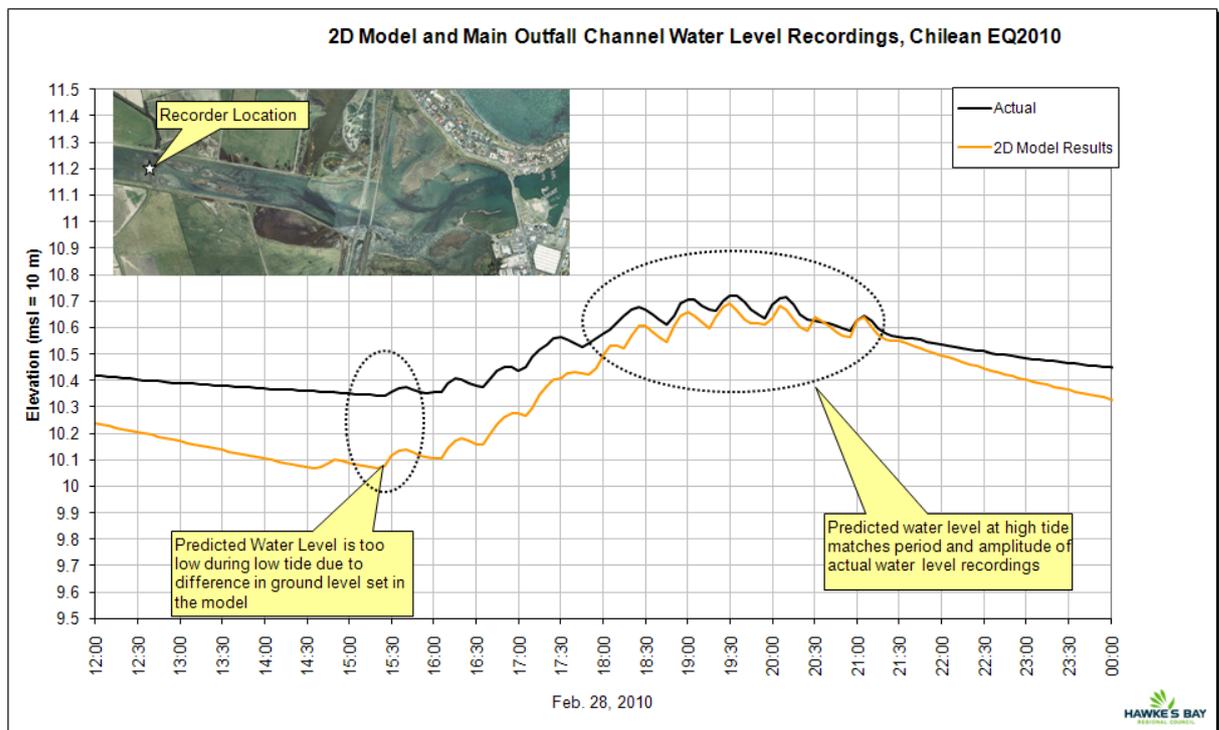
**Figure 9: Comparison of Actual and Modelled Water Level at Outfall Recorder by HBRC**

The tsunami also caused a series of surges in the inner harbour at Napier. The surges started at about 09:00 on Sunday 28 February (about 14 hours after the earthquake) and carried on for several days. Peak surges were just over 1 m (peak to trough, approximately 0.5m above water level at time), with a cycle time of about a 40 minutes. HBRC had recently developed a 2D model of the Napier Inner Harbour and Main Outfall Channel and results from the 2D model run indicate excellent correlation with observations. A comparison of the water level at the outfall channel recorder is shown in Figure 9.

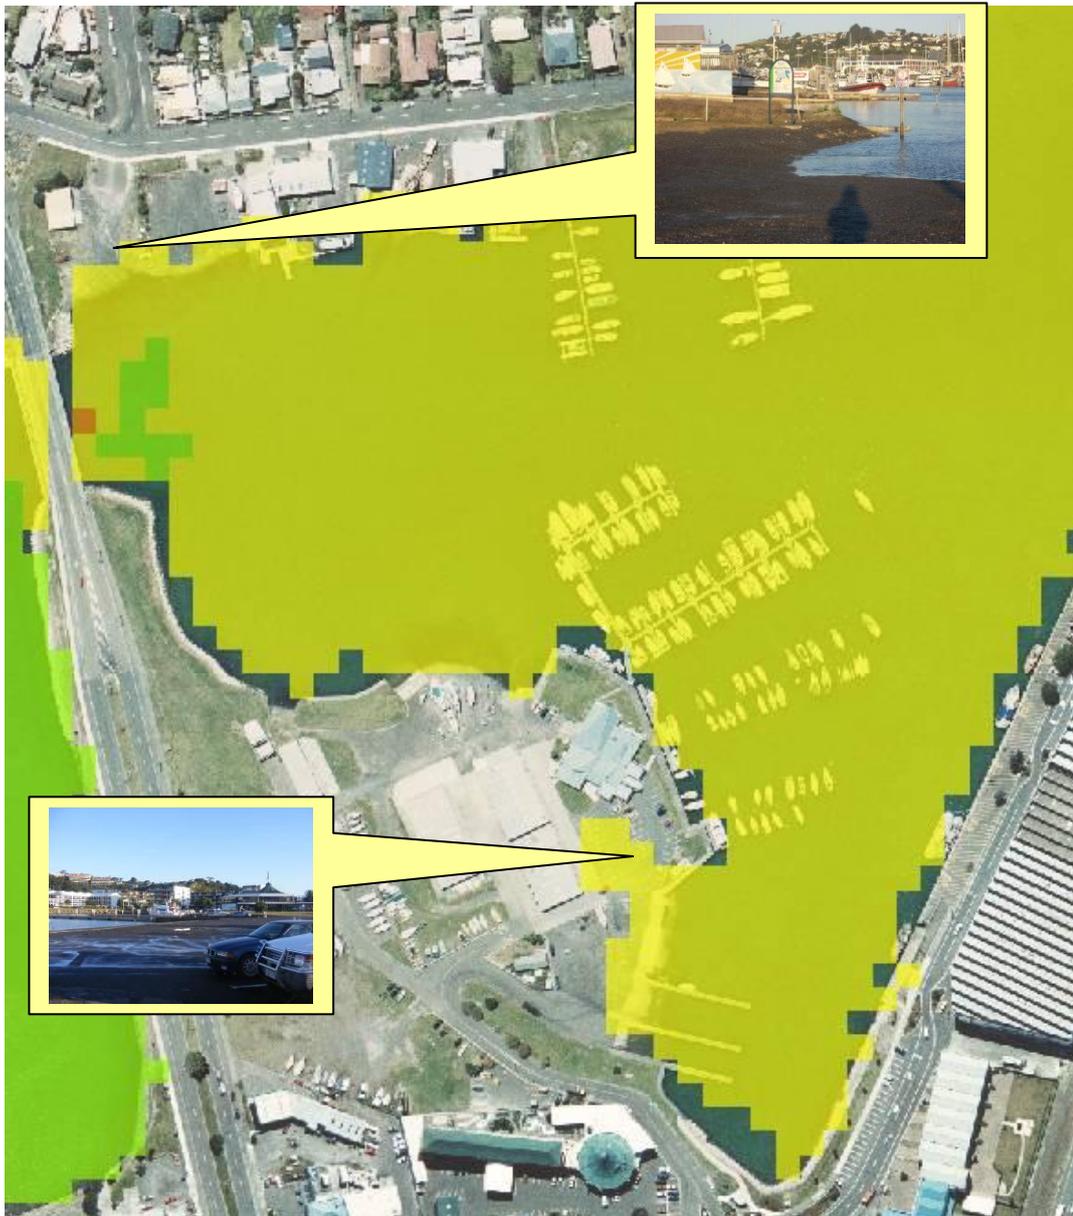
**Figure 10: Comparison of Actual and Modelled Water Level at Inner Harbour by HBRC**

Several visual observations in the inner harbour near the Napier Sailing Club were also compared to model results, as shown in Figure 10.

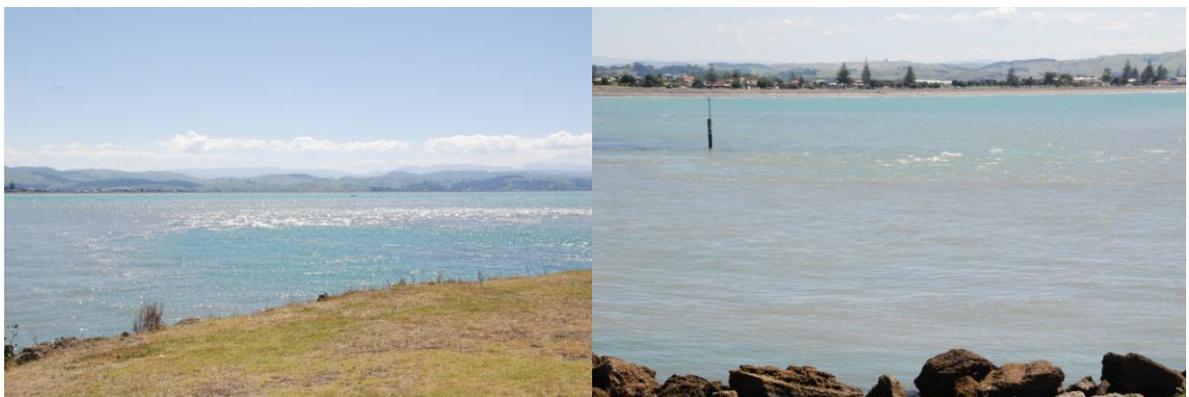
**Figure 11: Disturbed currents and discolouration of water at entrance to Inner Harbour at 1345 on 28th February 2010 taken by Acting Harbour Master John Paston**

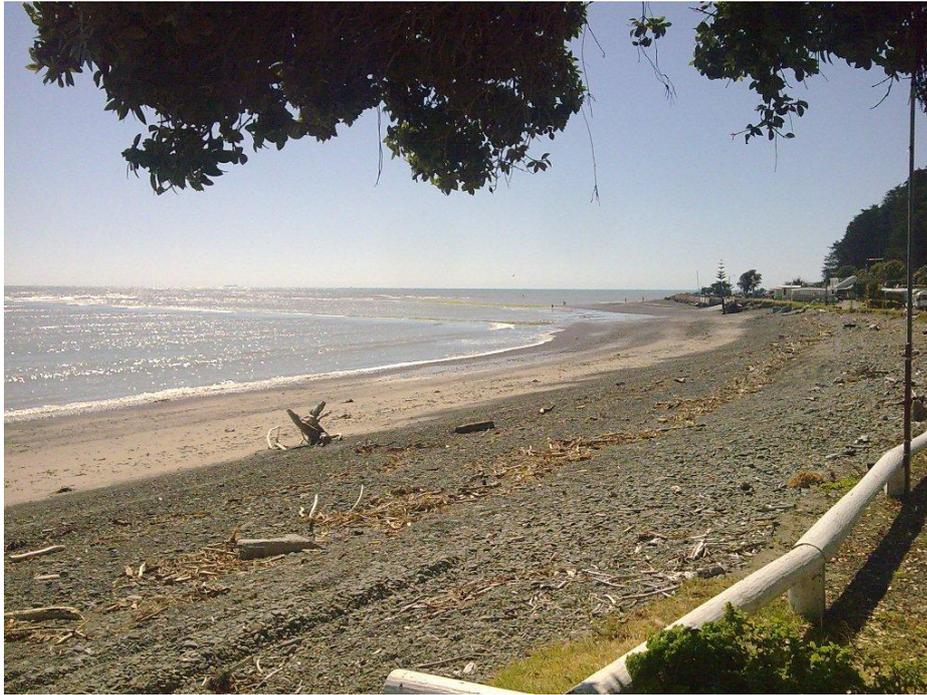
**Figure 12: A rare sight - Clifton Reefs exposed on 28 February 2010, Hastings**

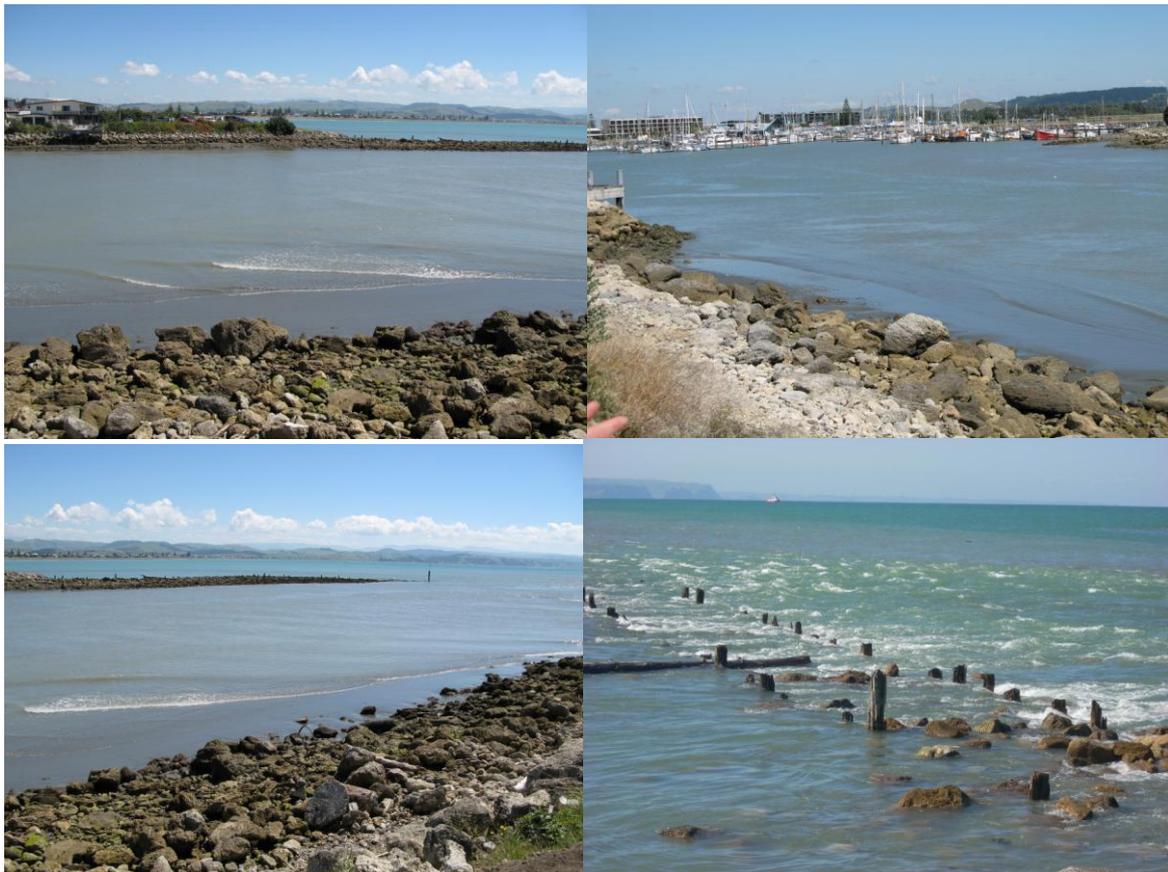
**Figure 13: Unusual slow moving wavelets at entrance to Napier Inner Harbour morning of 28 February 2010**

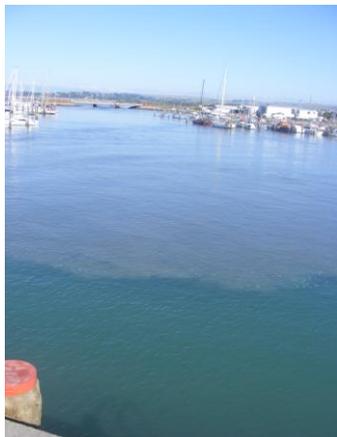
07 09:46 First discolouration noticed

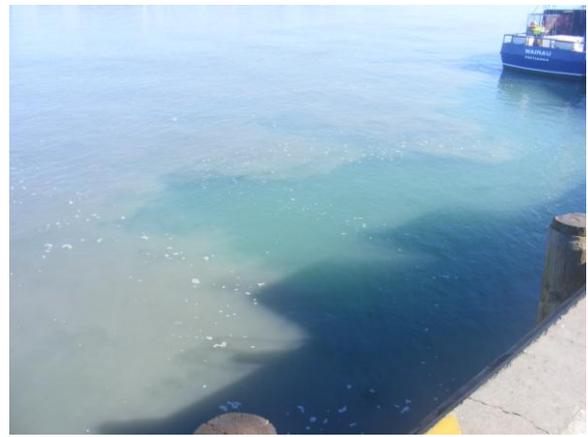
08 09:48 Scoured sediment from upper harbour

- 8) Sediment scouring from the upper harbour was obvious in outflow following the first small wave and arrival of the second. The wave buoy suggested a fall of approximately 0.8 metres due to tsunami action and tidal fall.

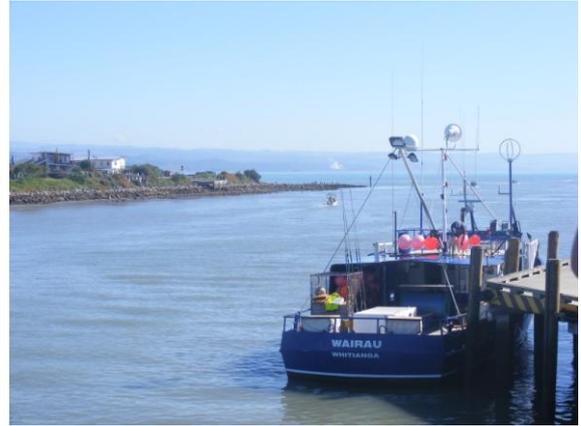
10 10:30 1<sup>st</sup> surge noticeable as small wavelets

- 2) The first smaller surges of less than 0.5 metres recorded by the Wave Buoy were noticeable only as very small wavelets (*a result of meeting of outflow and incoming surge??*) and the flow was non-turbulent.

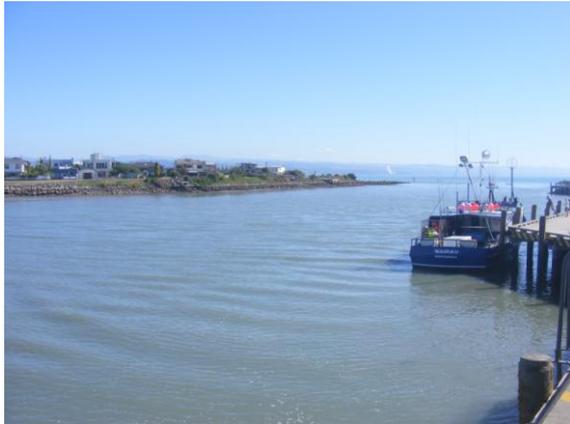
11 10:43 First surge as series of small waves

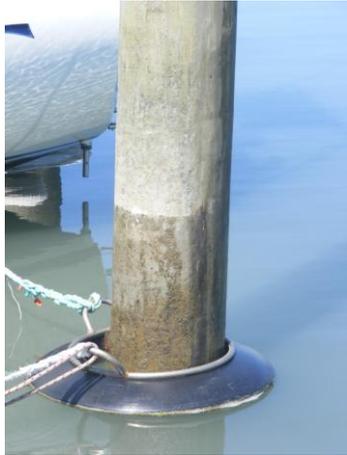
17 11:44 0.5 metre drop

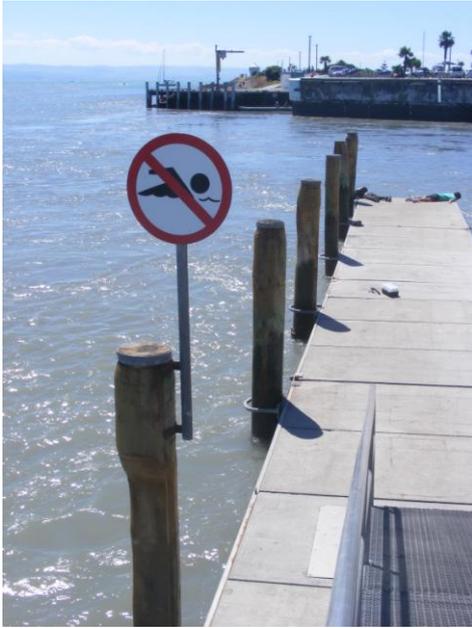
32 13:34 Incoming surge

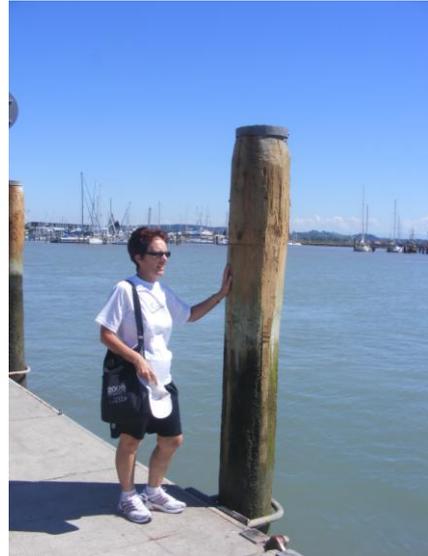
39 14:41 Out compare 37 (23 mins) Measured 1.00m

- 5) The maximum variation - as measured by tape against the wetted area of a pile - was 1.42 metres and another was measured at 1.00 metres. Comparative photo studies suggest this occurred for a number of waves. This suggests some amplification of the wave as recorded at the wave buoy; this may be due to an incoming surge arriving before the lagoon had drained completely, or the shape of the outer coastline/bay.

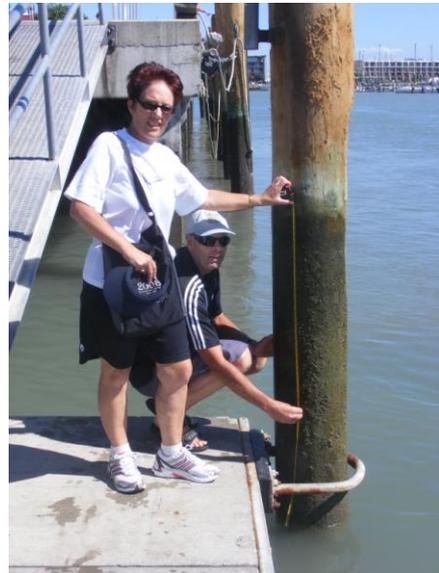
41 15:22 Out 1.42 metre drop in 18 mins

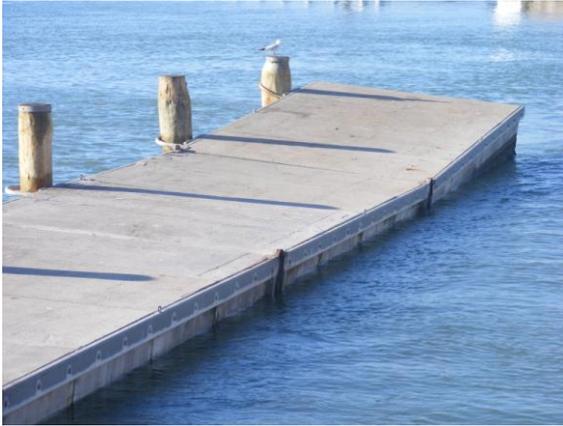
44 18:06 Pontoon jammed after high tide & surge

- With the coinciding of high tide and a storm surge, one end of the floating pontoon became wedged in a high position as the surge receded.
- Yachts moored both parallel and across the flow did not appear to be noticeably influenced.
- Had the larger surges coincided with high tide (approximately 3 hours difference) areas around the Yacht Club and Blue Water Hotel may have been inundated and there was some risk of yachts on older piles floating off their piles.

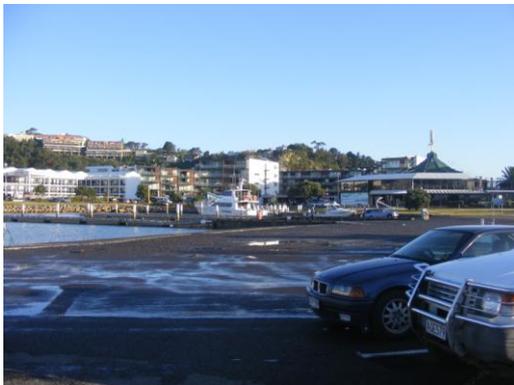
48 18:58 Flooding in Yacht Club Car Park

10) It was only with the coinciding of high tide and a tsunami surge did water rise above normal extreme high tide levels. It entered the Yacht Club car park on at least three reported occasions but did not top the fixed jetty along West Quay.
