# **Opihi and Tengawai rivers:**

## **Status of gravel resources and management implications**

**Report U05/31**

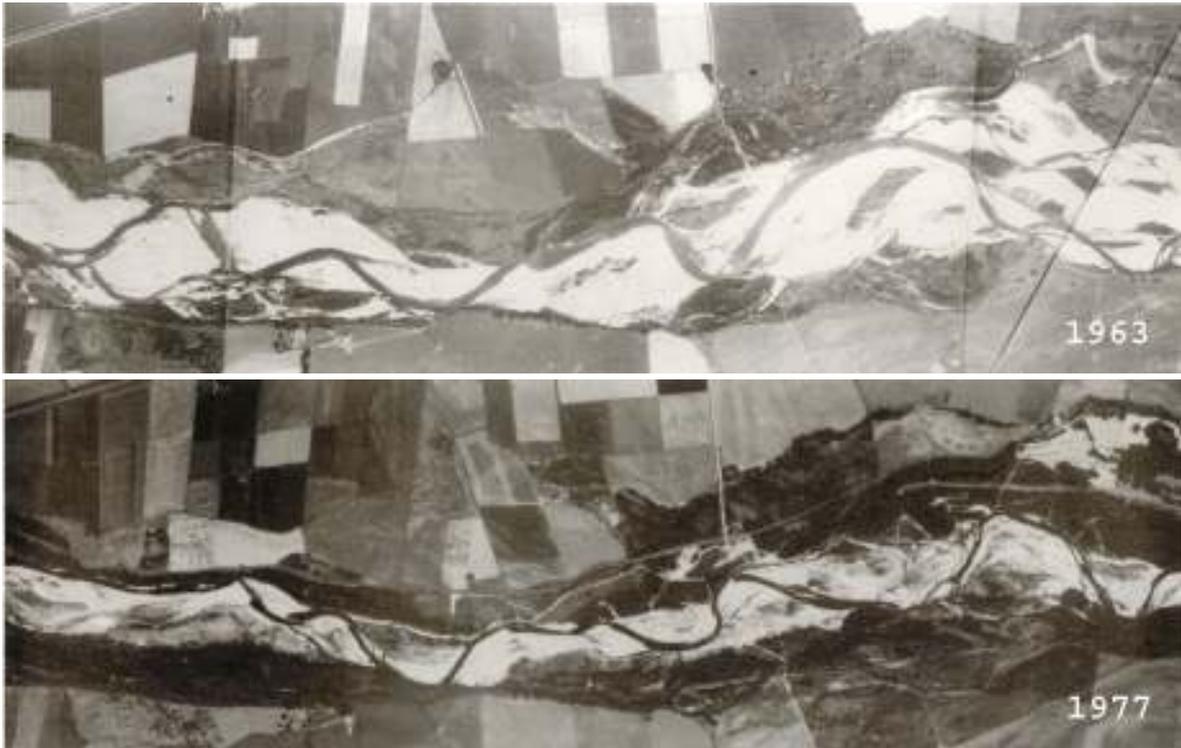
**Fig. 5 Opihi River km 8.1 to 12.5 (based on SCCB 1985)**

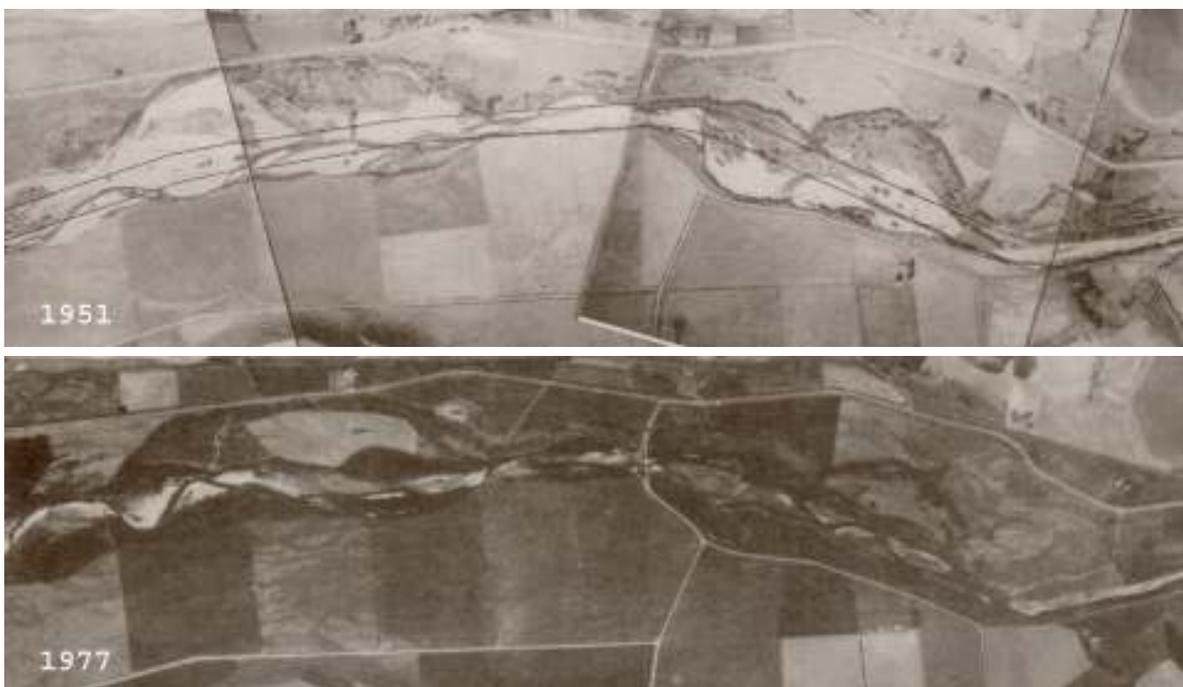
**Fig. 9 Tengawai River cross section km 29 to 33.5 (based  
on SCCB 1985)**

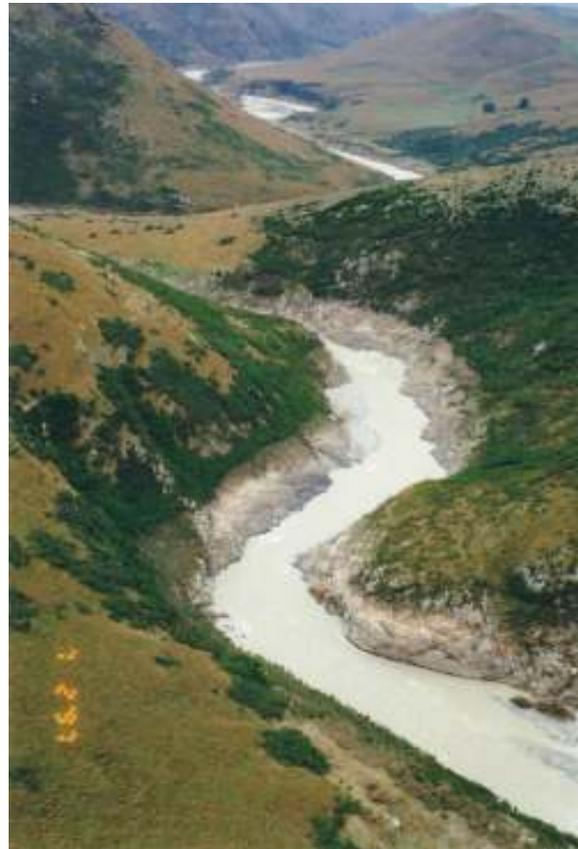
**Fig. 10 Opuha Gorge, 5 km downstream of Opuha Dam, February 1997 (Lees & Thomson 2003)**

A large input of sediment was derived from the dam breach itself (consisting of silty outwash gravels, river gravels, and rockfill from the dam foundations; Coleman *et al.* 2004) and from erosion of the river channel downstream (Fig. 10). The contribution of sediment from the breached embankment is probably modest (~250,000 m<sup>3</sup> based on a topographic map in Coleman *et al.* 2004). Contributions from the river channel have not been quantified, but could be substantial.
