# Tapu flood protection scheme design report

Prepared by:  
Megan Wood (Wainui Consulting Limited)

For:  
Waikato Regional Council  
Private Bag 3038  
Waikato Mail Centre  
HAMILTON 3240

20 December 2013

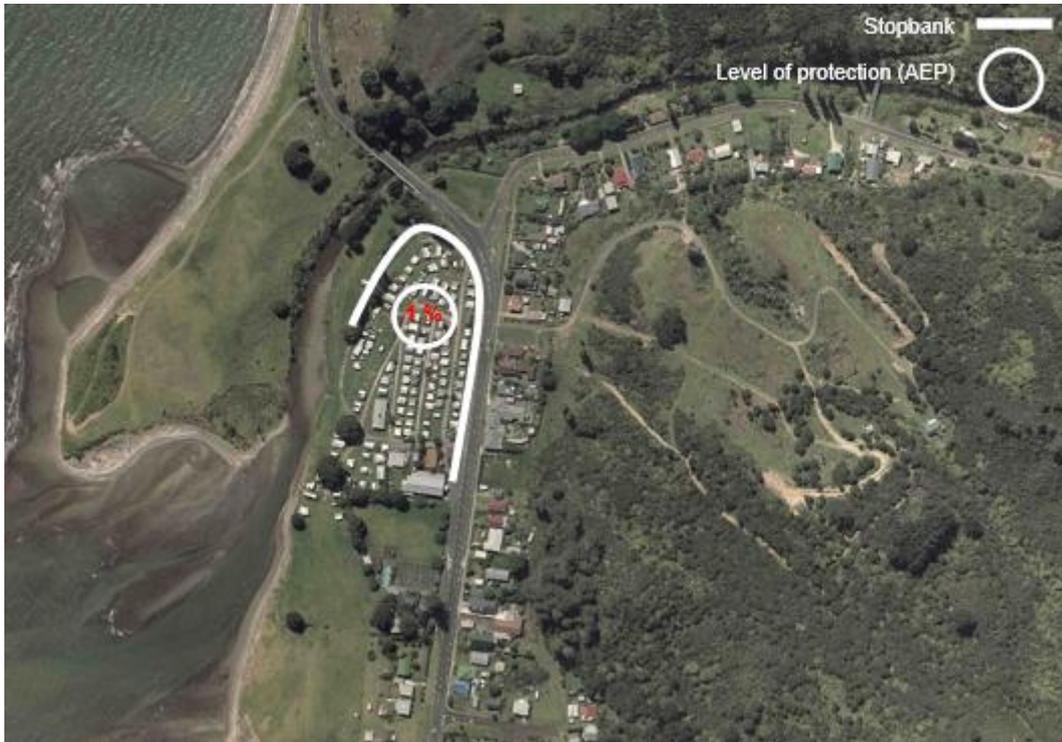
The flood protection scheme developed for Tapu provided protection to only a small portion of the community as illustrated in the figure below.

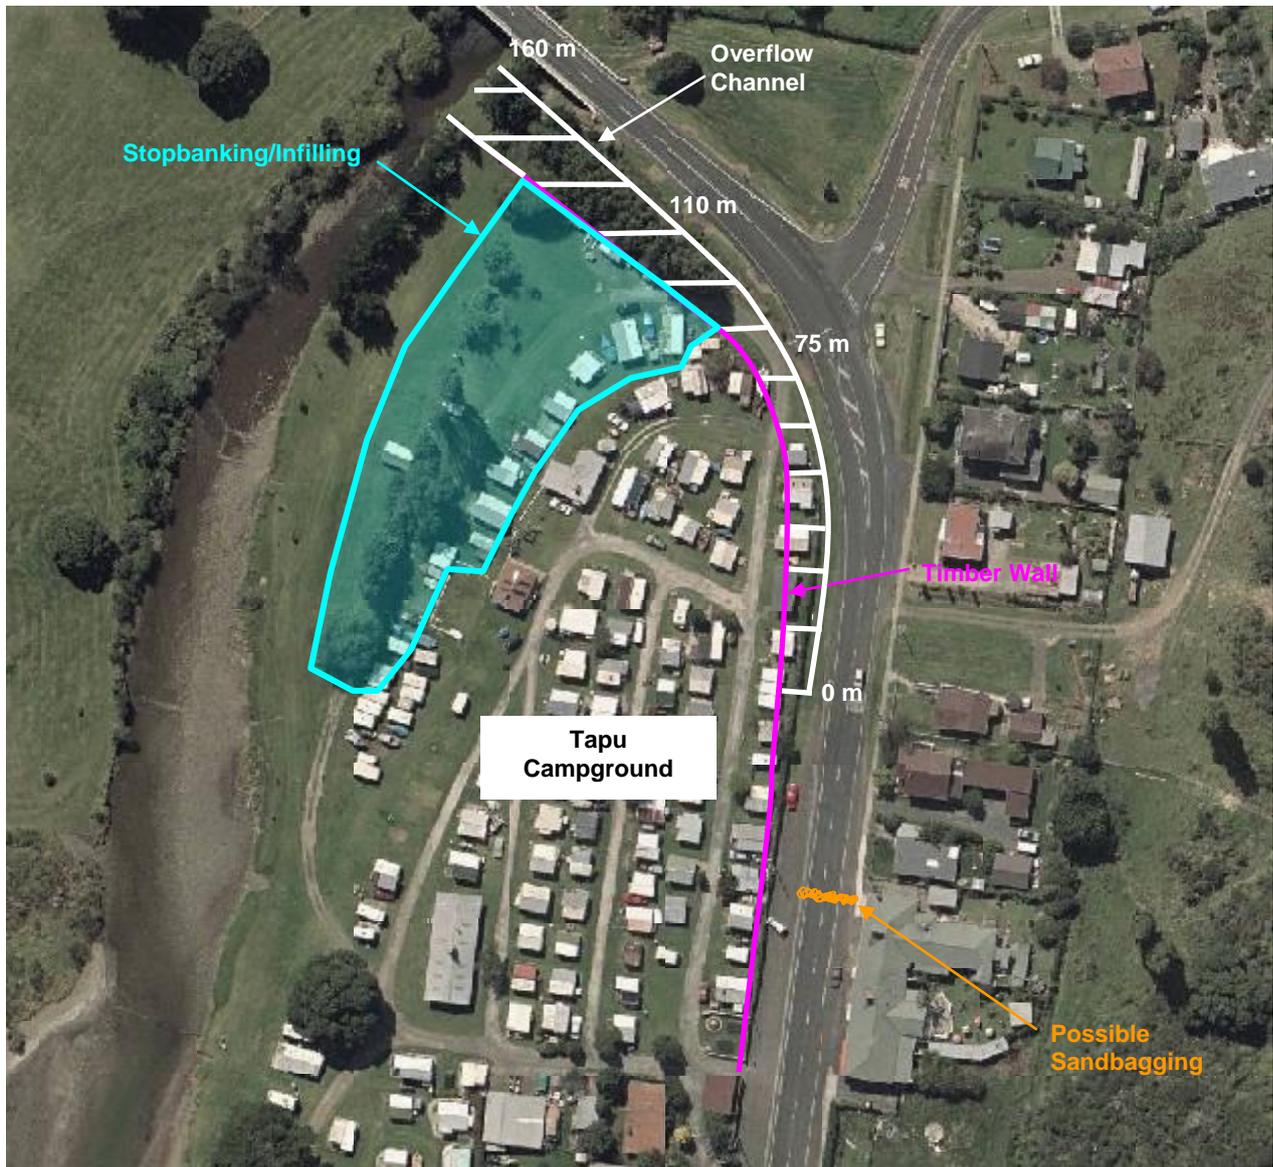
**Tapu flood protection scheme**

The flood protection scheme developed to protect the campground at Tapu comprises the following items:

- The lower terrace of the campground along the stream side has been protected from the 1% AEP flood event by raising the whole terrace above the flood level with 0.5 metre freeboard. This area has been formed as a stopbank with infilling behind it. The infilling is set back approximately 15-20 metres from the banks of the river.

A schematic of the completed work is illustrated in the figure below.

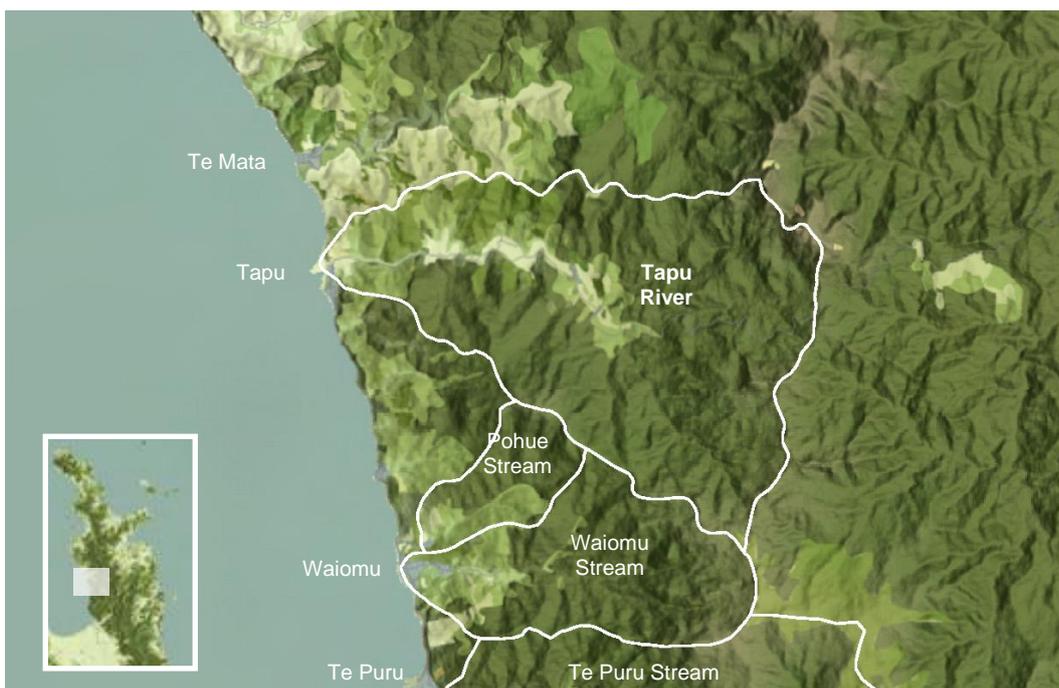
**Figure 2** Tapu River catchment

The Tapu River has a 27 km<sup>2</sup> catchment that originates in the western Coromandel Ranges (refer to Figure 2). This catchment is relatively steep and covered in regenerating native vegetation and scrub. It is also susceptible to short duration but high intensity rainfall events that cause flash flooding and debris flows in the Tapu River with little or no warning.

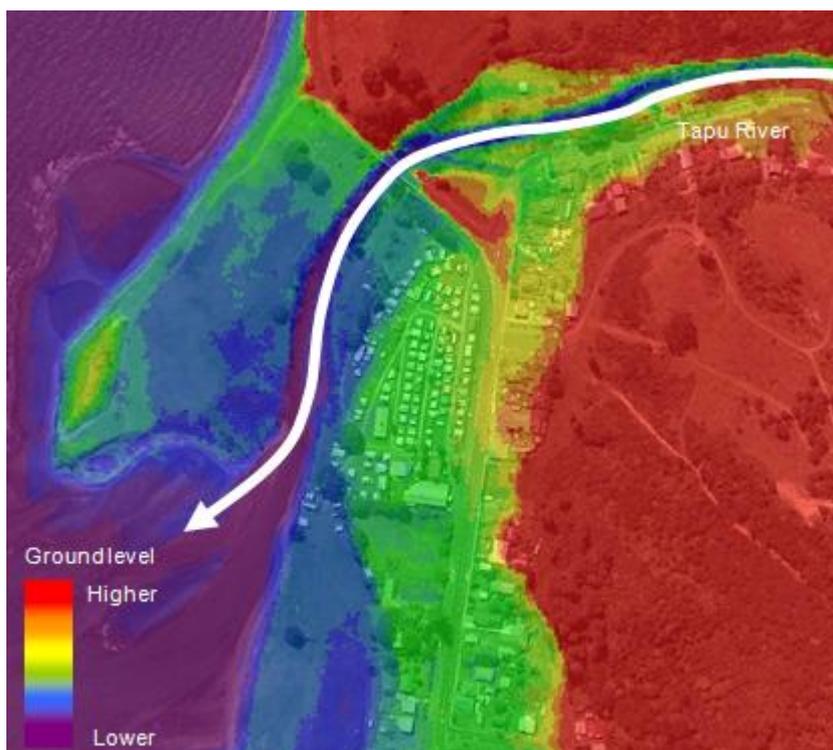
Figure 4 Ground level around the Tapu community

The Tapu community is located at the base of the Tapu River catchment on a coastal alluvial fan. The community consists of mainly residential development on the true left bank of the Tapu River. State Highway 25 runs through the Tapu community and crosses the Tapu River using a dual lane multi-span bridge. The Tapu-Coroglen Road runs parallel to the Tapu River. Parts of the Tapu community are located on the floodplain and sediment/debris fan created by the Tapu River (refer to Figure 4 and Figure 5 below).

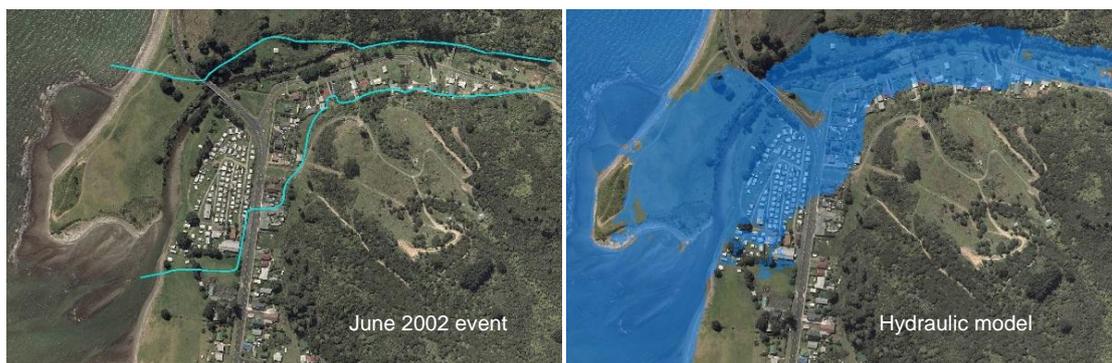
Figure 11 Comparison of modelled and observed flood extents

The river flood maps produced as part of model development process were compared with observations made during previous flood events in the Tapu River. This comparison, which includes the review of several Hauraki Catchment Board and Waikato Regional Council reports, showed that the maps were a reasonable representation of flooding in the Tapu River as illustrated in Figure 11 below.

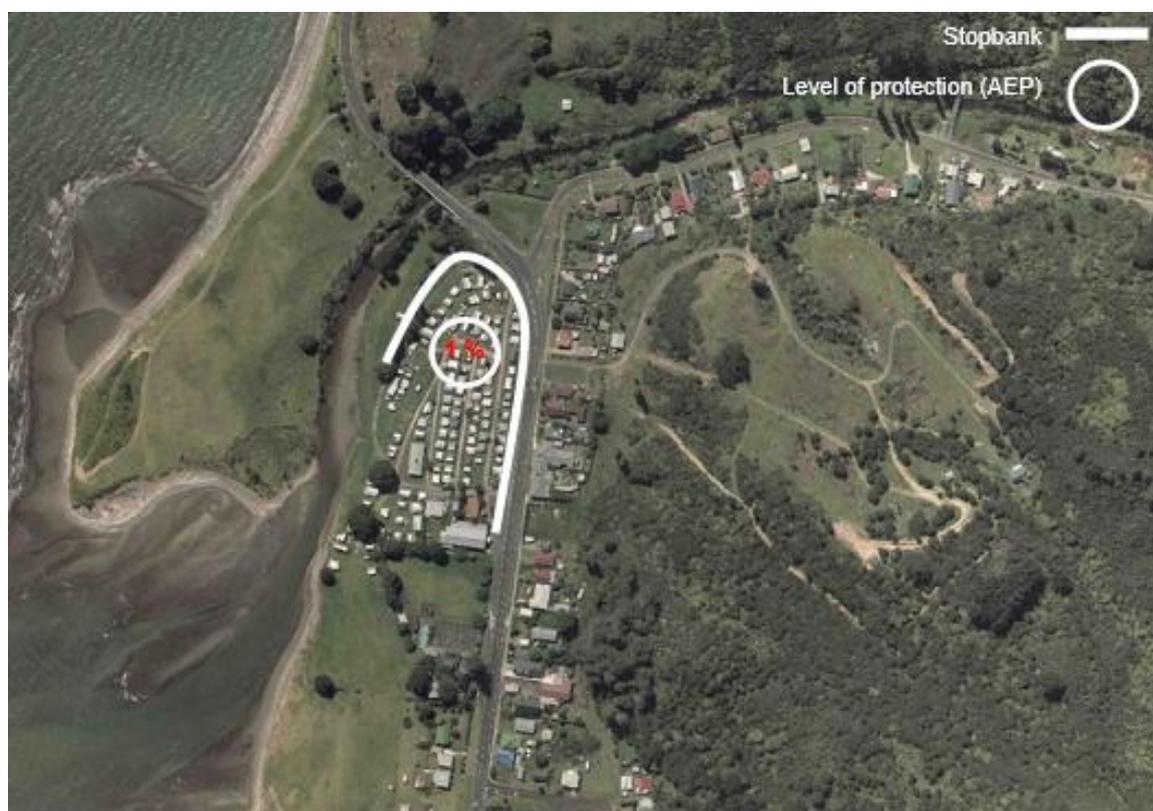
Figure 12 Flood defences in Tapu

The flood protection scheme developed for Tapu provided protection to only a small portion of the community as illustrated in Figure 12 below.

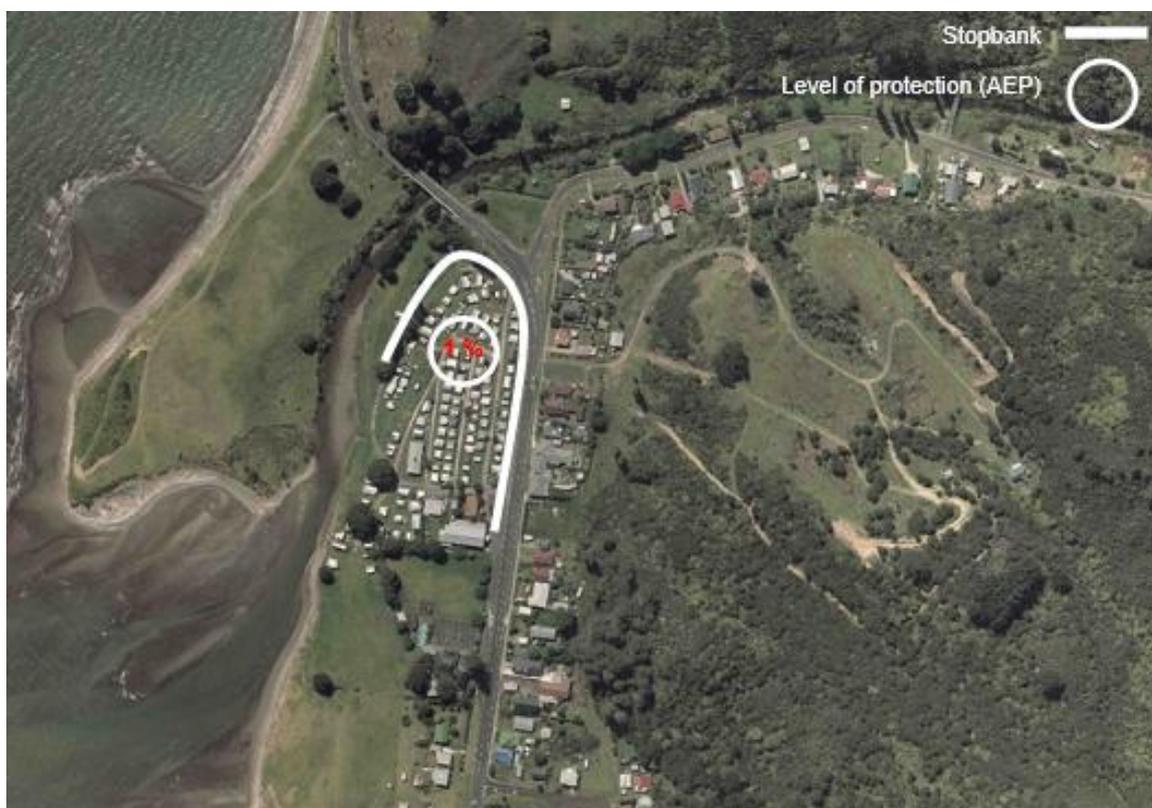
**Figure 17 Flood defences in Tapu**

The level of service provided by the scheme at the Tapu Campground is the existing 1% AEP event (without climate change) plus 500mm freeboard. The general location of the flood protection assets is shown in Figure 17 below. Refer to Appendix 2 for design details for the flood protection works at Tapu. As-built survey data is provided in Appendix 3.

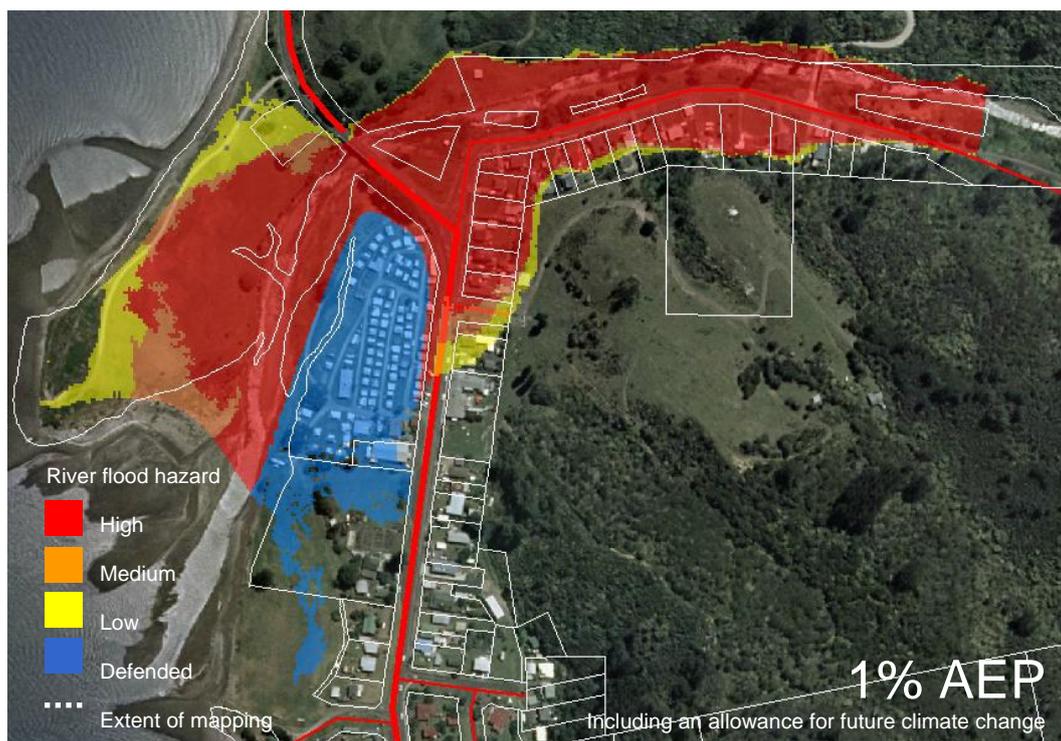
**Figure 20 River flood hazard map post-scheme**

The river flooding information has been used to produce a river flood hazard map for the Tapu community due to the Tapu River. Figure 20 shows the flood hazard map for Tapu where the land that is protected by the scheme is shaded in blue to represent its 'Defended' status.

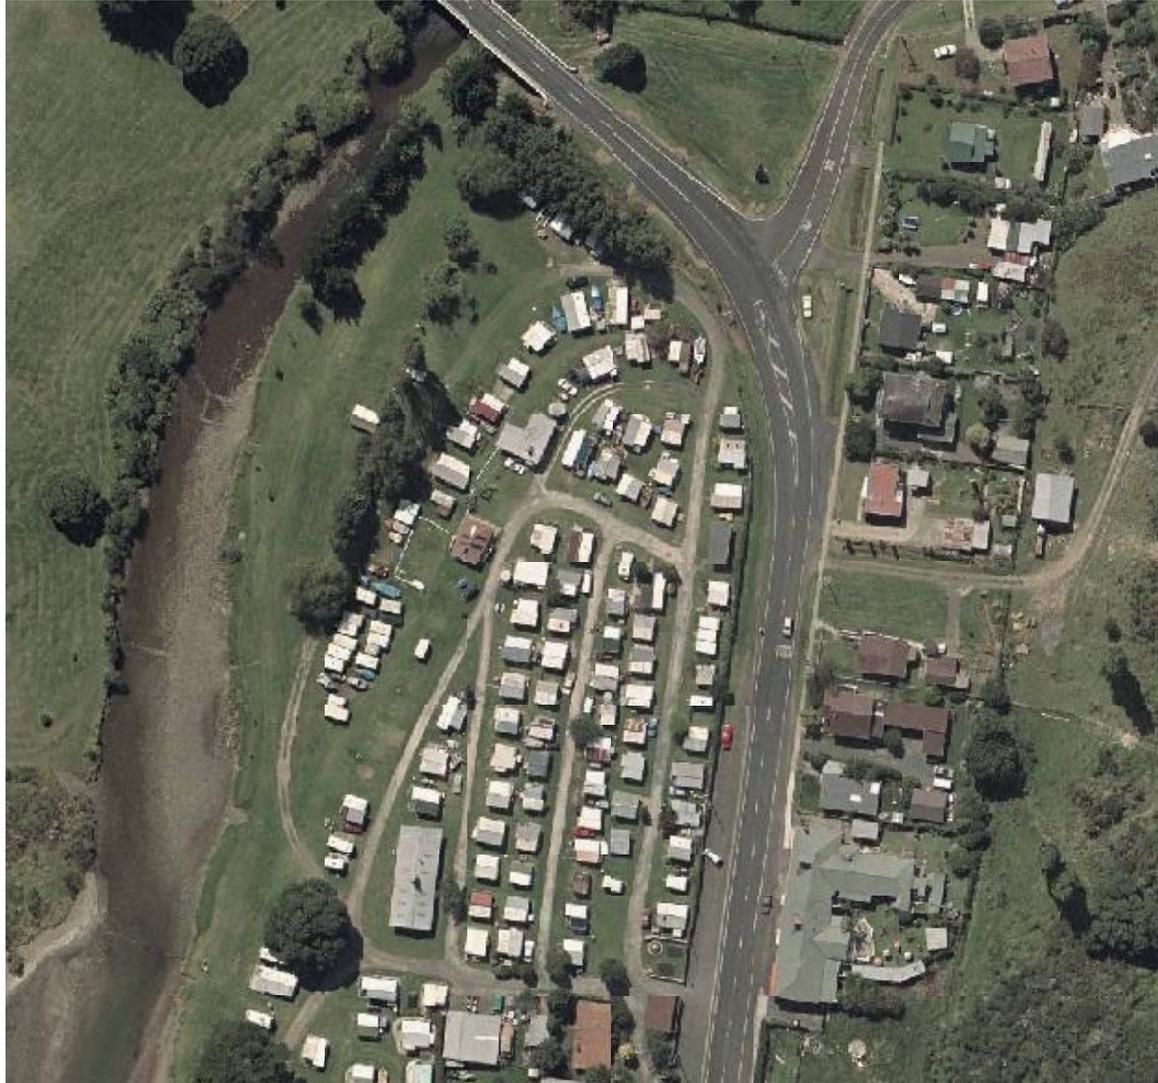
Note: refer approximate chainages on Figure 13 in main body of report

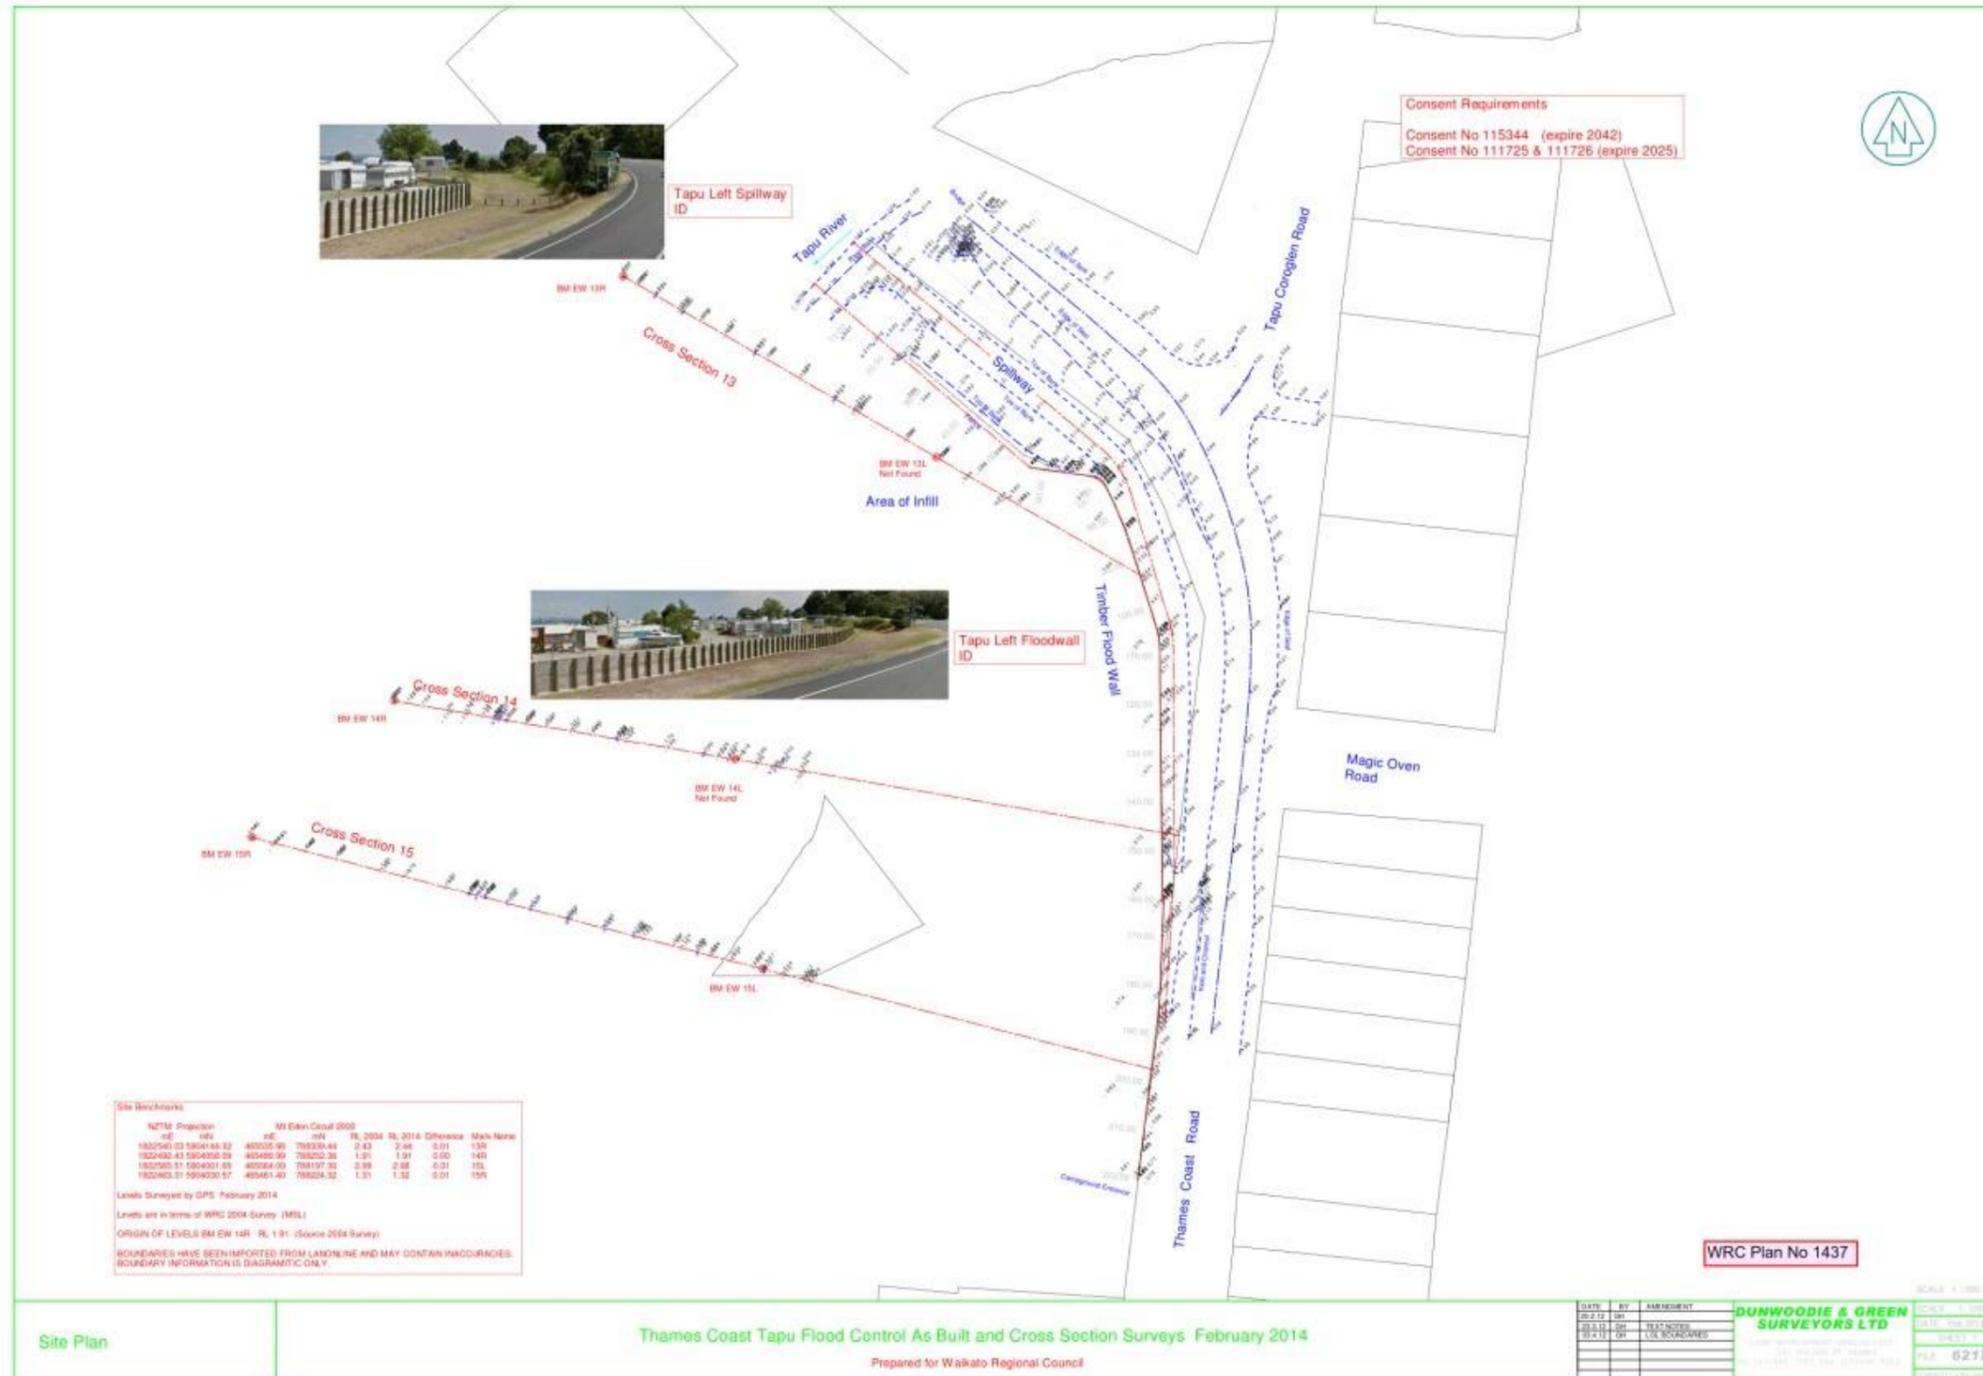
# Appendix 3 As-built survey

Levels are in terms of WRC 2004 Survey (MSL)  
 ORIGIN OF LEVELS BM EW 14R RL 1.91 (Reverse 2004 Survey)
