Coromandel flood protection scheme design report

Prepared by:
Megan Wood (Wainui Consulting Limited)

For:
Waikato Regional Council
Private Bag 3038
Waikato Mail Centre
HAMILTON 3240

23 May 2014

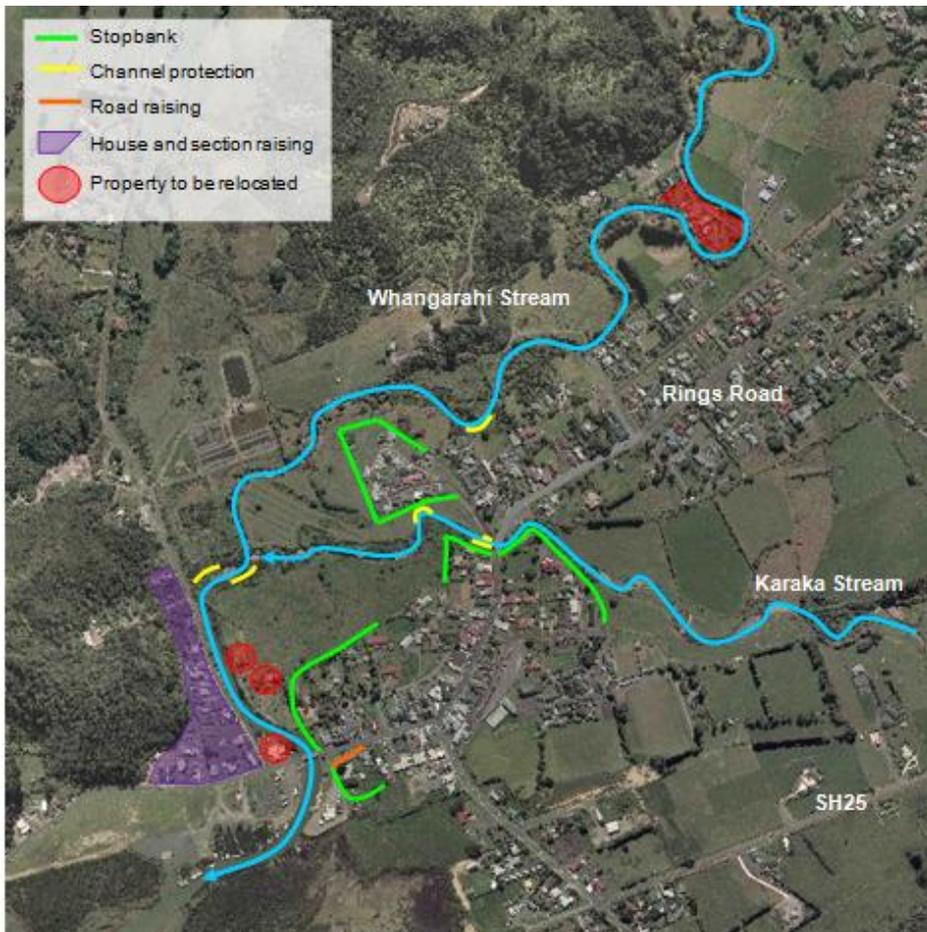
WRC worked with the community via the Coromandel town working group to develop the flood mitigation strategy for Coromandel and then consulted with the community on what was proposed. The following figure illustrates the full proposal.

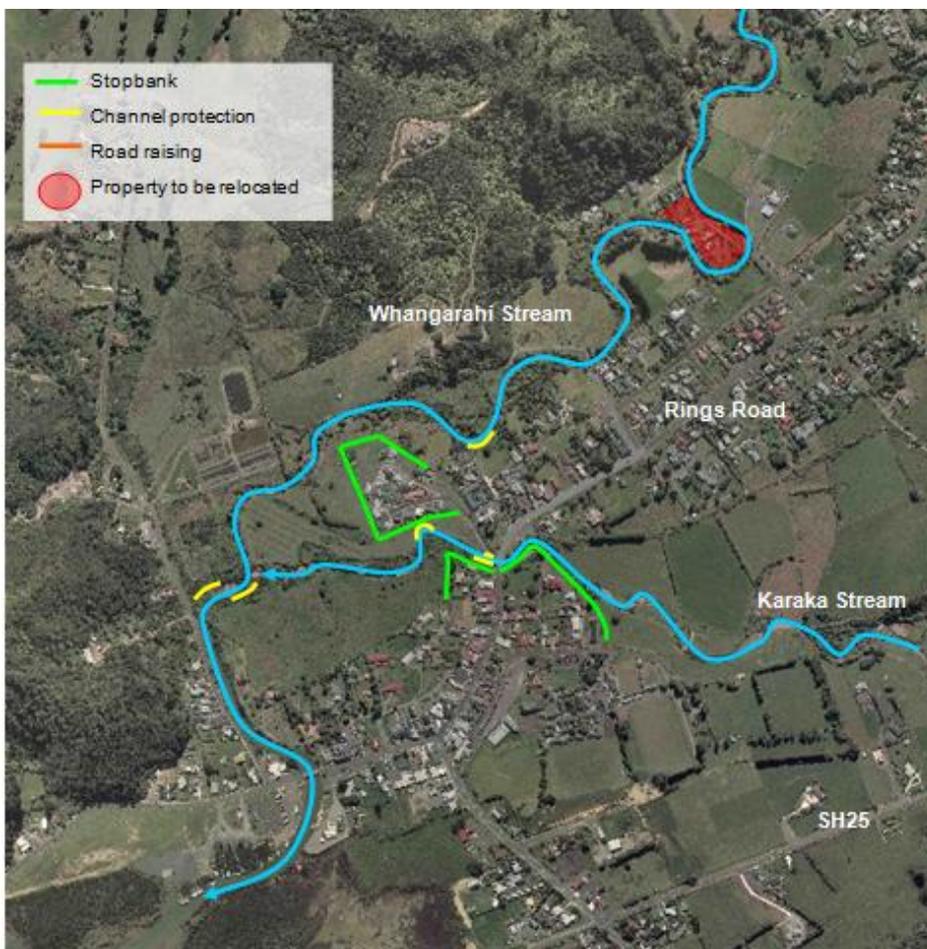
The community did not agree to the full scheme, so only a partial scheme was implemented that included the following components:

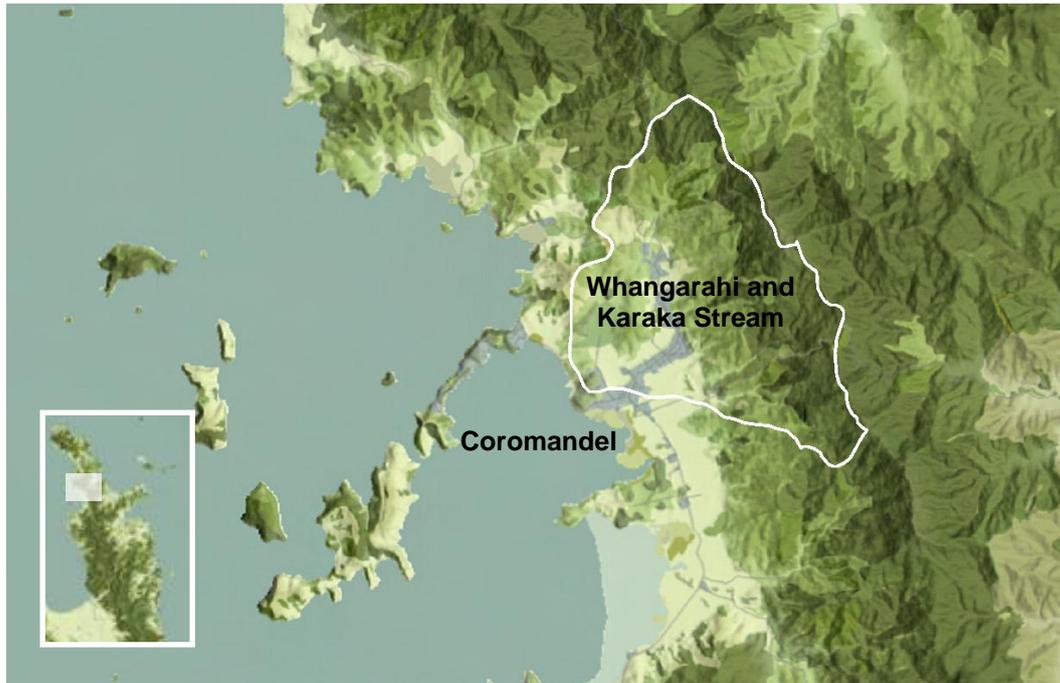
Figure 2 Whangarahi and Karaka Stream catchment

The Whangarahi and Karaka streams have a combined 16 km² catchment that originates in the western Coromandel ranges (refer to Figure 2). These catchments are relatively steep and covered in regenerating native vegetation and scrub. These catchments are also susceptible to short duration but high intensity rainfall events that cause flash flooding and debris flows in the Whangarahi and Karaka streams with little or no warning.

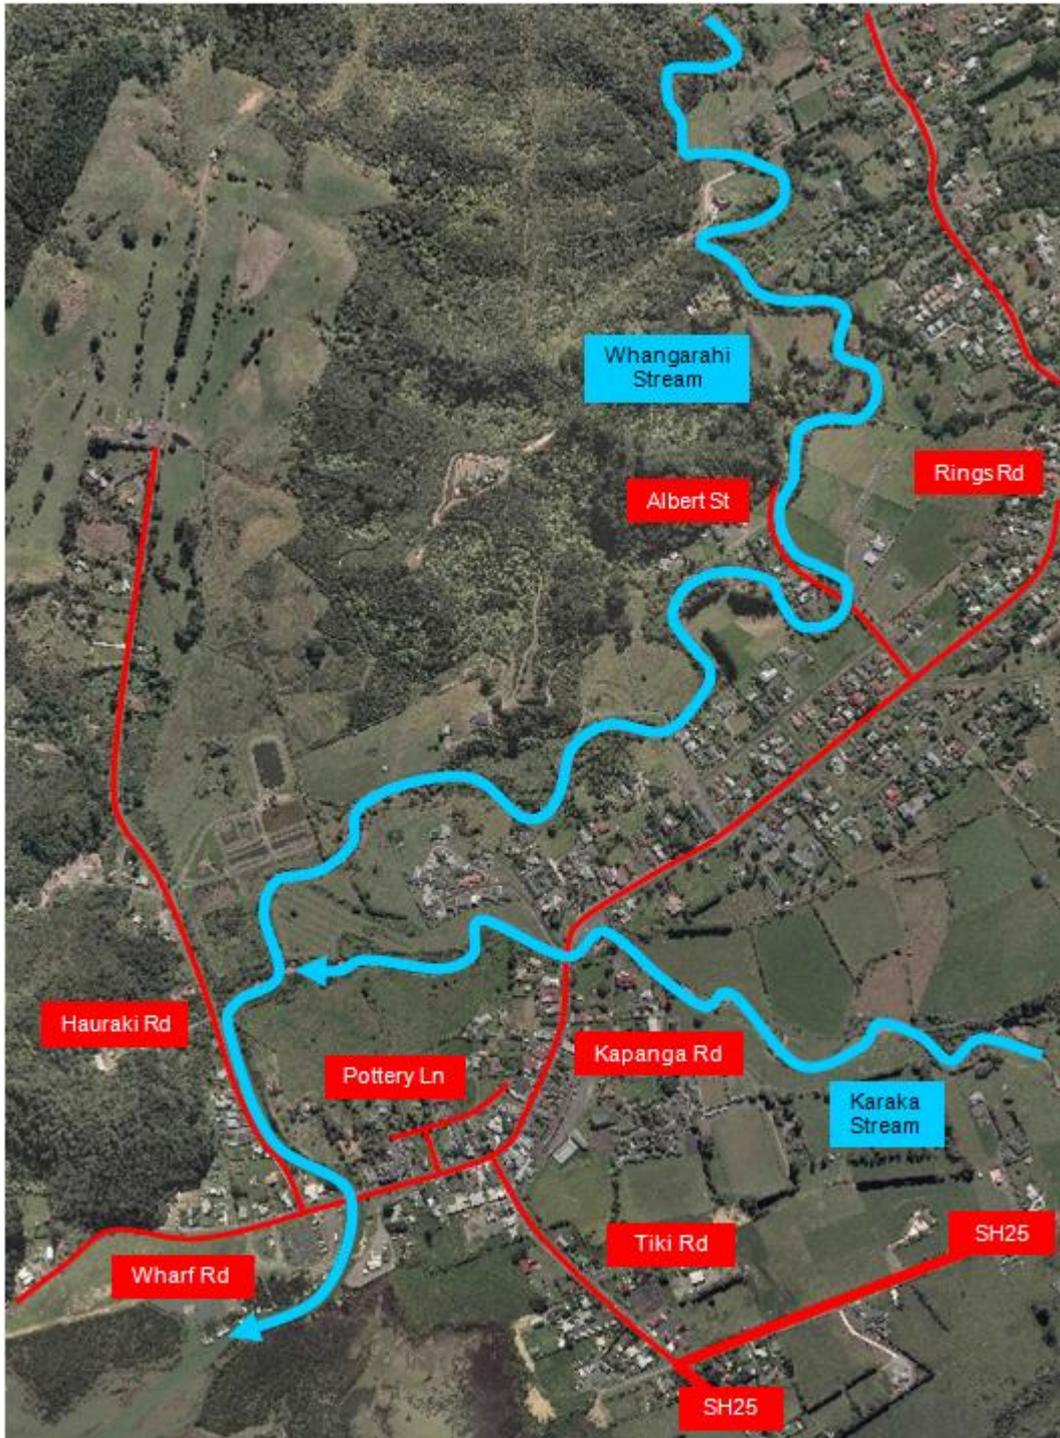
Figure 3 Coromandel town

The Whangarahi Stream flows out of the Coromandel ranges before draining to the Coromandel harbour. The Karaka Stream also originates in the Coromandel ranges, and flows through Coromandel town before draining into the Whangarahi Stream, refer to Figure 3.

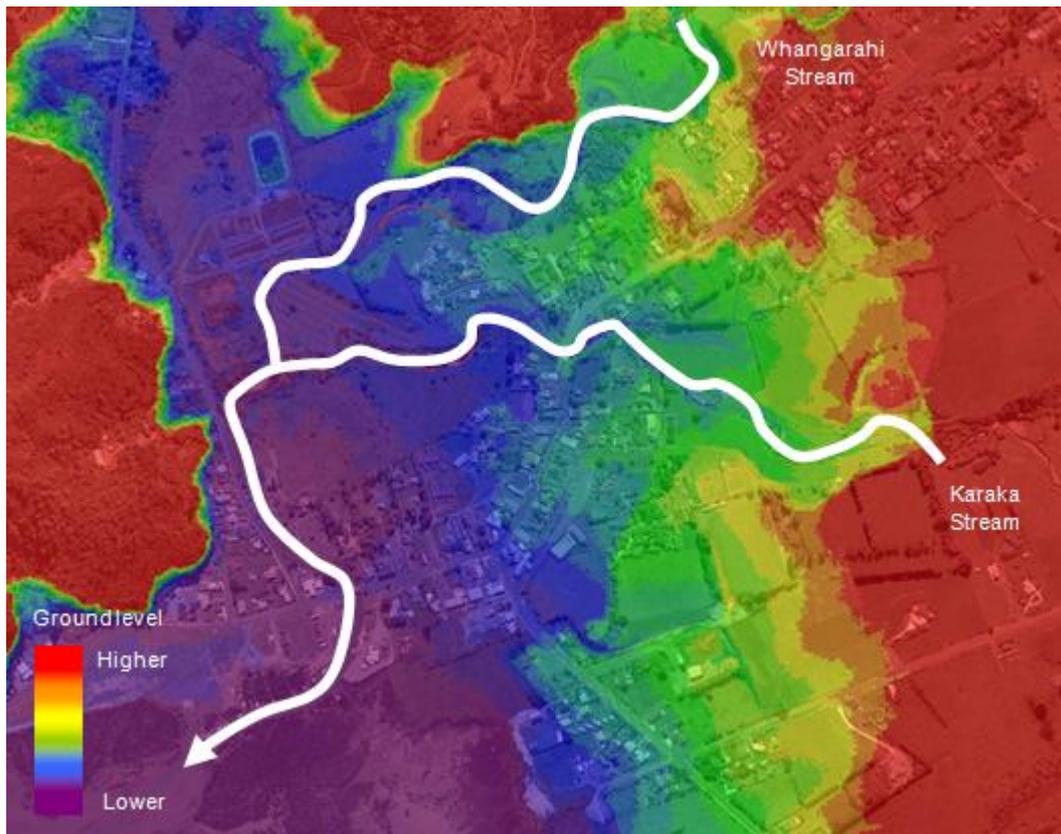
4 Ground level around Coromandel town

Parts of Coromandel town are located on the floodplain and sediment/debris fan created by Whangarahi and Karaka streams. Refer to Figure 4 and Figure 5 which illustrate the relative ground levels in Coromandel Town.

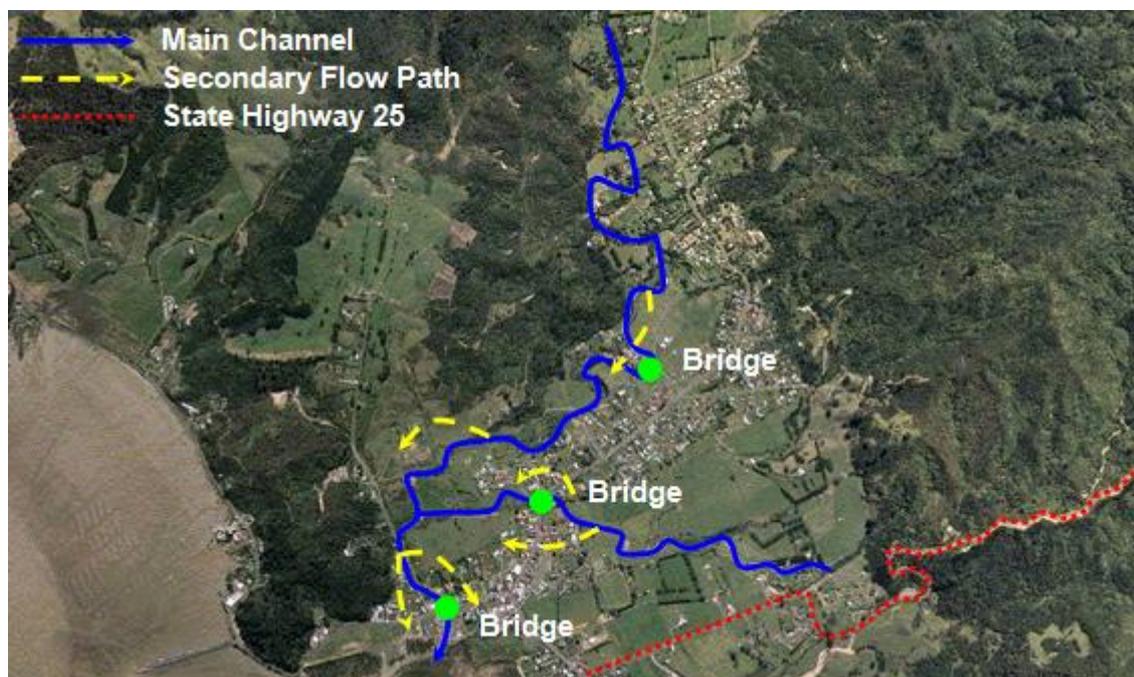
Figure 6 Indicative flooding mechanisms in Coromandel town

- On the Whangarahi Stream in the vicinity of the Albert Street and Pondarosa meanders.
- On the Whangarahi Stream in the vicinity of Hauraki Road.
- On the Karaka Stream in the vicinity of the Kapanga Road Bridge.

Figure 6 below illustrates the main areas where overland flow occurs in Coromandel town.

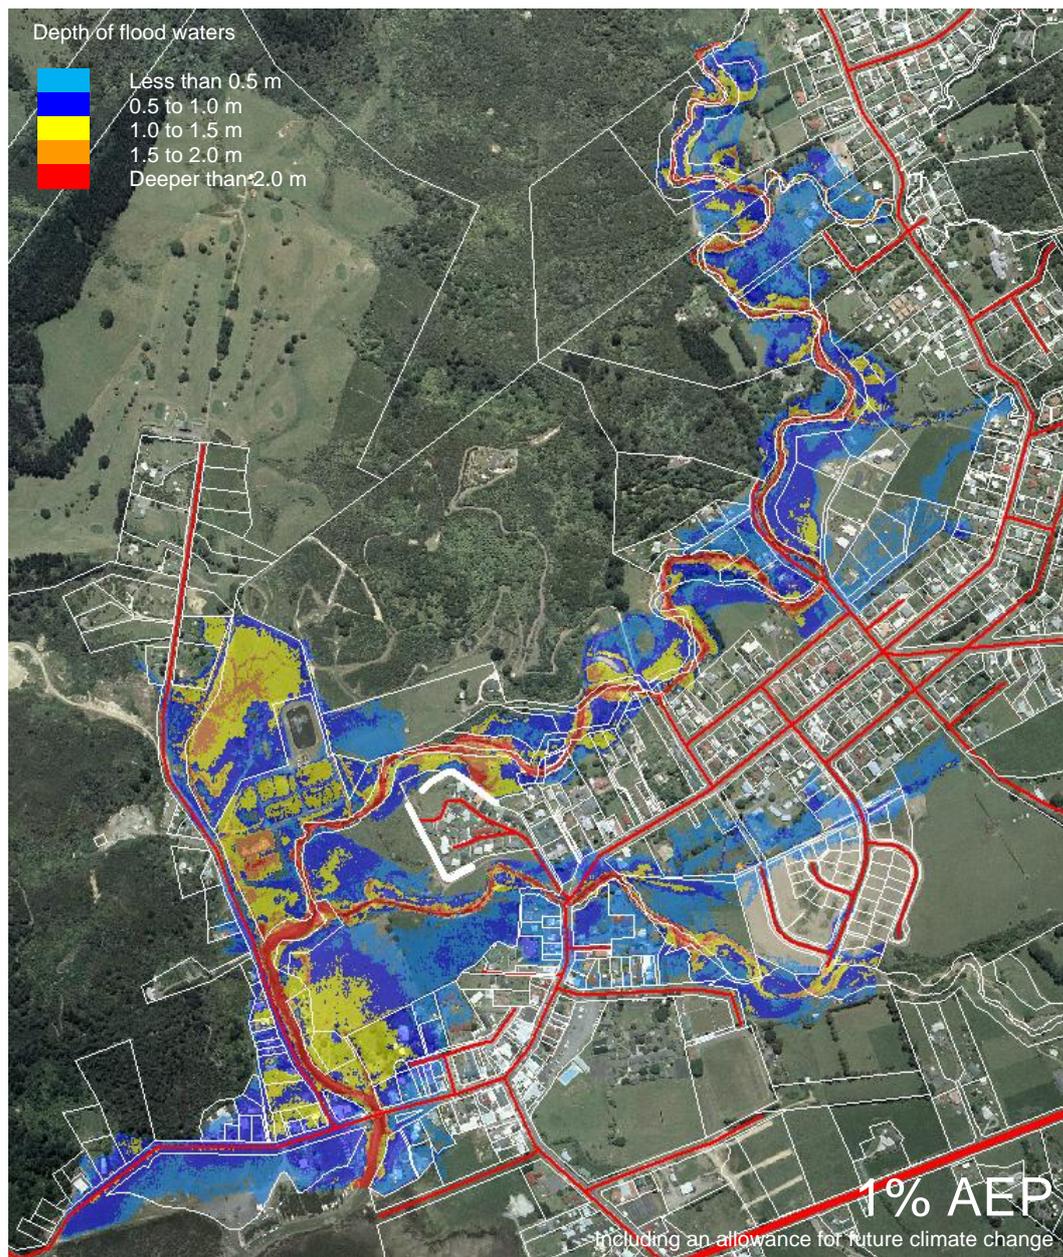
Figure 7 Predicted flood extents for 1% AEP event (with climate change)

Based on the assessment of Coromandel town flood hazards at the time of developing the flood protection scheme, it was assessed that there were about 60 properties in Coromandel that were at risk from flooding from a 1% Annual Exceedance Probability (AEP) event. Of these properties, 35 were houses, 10 were basements or sheds and 15 were sections only. Most of the properties affected were identified to be located in the lower reaches of the Karaka Stream where it joins the Whangarahi Stream. This included a portion of the central business district (on the true left bank) and properties on Hauraki Road (right bank) in the vicinity of the Wharf Road bridge. Upstream, three properties on Albert Street (right bank) were also assessed to be prone to flooding. Figure 7 below illustrates the predicted flood extents at Coromandel for the 1% annual exceedance probability (AEP) event with an allowance for predicted climate change.

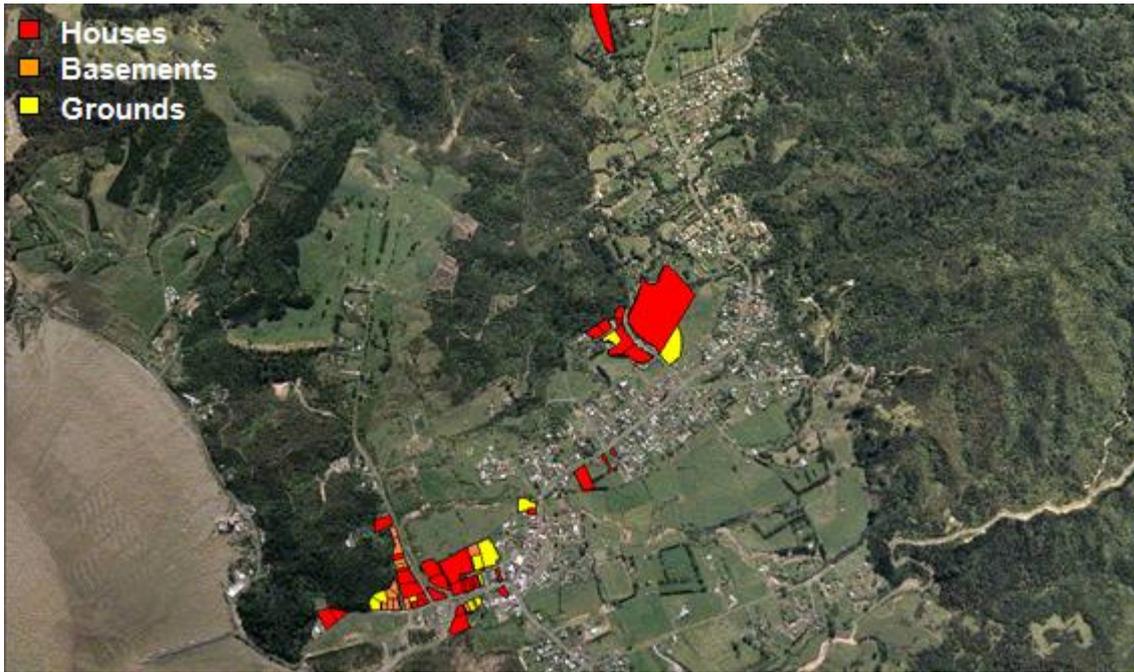
Figure 8 Property damage within Coromandel Town during the 'Weather Bomb'

Damage to properties within Coromandel town from the Weather Bomb was focused on those properties immediately adjacent to the Whangarahi and Karaka streams, and those that are located within the secondary overland flow paths. Figure 8 below illustrates the property damage that occurred within Coromandel town during the 'Weather Bomb'.

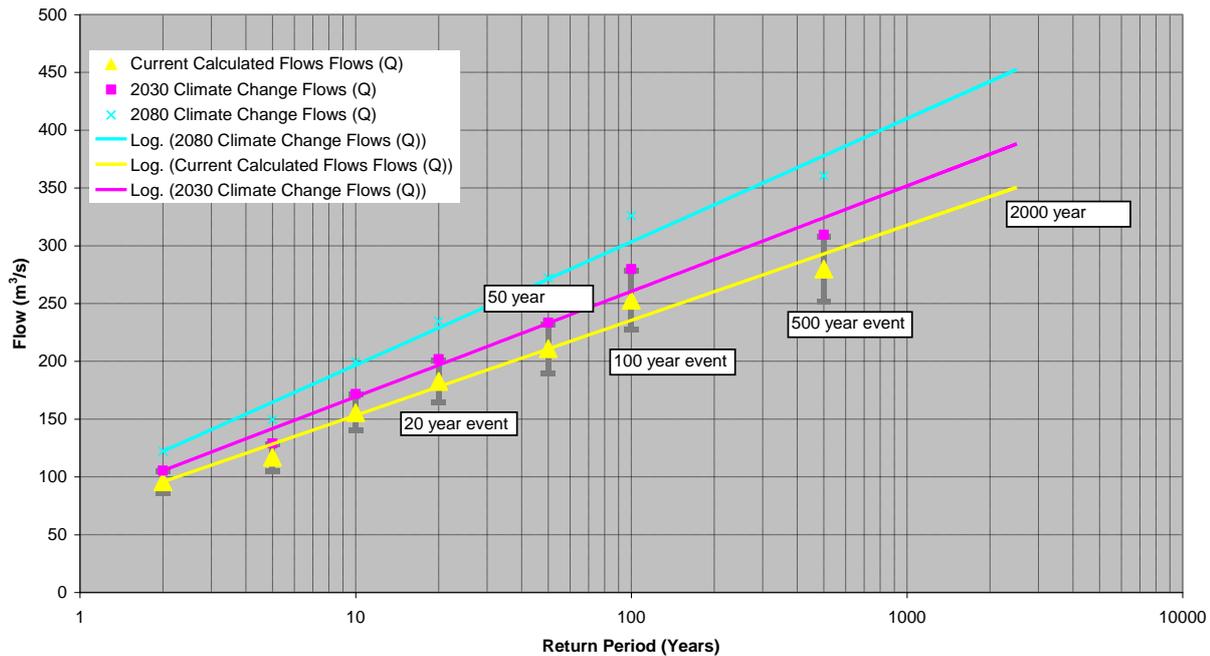
Figure 10 Whangarahi Stream hydrological summary

From the above assessment, the predicted future 1% AEP event flows for the Whangarahi Stream is estimated to be approximately 304m³/s. It was this flow which was then used to determine each subcatchment contribution.

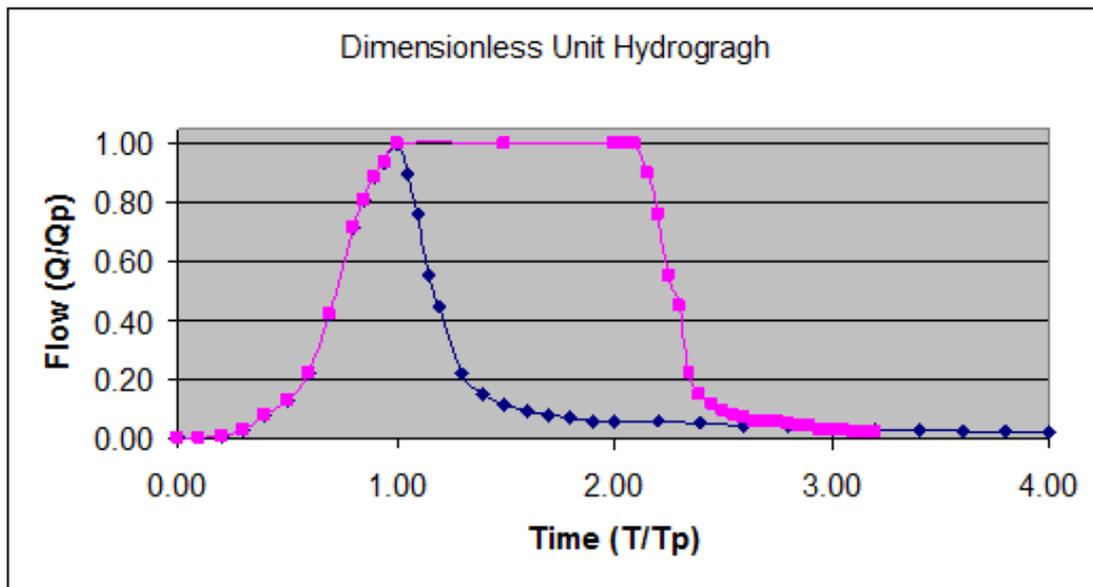
Figure 11 Dimensionless unit hydrograph

To allow realistic modelling it was necessary to create a hydrograph to input flows into the model. A dimensionless unit hydrograph was created by examining five historic floods recorded on the Kauaeranga River at Smiths (WRC recording site 9301). The dimensionless hydrograph used is shown below.

A sustained period of peak flow was also included for this assessment. This was considered appropriate given that the initial calculation related to the time of concentration of the whole catchment (Whangarahi catchment). A rainfall event of this nature would be expected to produce extended peak flows in the smaller subcatchments. This also ensured that the peaks of the smaller catchments would coincide and give peak flows at the mouth of the Whangarahi Stream similar to the Whangarahi Stream peak flow calculation.

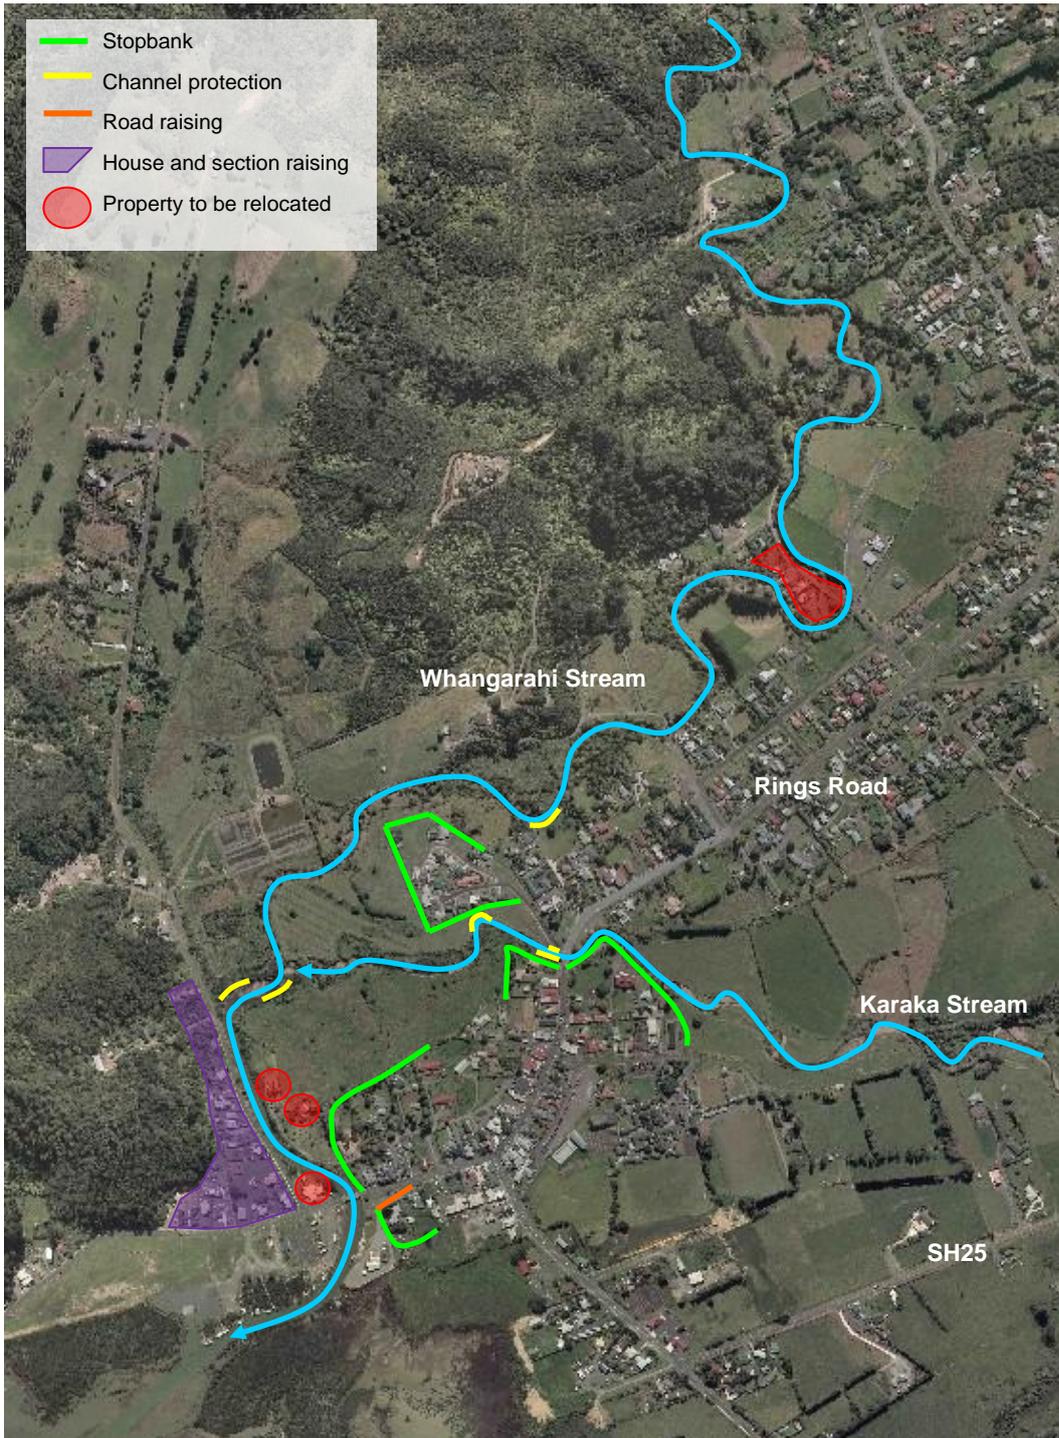
Figure 12 Proposed flood protection scheme for Coromandel

- The provision of a stopbank/floodwall and localised road raising along the left bank of the Whangarahi Stream in the lower CBD.
- Raise the land and buildings on the right bank of the Whangarahi Stream on Hauraki Road.

- Planning controls to be applied to areas at flood risk restricting future development within the area via the proposed Natural Hazards Variation to the Thames Coromandel District Plan, to ensure that the floodway is defined and protected into the future, with no buildings located in the floodway.

Consultation was undertaken with the community about the proposed scheme however feedback indicated that there was not a consensus to implement the full protection scheme. WRC worked with the community to implement a partial flood protection scheme for Coromandel town as discussed below.

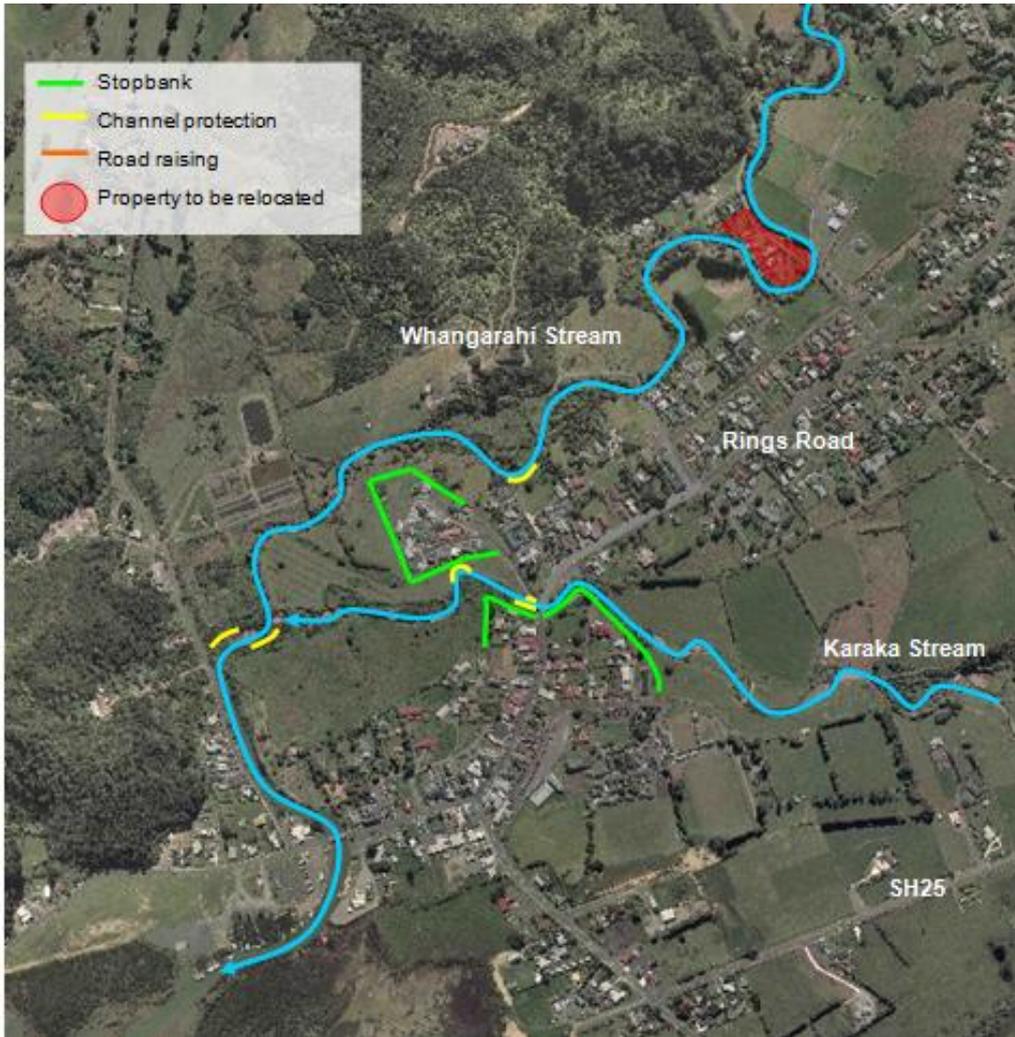
Figure 13 Completed flood mitigation works at Coromandel

The components of the completed works are illustrated in Figure 13 below and are discussed in more detail in the following sections.

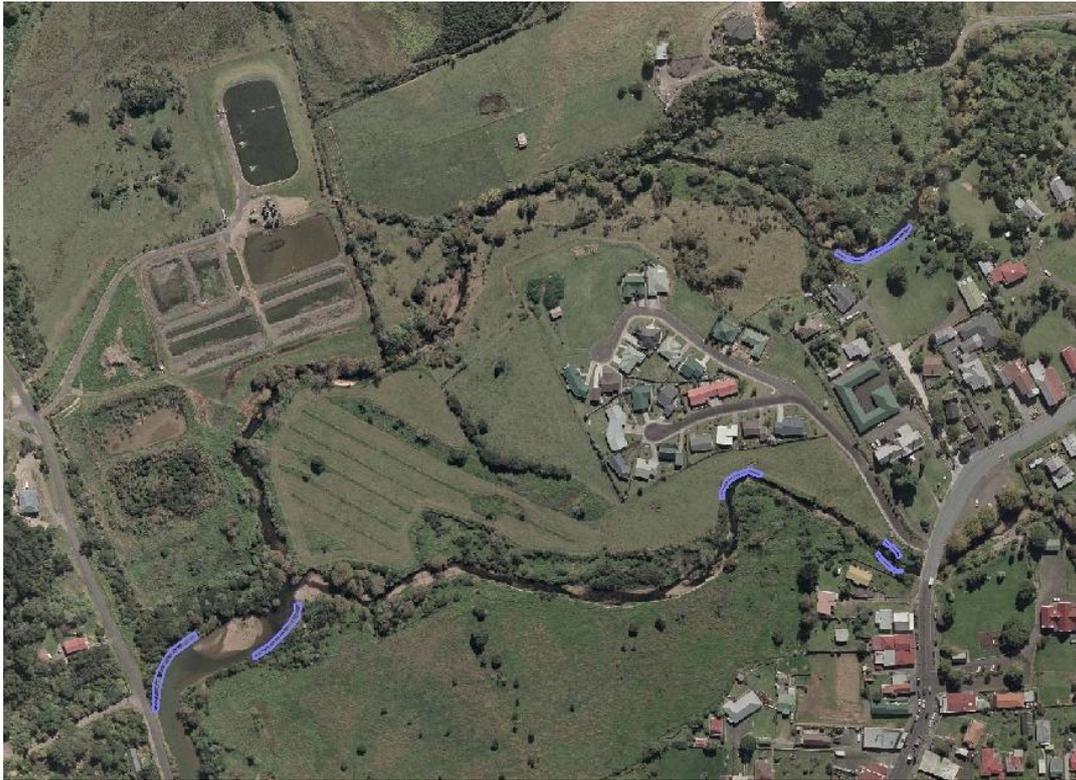
Figure 14 Erosion protection works in the Whangarahi and Karaka streams

- Construction of erosion protection works (consisting of rock rip rap with gravel filter cloth cover) on the stream banks at critical bends (refer to Figure 14 for proposed extent of works).
- Construction of works to improve the management of flood flows from the 'golf course' catchment (ie channel widening and an improved waterway crossing for the Coromandel town wastewater treatment plant).
- Fencing and riparian planting along the Karaka Stream between the Kapanga Road bridge and SH25 for a 1000m channel length. Refer to Figure 15 for the indicative alignment.

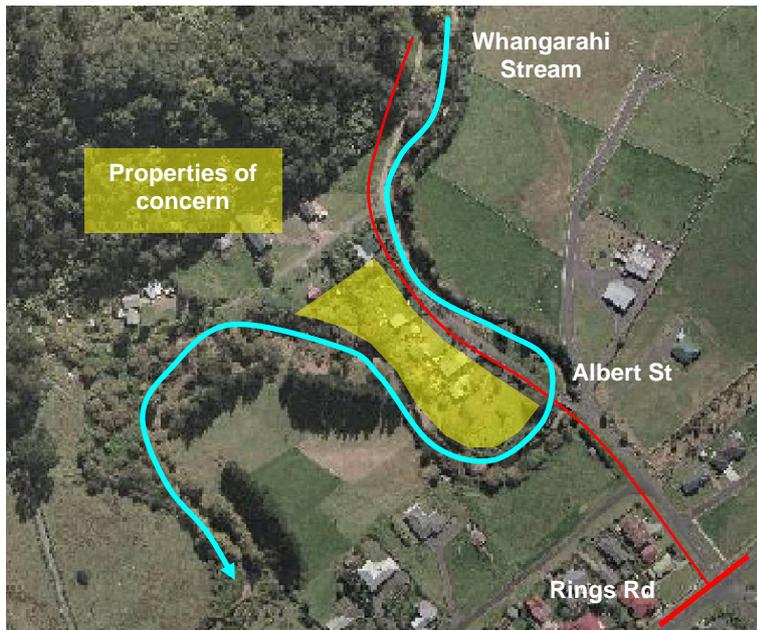
Figure 16 North western section of Albert Street

Early on in the investigations for Coromandel town, it was identified that four properties on Albert Street were at particularly high risk from flooding from Whangarahi Stream. These four properties experienced severe flooding in the 2002 Weather Bomb and another event that occurred within a year of the weather boom. The four properties are unique in that they are bounded by the Whangarahi Stream to both the north and to the south due to a sharp loop in the stream's channel. Figure 16 below shows the location of the four properties on Albert Street.

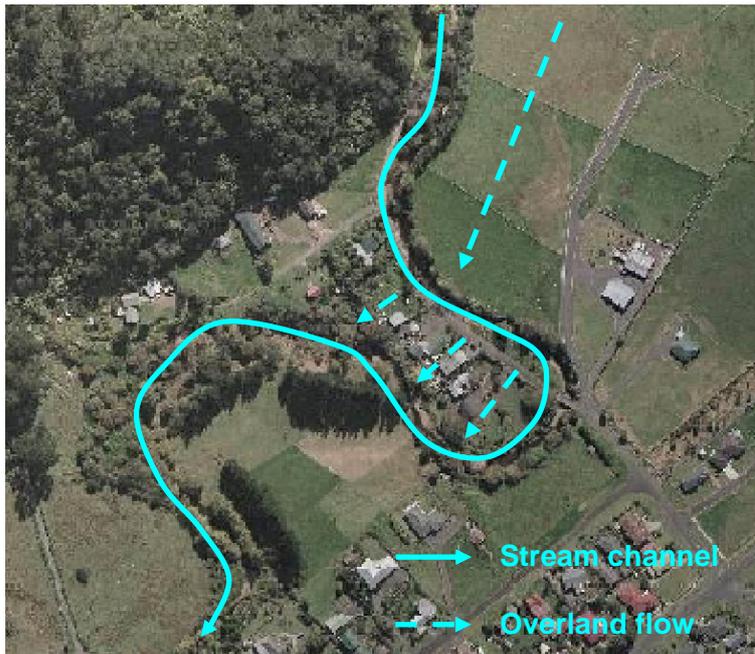
Figure 17 Overland flow across the Albert Street meander during significant flood events

Purchase of these properties completely removes the risks to life for these houses and doesn't incorporate residual risks. It also provides opportunities to improve the amenity values and access to the stream. It provides a long term solution for these properties and contributes substantially to improve the long-term community outcomes of the whole project.

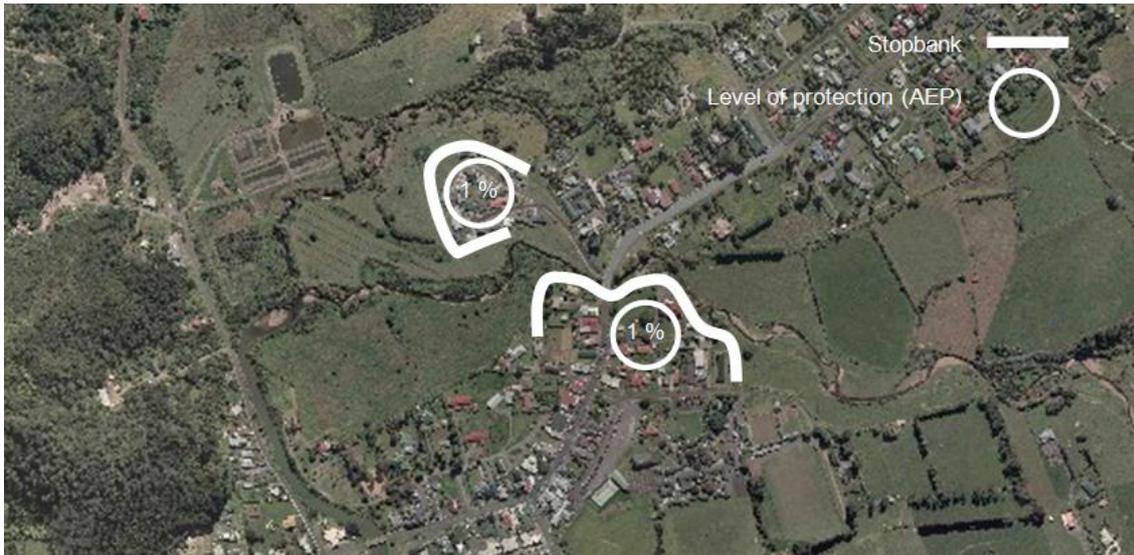
Figure 18 Flood defences in Coromandel town

WRC has constructed flood defences in Coromandel town, however, these defences only provide protection to a small number of properties (refer to Figure 18).

As illustrated, flood protection works have been constructed at two locations in Coromandel. The first provide protection to Elizabeth Park Retirement Village and the second were constructed to protect a portion of the CBD area and residential dwellings, in the vicinity of Kapanga Road bridge. This section provides details about what was constructed.

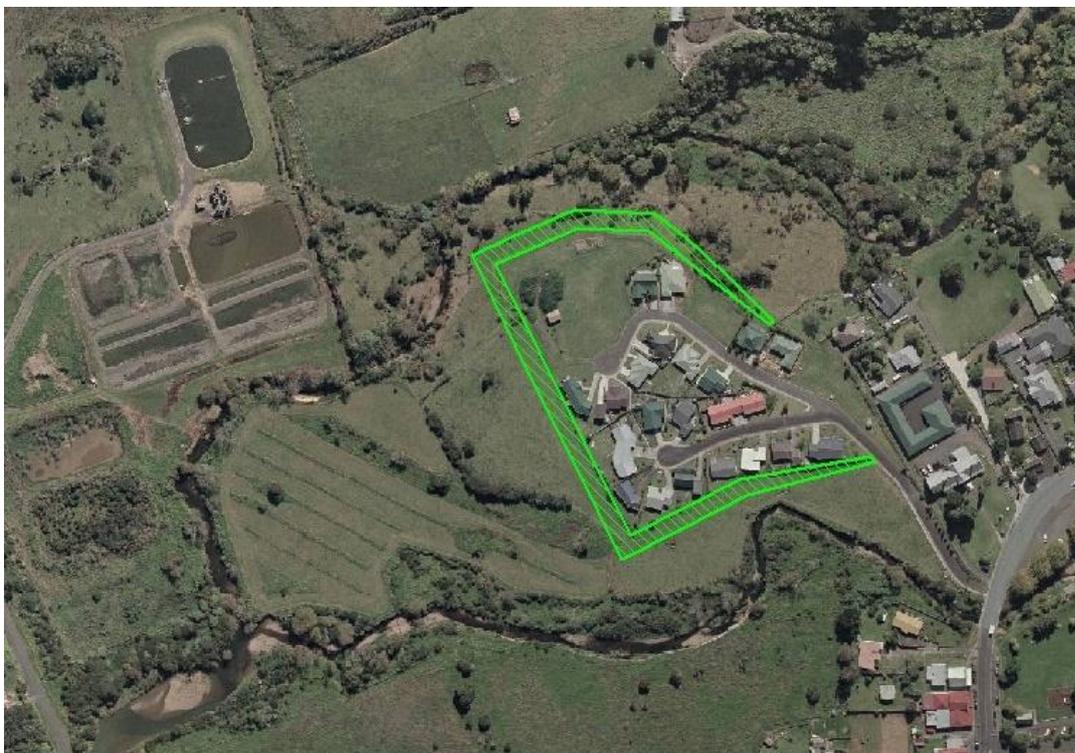
Figure 19 Flood defence constructed at Elizabeth Park Retirement Village

The works included the construction of a 1-2m high stopbank around the Elizabeth Park Retirement Village, on retirement village property. The design standard for the stopbank is the 1% AEP flood level plus 500mm freeboard. The indicative alignment of the constructed flood defences is shown in Figure 19. As-built survey information for the flood defences is provided in Appendix 3.

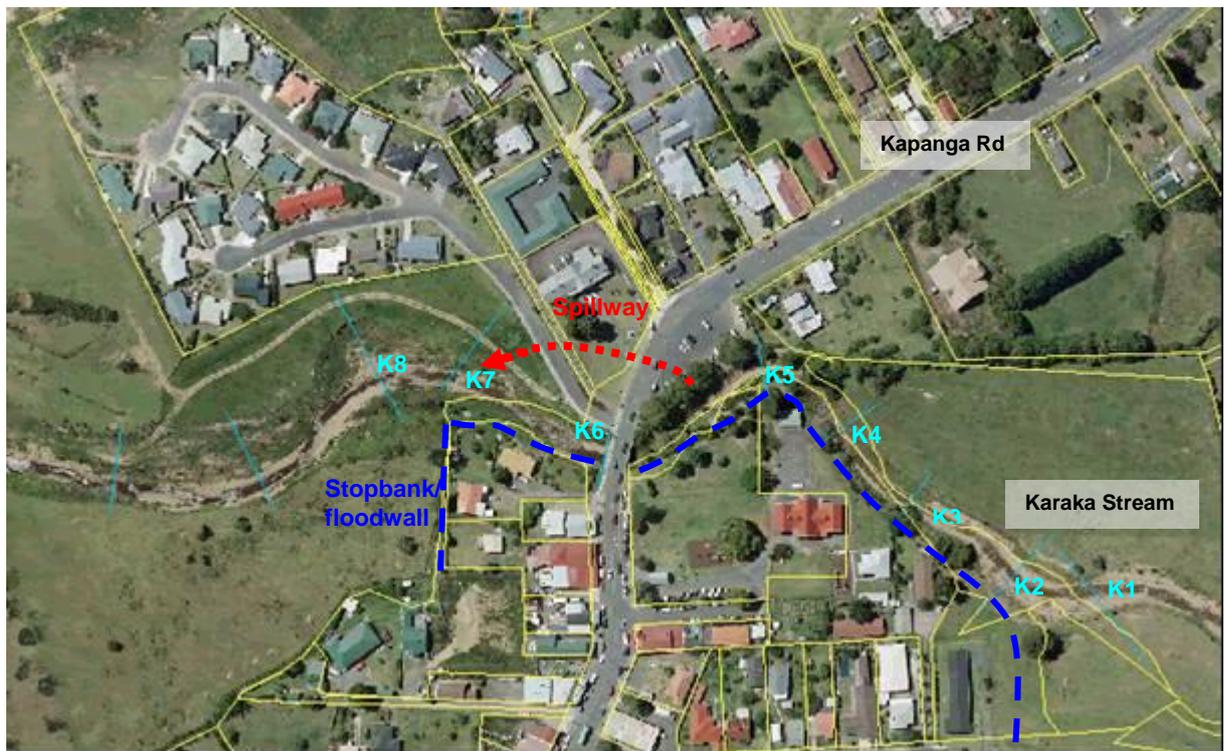
Figure 20 Flood defence constructed at Kapanga Road bridge

Design details for what was constructed are included in Appendix 2 and WRC DM#1536543. The design standard for the stopbank is the 1% AEP flood level plus 500mm freeboard. The indicative alignment of the constructed flood defences is shown in Figure 20. As-built survey information for the flood defences is provided in Appendix 3.

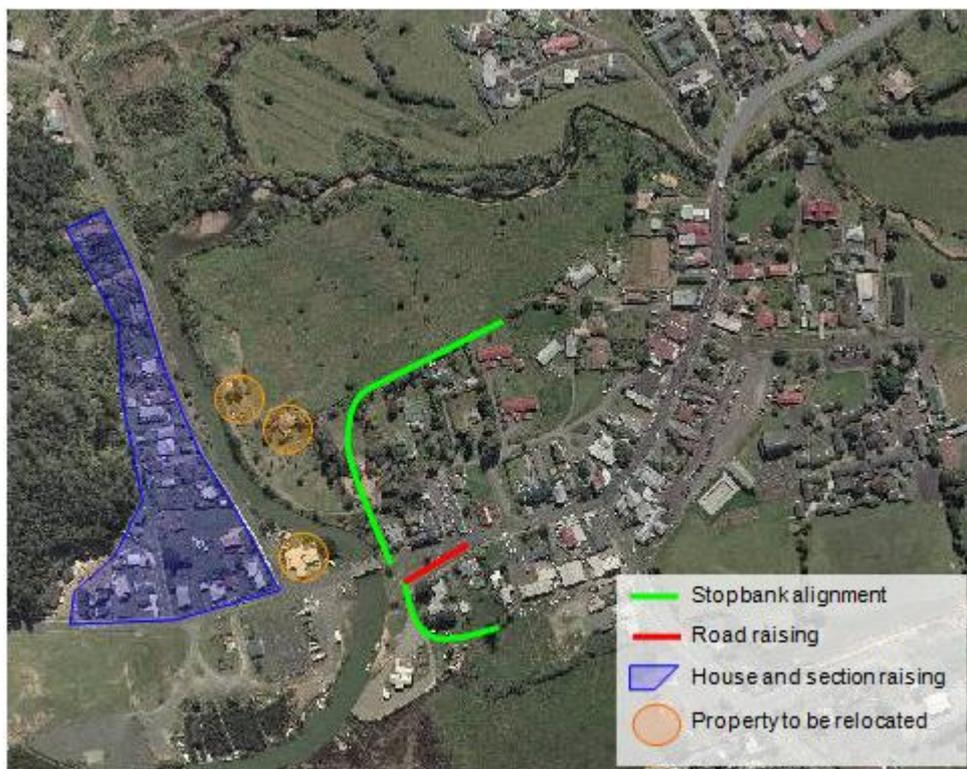
Figure 21 Proposed future flood protection mitigation measures

- Provision for adequate floodway within the current floodplain, by relocating several at-risk properties located in the lower reach of the Whangarahi Stream floodplain (two residential and one commercial). The locations of the properties are illustrated in Figure 21 below. This property purchase would help to keep the Whangarahi Stream floodway free of obstructions and ensure no future development in this area.
- The provision of a stopbank/floodwall along the left bank of the Whangarahi Stream in the lower CBD.
- Raise the land and buildings on the right bank of the Whangarahi Stream on Hauraki Road.

The following outlines the key aspects of these components of the full proposed scheme:

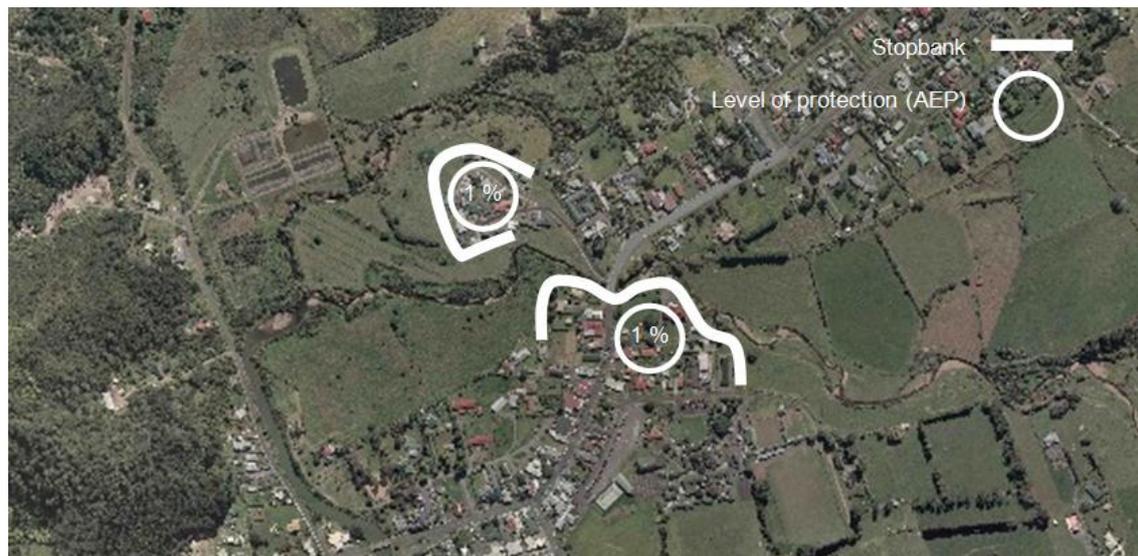
Figure 22 Flood defences in Coromandel town

The flood protection scheme on Whangarahi and Karaka streams in Coromandel is identified as needing to be maintained and managed to ensure the level of service for flood protection assets is maintained. The level of service provided by the scheme at Elizabeth Park Retirement Village and on Karaka Stream in the vicinity of the Kapanga Road Bridge is the existing 1% AEP event (without climate change) plus 500mm freeboard. The general location of the flood protection assets is shown in Figure 22 below. Refer to Appendix 2 for design details for the flood protection works on Karaka Stream. As-built survey data is provided in Appendix 3.

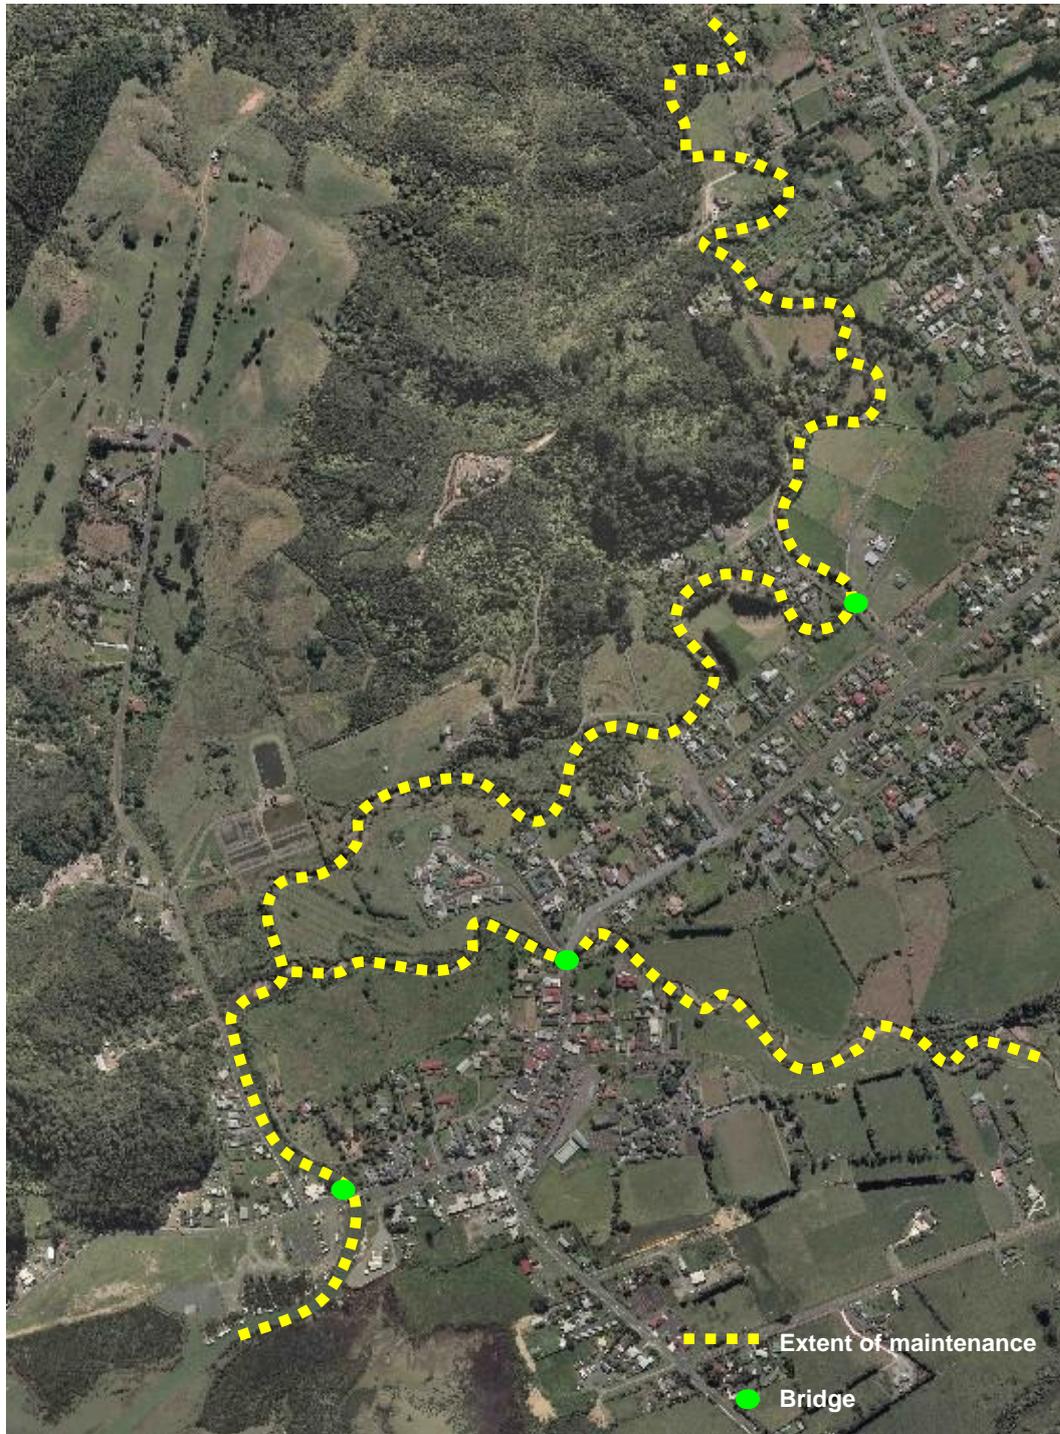
Figure 23 Extent of channel maintenance

The Whangarahi and Karaka streams are monitored and periodically maintained by the WRC to remove accumulated sediment and debris, refer to Figure 23 below for the indicative extent of works. This work maintains the capacity of these streams and reduces the risk to adjacent land that would otherwise be inundated more frequently from stream flooding.

The annual maintenance programme includes the removal of accumulating gravel and sediment in the Whangarahi and Karaka streams, based on current cross sectional areas. These works are carried after annual inspection and monitoring of changes in the streams. The specific activities associated with this annual work programme include:

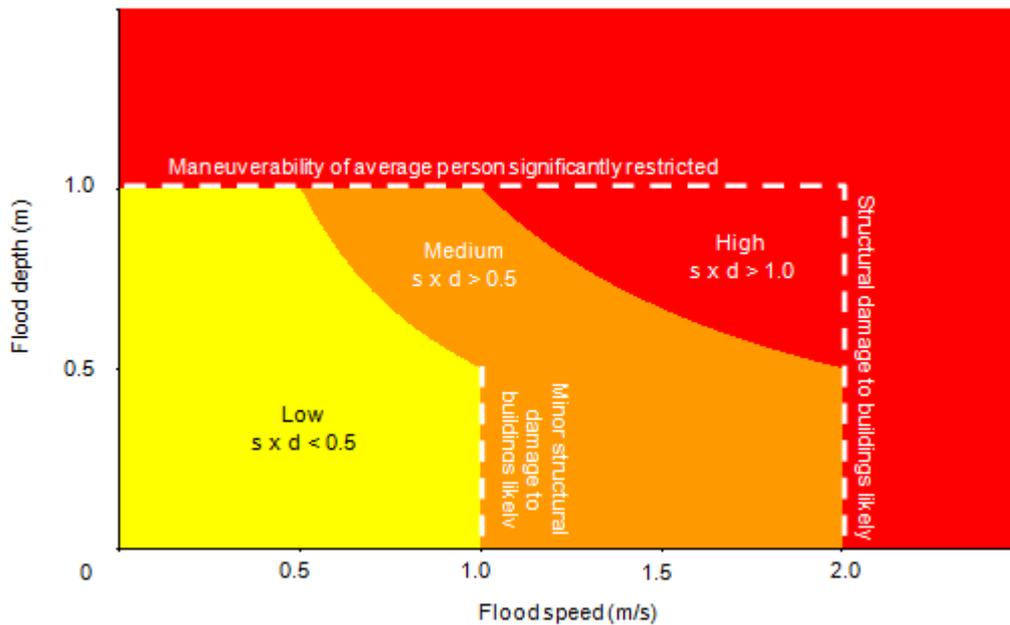
Figure 24 River flood hazard classification matrix

The three levels of river flood hazard (low, medium and high) have then been quantified through the creation of a matrix that assigns a river flood hazard level based on the predicted depth and speed of flooding (refer to Figure 24).

The following two scenarios also result in a 'high' flood hazard classification:
