Coromandel flood protection scheme design report

Prepared by:
Megan Wood (Wainui Consulting Limited)

For:
Waikato Regional Council
Private Bag 3038
Waikato Mail Centre
HAMILTON 3240

23 May 2014

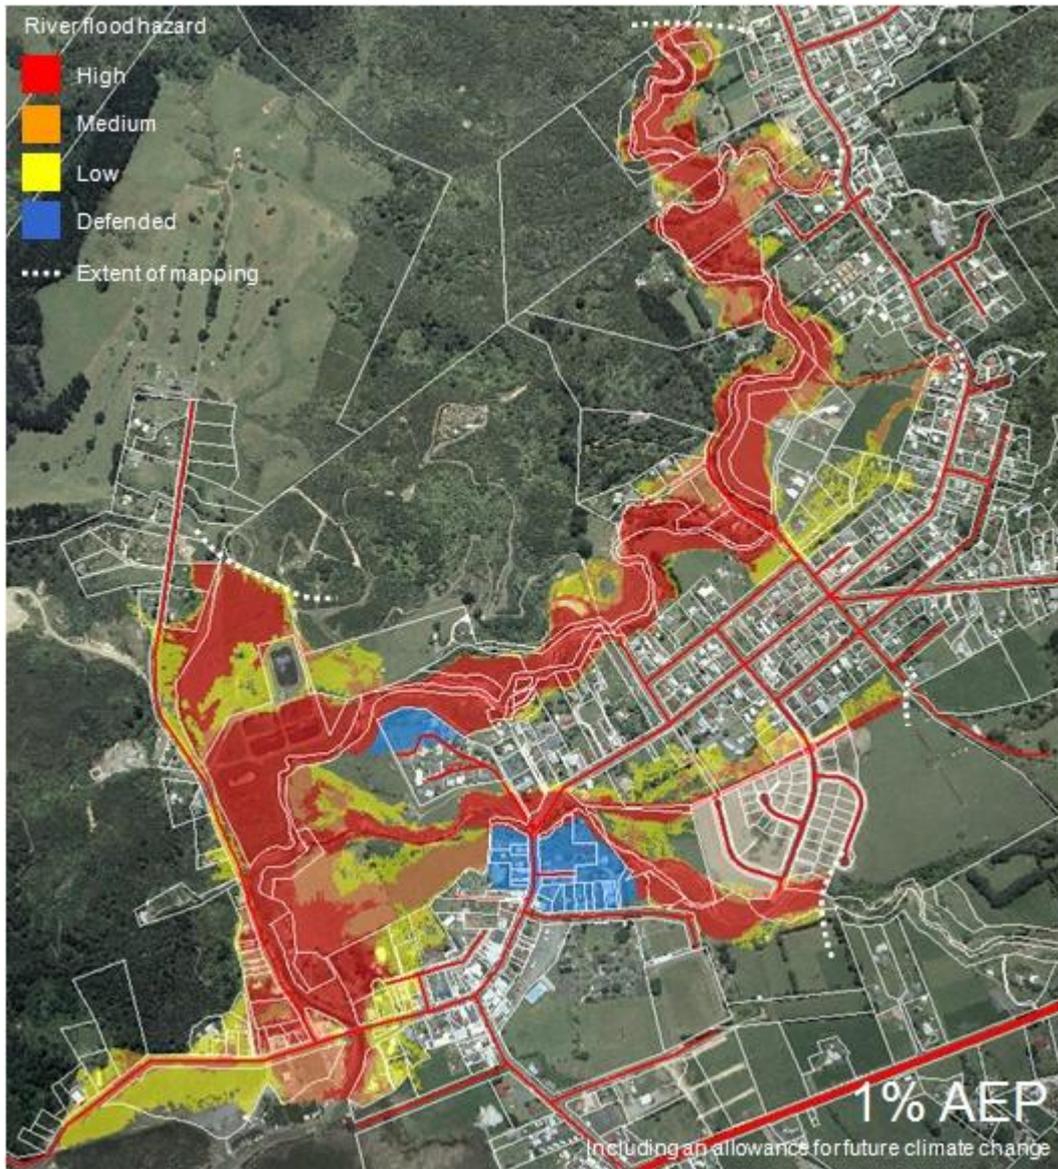
Figure 25 River flood hazard map for Coromandel

The river flooding information described in the sections above has been used to produce a river flood hazard map for Coromandel town due to the Whangarahi and Karaka streams. Figure 25 shows the flood hazard map for Coromandel town with the area that is now protected by the scheme shaded in blue to represent its 'Defended' status.

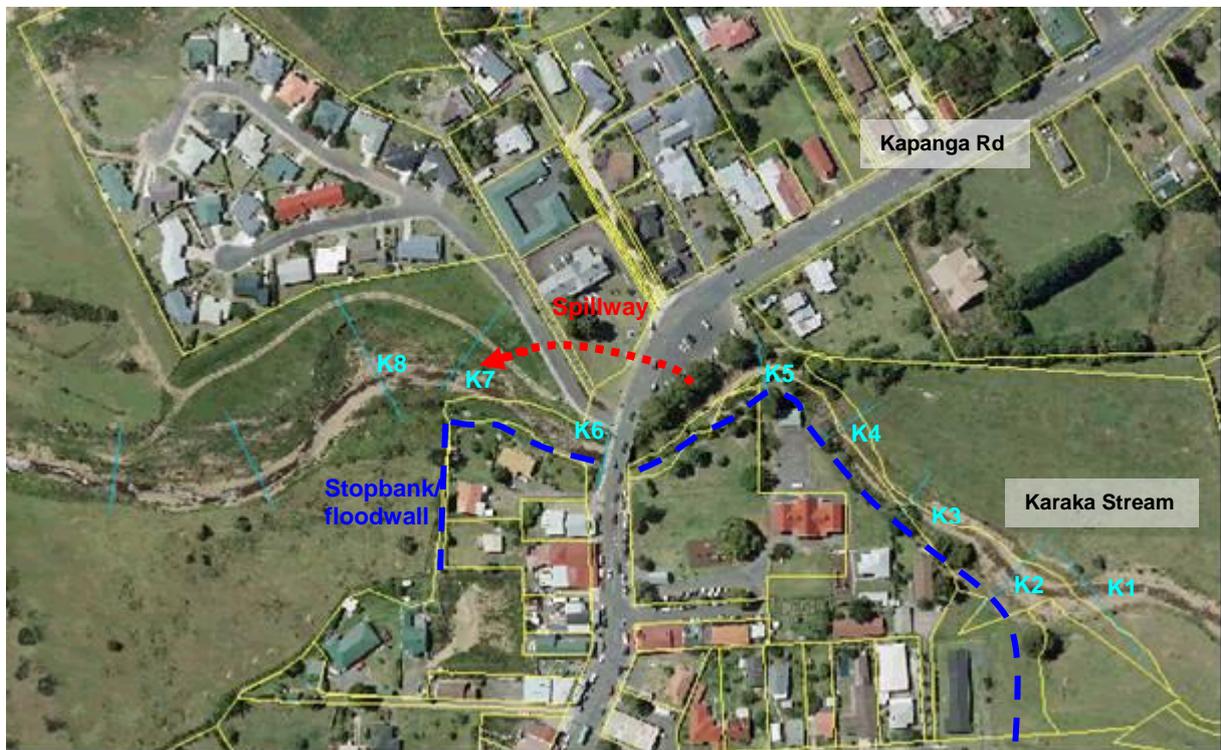
Figure 1 Karaka Stream flood protection works

The following figure shows the key features of the system, including the existing spillway, and provides a preliminary alignment for the stopbank/flood wall. Note that the alignment will be finalised pending discussions with affected landowners, hence being shown as a dashed line.

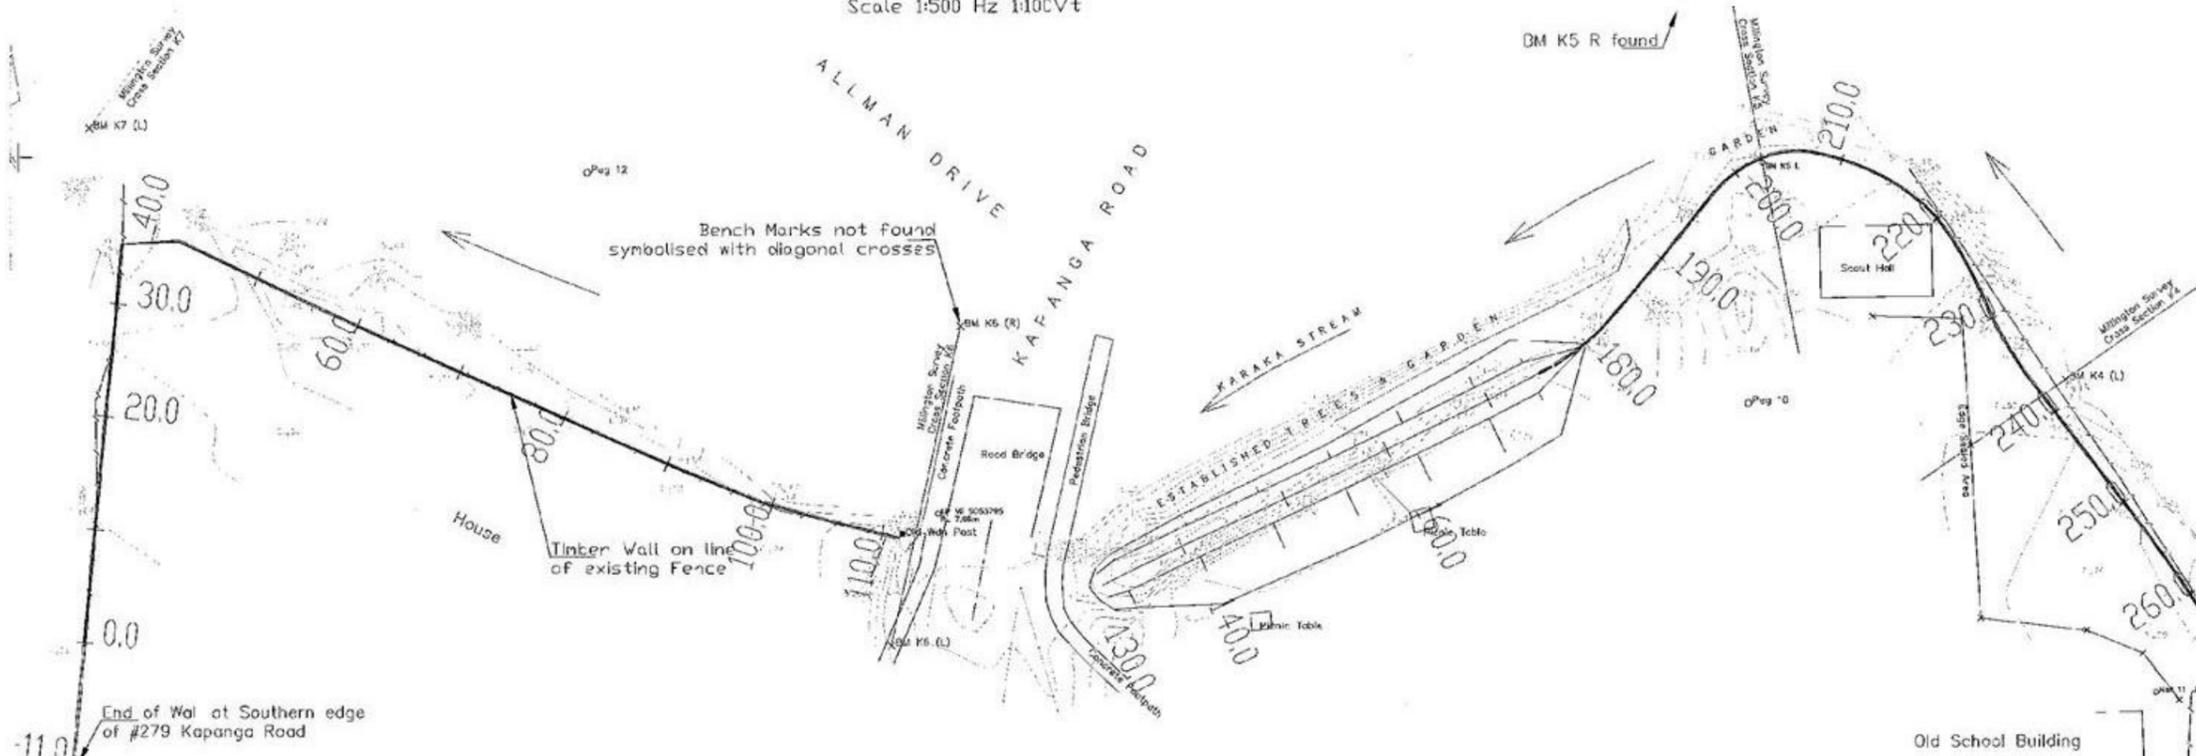
Wall Longsection
Scale 1:500 Htz 1:100Vt

AMENDMENTS
1. Design alignment between 190-210 moved from Chainage 230-310 changed to wall and fence.

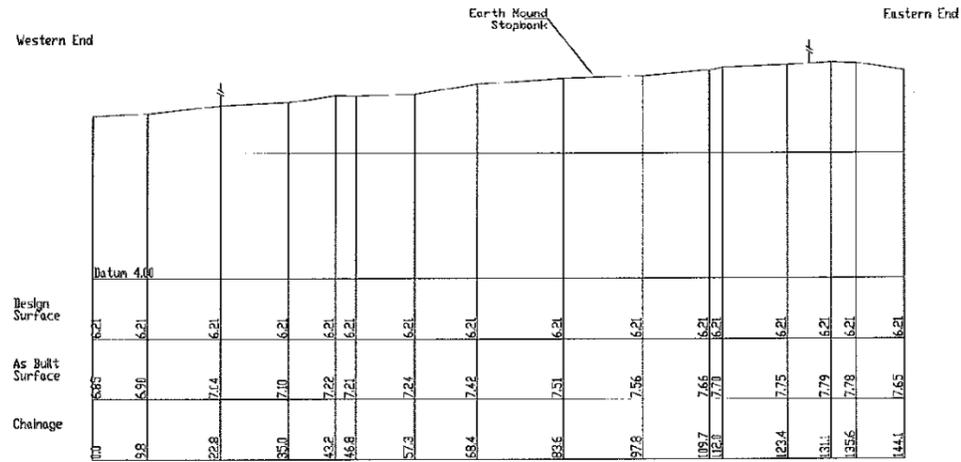
Elizabeth Park Retirement Village Stopbank Section 2 Crest Longsection

Scales 1:500Hz 1:50Vt

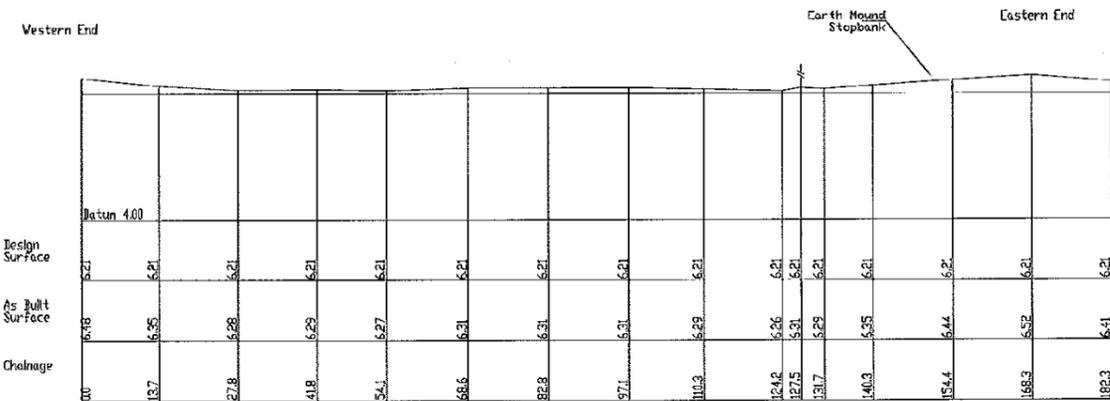
Elizabeth Park Retirement Village Stopbank Section 1 Crest Longsection

Scales 1:500Hz 1:50Vt
