Sinter-forming springs and geysers of the Waikato region

Prepared by:
Ashley D. Cody¹
Ron F. Keam²
Jesse Lebe⁴
Bridget Lynne³
Katherine Luketina⁴

⁴Waikato Regional Council

For:
Waikato Regional Council
Private Bag 3038
Waikato Mail Centre
HAMILTON 3240

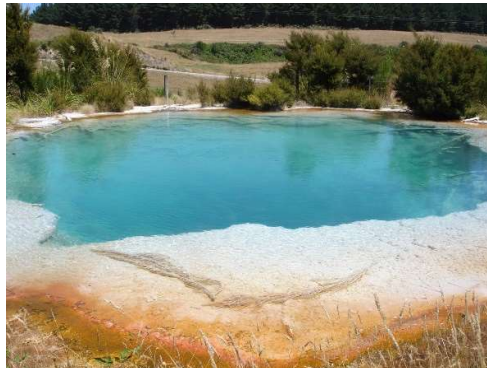
Figure 3-2: Southern Spring, Whangapoa

Description: The spring lies about 100 m south of Ohakuri Road, beside the farm access drive. The spring is sub-circular, about 12 m in diameter, with vertical walls visible beneath the surface. The water is clear, has no odour, and occasionally produces bubble swarms, probably caused by the evolution of CO₂. Since Waikato Regional Council started monitoring the spring in 1995, the water temperature has ranged between 55 and 70 °C.

The spring is often used for scalding fur and feathers off game, and wooden pallets and other temporary structures can sometimes be found around the shallows of the pool edge. Litter and feathers, hair, bones, and other animal remains are also occasionally left around the pool margins.

Condition: Recoverable. The spring's natural head has been decreased several metres by an artificial channel.

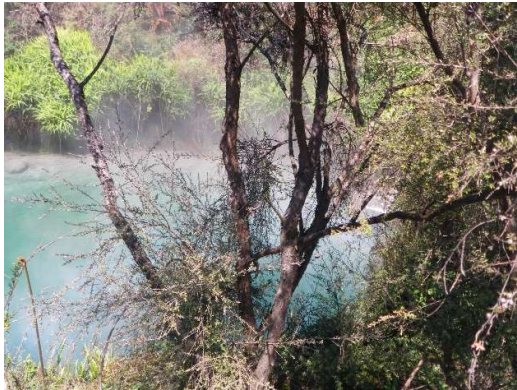
Figure 3-3: Northern Pool, Whangapoa

The pool fills a crater which may have been of hydrothermal eruption origin. Geothermal ferns inhabit the steep sides of the crater.

Condition: Recoverable. The vent has been filled in with logs and earth.

The sinter-lined vent provided a rare opportunity to see the near-surface dimensions of a large spring. The digging of posts for fencing has shown that there is sinter under the flat ground around the top of the crater. The surrounding land has been cleared of pine and the crater fenced off. The fill has started to degrade and slumping has occurred, so if the fill is not topped up, at least the upper part of the vent should become visible again.

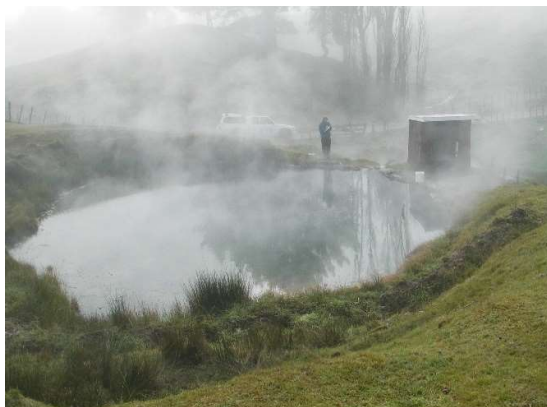
Figure 4-1: Waipupumahana

Description: This is the largest active feature remaining in Horohoro. It is a circular pool about 12 m in diameter with vertical sinter walls on the eastern half of its circumference. It has clear, blue water with a temperature around 50 °C, no odour, and occasional bubble swarms, most likely caused by evolution of CO₂. Since Waikato Regional Council started monitoring the spring in 1995, the water temperature has ranged between 48 and 56 °C. The outflow is about 0.5 to 1.0 l s⁻¹.

The pool is on Māori land. A channel about 0.25 m wide x 0.3 m deep has been excavated through the sinter wall to provide a single concentrated channel outflow for filling a bath. Consequently, there is no longer the dispersed outflow necessary for sinter accumulation. The owners have told Ashley Cody that they have considered blocking the channel to restore the pool to its natural condition. However, this has yet to occur. The pool would also benefit from fencing off from stock, and planting the margins with native species. The steep bank surrounding some of the pool is prone to

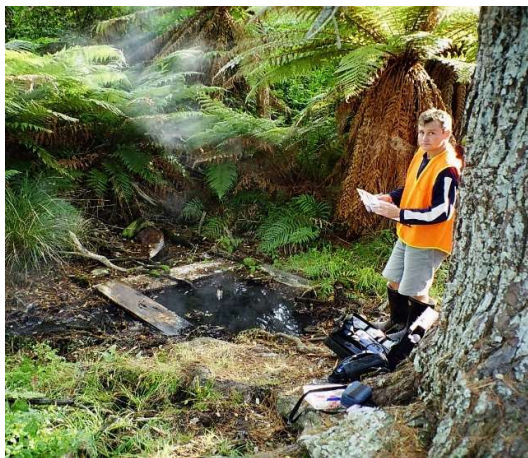
Figure 4-2: Gully spring

Type: Hot spring weakly depositing silica to form sinter.

Condition: Unaltered.

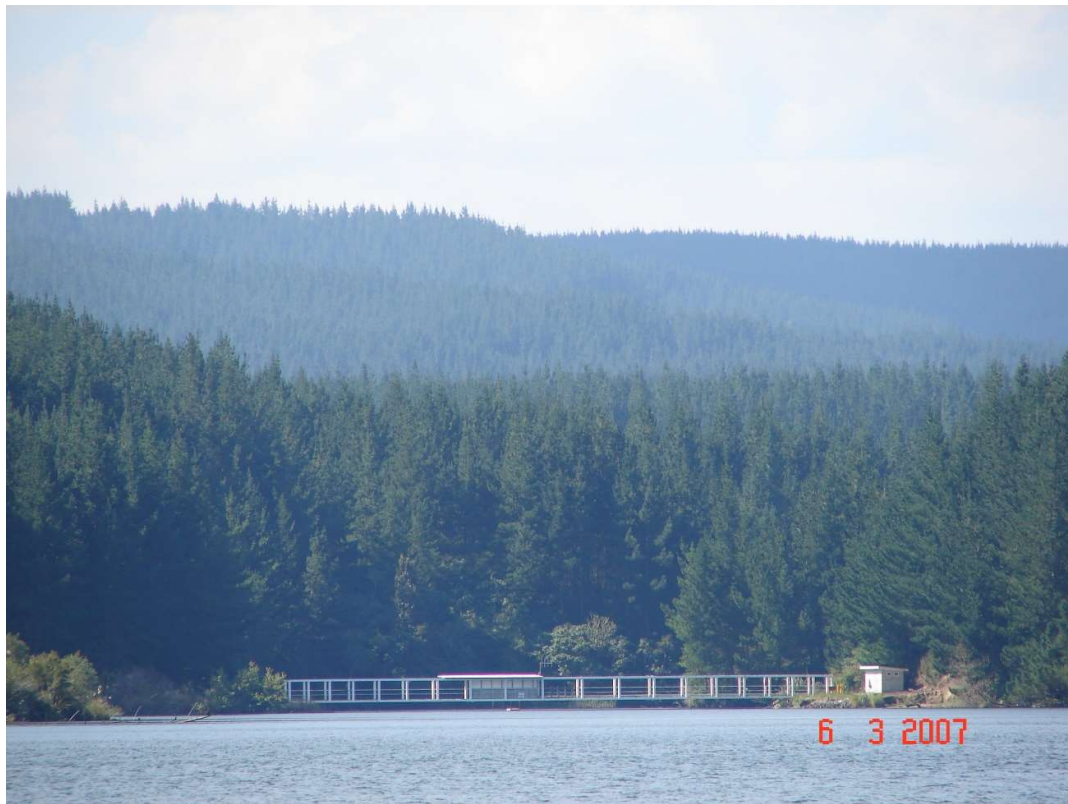
Condition: Inundated.

Figure 5-1: Sinter springs discharge on the bed of Lake Maraetai

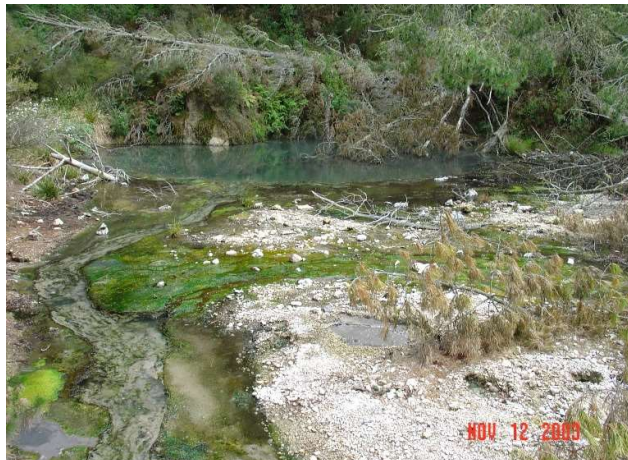
On 19 April 2005, this spring was the site of a large hydrothermal eruption which led to the formation of a crater pool. A mud pool also formed on the east side of the crater. Intense rain events have scoured and deposited pumice gravels from proximal slopes and crater walls into the lake. This causes the pool to be completely infilled by sediments such as in 1999 (Cody 2000), or partially infilled as observed in 2020, turning the water colour into dark brown.

Figure 7-1: Southern Spring partially covered by cyanobacterial mats and pumiceous debris

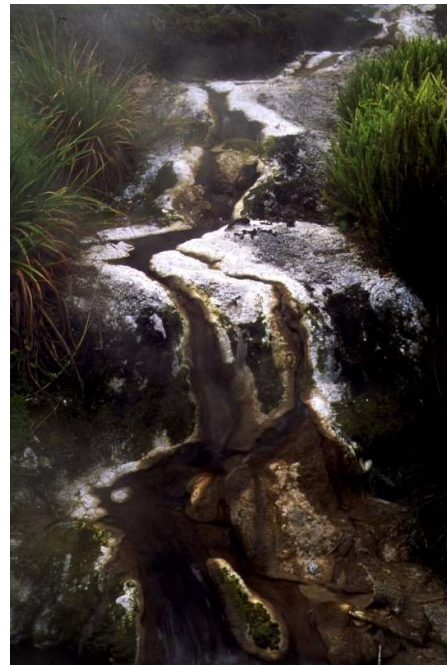
Condition: Extinct.

Threats: Moderately threatened. Being on a low bank close to Orakonui Stream the spring and its calcite formations are at risk of flood damage. The surrounding vertical bank is composed of unstable weak alluvium.

Figure 7-2: Outlet from Calcite Spring in 1995. Copyright Shaun Barnett.

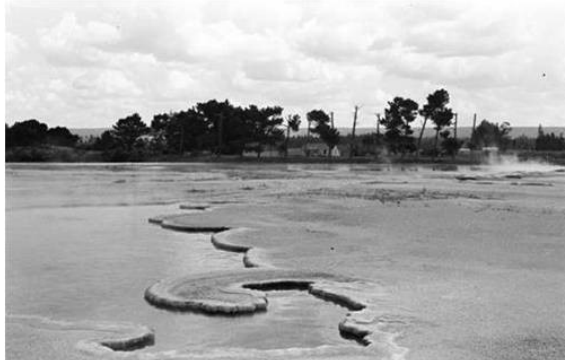
Condition: The natural flow of the pool is extinct. The sinter is recoverable by artificial means.

The outflow has been re-routed away from the silica terrace down a channel dug through the sinters to provide hot water to a bath house for the Ohaaki Marae. The pool waters are chemically altered and therefore the silica deposition is different from that of the original boiling alkaline upflow. The outflow is approximately 5 L/s.

Figure 8-1: Ohaaki Pool before it was affected by extraction. Copyright Ron Kearn.

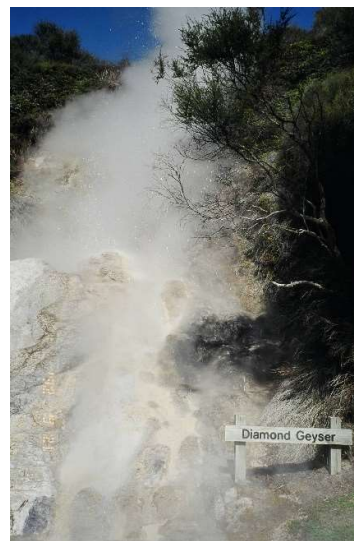
Description: An active geyser, which during the years 1995 to 2005 was observed by Ashley Cody to erupt 3 to 8 m high in pulsating jets for several hours, with approximately 1 L/s overflow. The frequency and duration of eruptions were less before Lake Ohakuri was formed. However, no eruptions were witnessed during 2007 and April 2008. During this time, only a trickle of water constantly flowed over the vent rim and down the slopes of the geyser mound. The vent is approximately 1 m in diameter, and about 3 m above the level of the path that passes across the outflow. The water temperature in the pool at the top of the geyser mound measured 93 °C in March 2008. The geyser has an apron of hard creamy-white sinters, covering approximately 7 m x 15 m in spatial extent. Nodular and spicular geyselite textures occur in the splash zone around the vent and down the 3 m high vent slope. The outflow fans across the south-east portion of Rainbow terrace, where coloured microbial mats flourish.

Figure 9-2: Diamond Geyser Erupting in 2004.

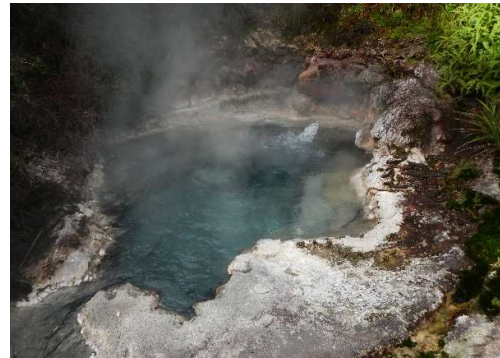
Description: This is an intermittently boiling spring with a temperature around 99 °C. Since 1995 it has been typically boiling with the height of ebullition about 0.5 m and flow rate around 0.5 L/s. The overflow passes through an artificial channel across a narrow sinter terrace which spills down the scarp of Rainbow Fault above S108-110. It boils for several days or weeks at a time, then stops boiling and the vent basin dries out for a period of time. On December 5th 2007 the pool drained overnight and had not refilled by April 25th 2008. The vent is a basin about 2.5 m in diameter surrounded by manuka scrub. There appears to be a sympathetic action with Diamond Geyser (described above), as data-logger records show that S111's boiling episodes frequently occur at the same time as eruptions from Diamond Geyser (Cody, 1996).

Figure 9-6: My Lady's Lace with a high water level.

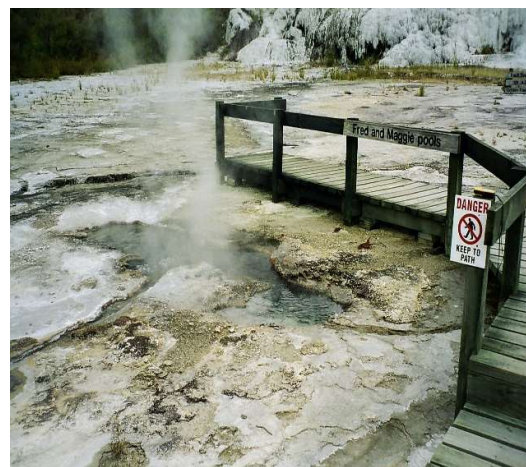
Description: The basin is about 2 m in diameter, and irregular in shape. From the mid-1990s to 2008 the temperature of the pool has been constant around 98 °C with a flow of approximately 0.1 L/s. Smooth, massive sinters coat the walls and the outflow channel. Discharge from the springs deposit silica and contribute to build up of the sinter terrace.

Figure 9-7: Fred and Maggie pools in 2003.

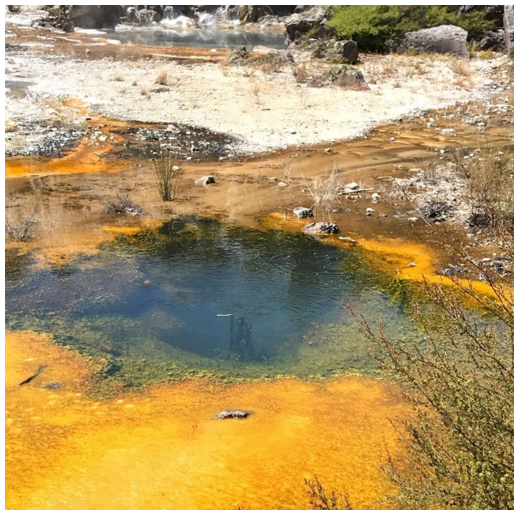
Figure 9-8: An overflown Manganese Pool with visible conophyton stromatolite growths in February 2020. Copyright Jesse Ledwin Lebe.

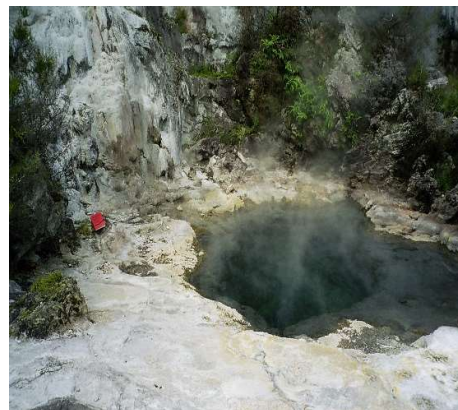
Description: A calm, clear hot spring about 4 m in diameter at the base of Golden Fleece fault scarp, with massive sinter walls and surrounds. Since monitoring began in 1995, the spring remained below overflow for most of the time, but recommenced overflowing intermittently in September 2002. It had a period of geysering in the late 1940s.

Figure 9-9: Cauldron geyser in 2003.

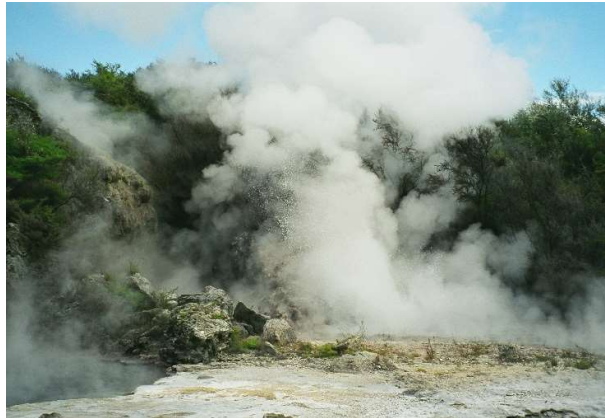
Description: This feature had a period of eruptive activity from November 1982 to June 1983 (Cody, 2002c). It also erupted in 1996. In September 2002 it resumed overflowing, and then began erupting approximately seven times per day for 17 minutes at a time. Eruptions consisted of multiple spurts 5 to 8 m high in all directions and lasted for about 8 minutes, producing a flow of approximately 10 L/s (A.D.Cody, emails to Katherine Luketina, 19/11/2002 and 5/12/2002). This lasted until early 2003, when it continued boiling but ceased erupting (Cody, 2003a). During 2007 and April 2008, the water level of the pool varied considerably, rising and falling up to 1 m but remaining at least 0.5 m below the rim. In 2008, the water temperature was 93 °C, clear and calm.

Figure 9-11: Wairiri Geyser erupting in 2004.

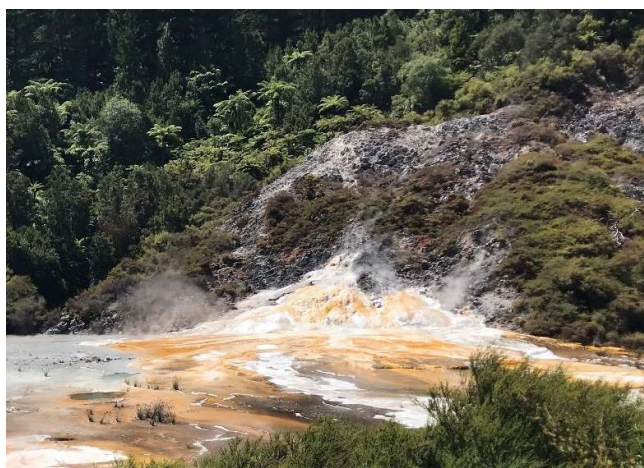
Description: Two intermittently active geysers with massive creamy, white sinters that cascade down the slope. The vent of S812 is about 1.5 m in diameter and about 2 m up from the terrace level. Since Waikato Regional Council monitoring began in 1995 the geyser has exhibited periods

Figure 9-17: Pyramid of Geyser on February 2020. Copyright Jesse Ledwin Lebe.

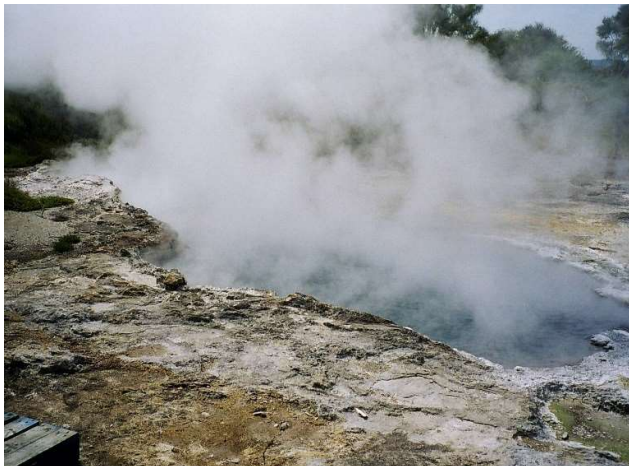
Condition: Unaltered.

Threats: Moderately threatened. If the Reporoa geothermal system classification were changed to Development, the spring would be highly vulnerable to any geothermal well production reducing aquifer pressure and stopping all flows. It is also at risk from any human activities such as diversion of outflow into a narrow channel, which would stop sinter formation.

Figure 10-1: Māori Spring in 2004.

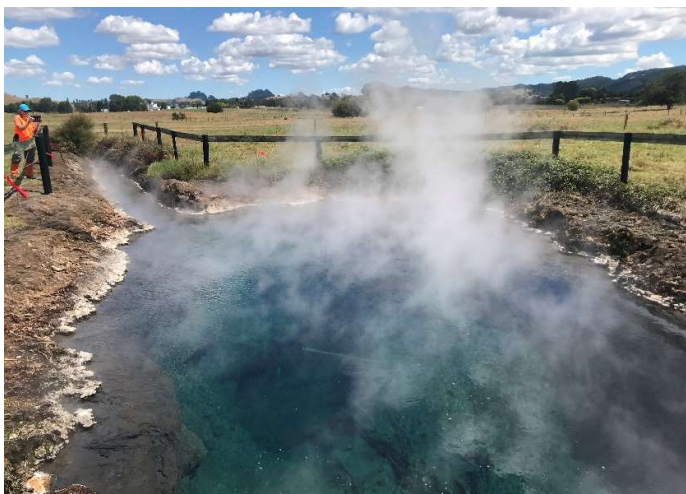
Description: A large, circular hot spring about 8 m in diameter with clear, calm alkaline water. In 1999, a channel was dug to contain the outflow of about 1 L/s. In clear sunlight the view down the vent shows vertical to overhanging walls to a depth of more than 6 m. There is no present silica deposition in the surrounding area due to the outflow being directed into an artificial channel.

Figure 10-2: South Spring in February 2020.

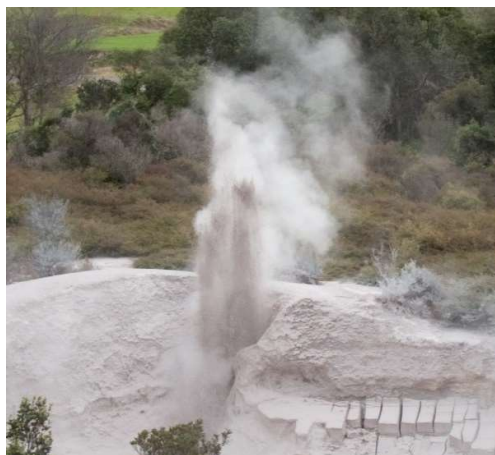
Description: This geyser is possibly unique in that its discharge is muddy water, erupted from a narrow vent in the side of a large mud pool. Since Waikato Regional Council started monitoring the geyser in 1995, it has exhibited three types of activities. It has periods of dormancy, interspersed with infrequent large eruptions that may take place only every few months. These eruptions coat the surrounding vegetation with mud. The geyser also has periods in which it has smaller, more frequent eruptions, ejecting a column of grey, muddy water 3 to 10 m high as a

Figure 14-1: Te Kopia Mud Geyser erupting in 2009.

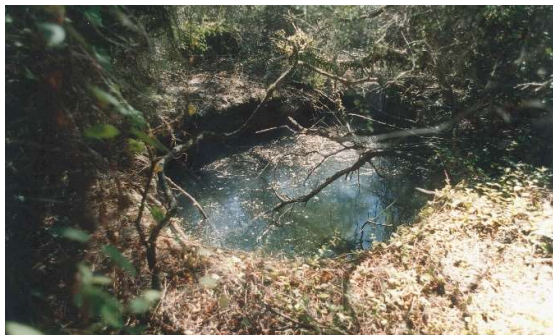
Description: A hot, clear spring about 2 m in diameter, found in the bush downstream of the Tokaanu domain, close to the Atakorereke Stream. The spring has sinter

Figure 15-1: Te Korokoro A Te Poinga in 2000.
Copyright Ashley D Cody.

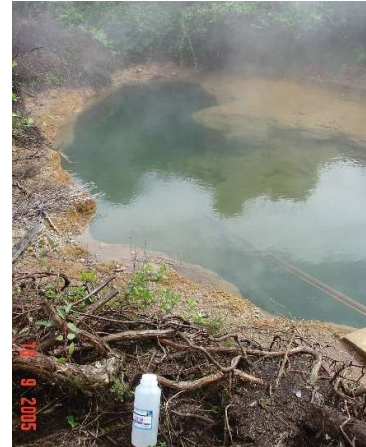
Description: A hot, clear spring about 6 m long and with a maximum width of 2 m. It is surrounded by a flat sinter apron at the south-east end of the marae grounds, which is across the road from the public baths. It is about 30 m north from the roadside and surrounded by a high fence covered in Japanese honeysuckle.

Figure 15-2: Tuwhare Spring in 2005.

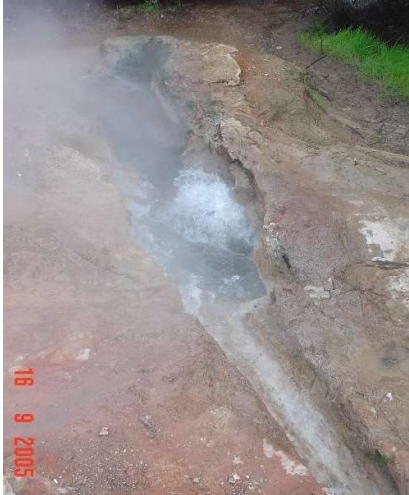
Threats: Severely threatened. Taumatapuhipuhi is vulnerable to increased well draw off lowering supply pressures. The surface overflow is now confined to splashes around the vent and a dug channel to supply an open-air bath. Consequently, the sinter terrace is weathered and degraded by foot traffic, and no longer provides a steam-impermeable barrier. Steam now escapes from many points on the apron, and assuming that these discharges are connected to the geyser, this reduces the internal pressure and heat retention, which in turn reduce the geyser's ability to erupt. Plugging the outflow channel would allow surface overflows to restore natural sinter sheet formation.

Figure 15-3: Taumatapuhipuhi Geyser in 2005.

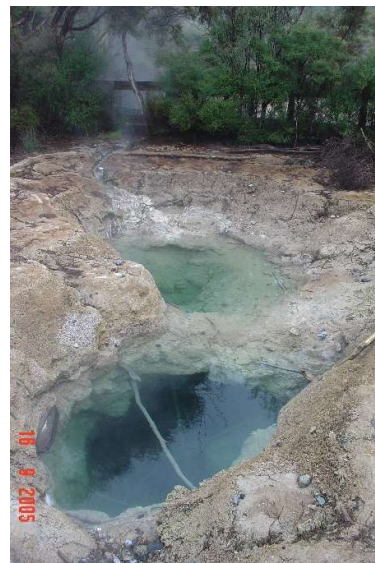
Description: Matewai spring has sinter walls and surfaces. The water is steadily convecting, with occasional bubble plumes. Silica deposits as highly porous, coral-like masses.

Figure 15-4: Matewai Spring in 2005.

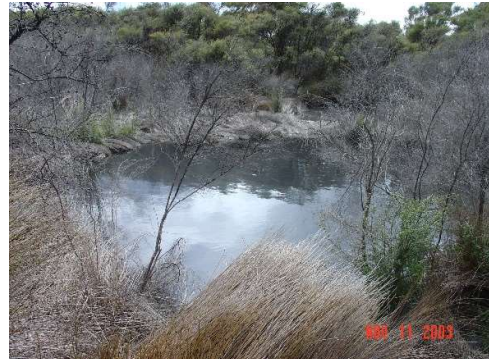
Description: An algae-covered warm pool at the edge of the swamp, on the northern side of the return part of the path. The pool is about 5 m wide and 7 m long, with calm water. Since Waikato Regional Council started monitoring the spring in 2001, the water, which is generally approximately 0.21 m below overflow level, has maintained a pH of about 6, and a temperature range from 23 °C to 45 °C.

Figure 15-7: Teretere Spring in 2004.

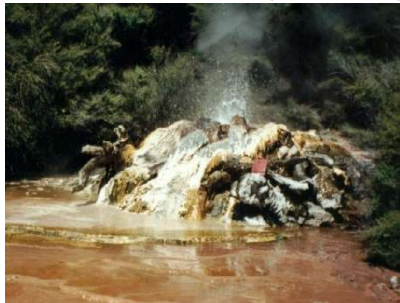
Description: A well was drilled in 1942 and left open to discharge at the surface. It was capped at least once but the cap eventually corroded. Most of the time since 1942 it has discharged at the surface. It is situated about 200 m west from Paureni spring, on the northern foot of a hillside and in an area of tall kanuka scrub. The vegetation gives way to the north onto swampy raupo wetland. The drill hole has built up silica sinter terrace surrounds (Severne, 1995; Mahon and Klyen, 1968). This bore is not a natural feature, and should be closed, as its existence is detrimental to natural features. It is not represented in the table of features at the end of this report.

Figure 15-8: Healy's Bore No.2 in 2004.

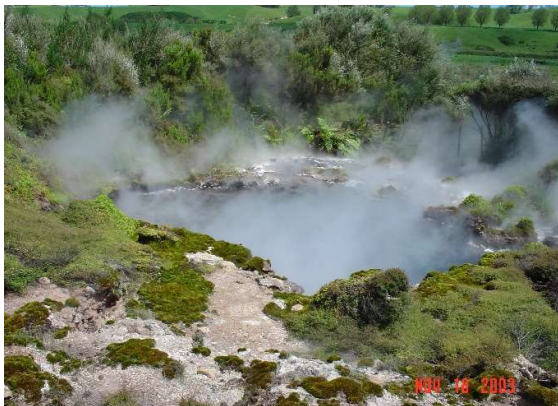
Threats: Severely threatened. The springs are vulnerable to drainage of surrounding soft marshy ground by farmers; or cattle crushing the weak crumbly ground at pool sides. They are presently just within a DOC reserve.

Figure 18-1: HT Geyser in 2003.

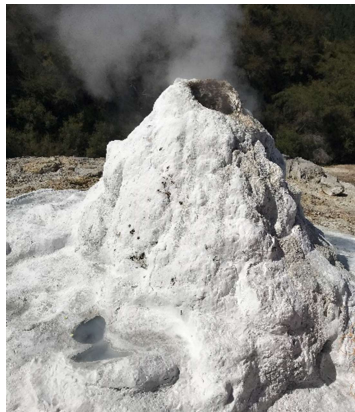
Threats: Moderately threatened. Continued soaping affects the cone structure and composition. The feature and its sinter surrounds are easily accessed by the public.

Figure 19-3: Lady Knox Geyser on February 2020.
Copyright Jesse Ledwin Lebe.
