TECHNICAL INFORMATION CIRCULAR NO. 194

THE MARLBOROUGH - NELSON BAYS FLOODS

Of 8-10 JULY 1983

A.M. Quayle, M.W. Pointer and N. Challands

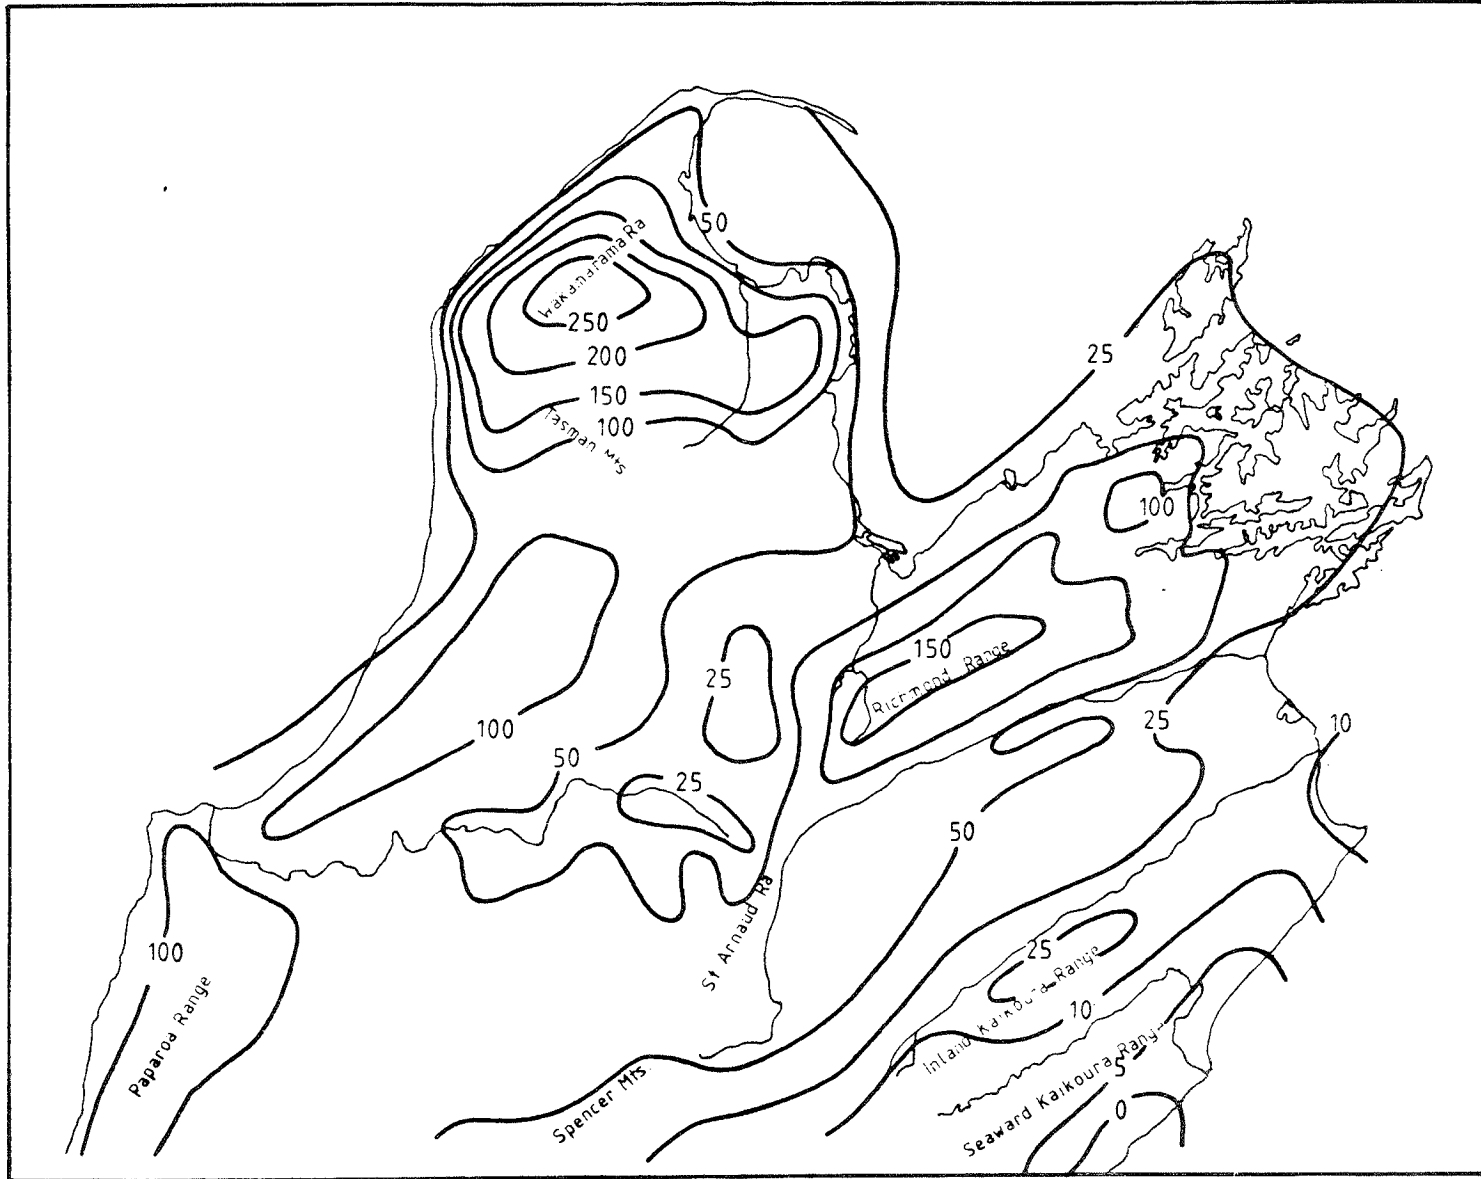
Fig. 6: Isohyets (mm) of 24 hour rainfall, 8 July 1983.
(9am July 8th to 9am July 9th).

Figures 6 and 7 show the distribution of rainfall on July 8 and 9 and Fig. 8 shows the rainfall distribution of July 8 plus July 9 (i.e the 2 days of heaviest rain).

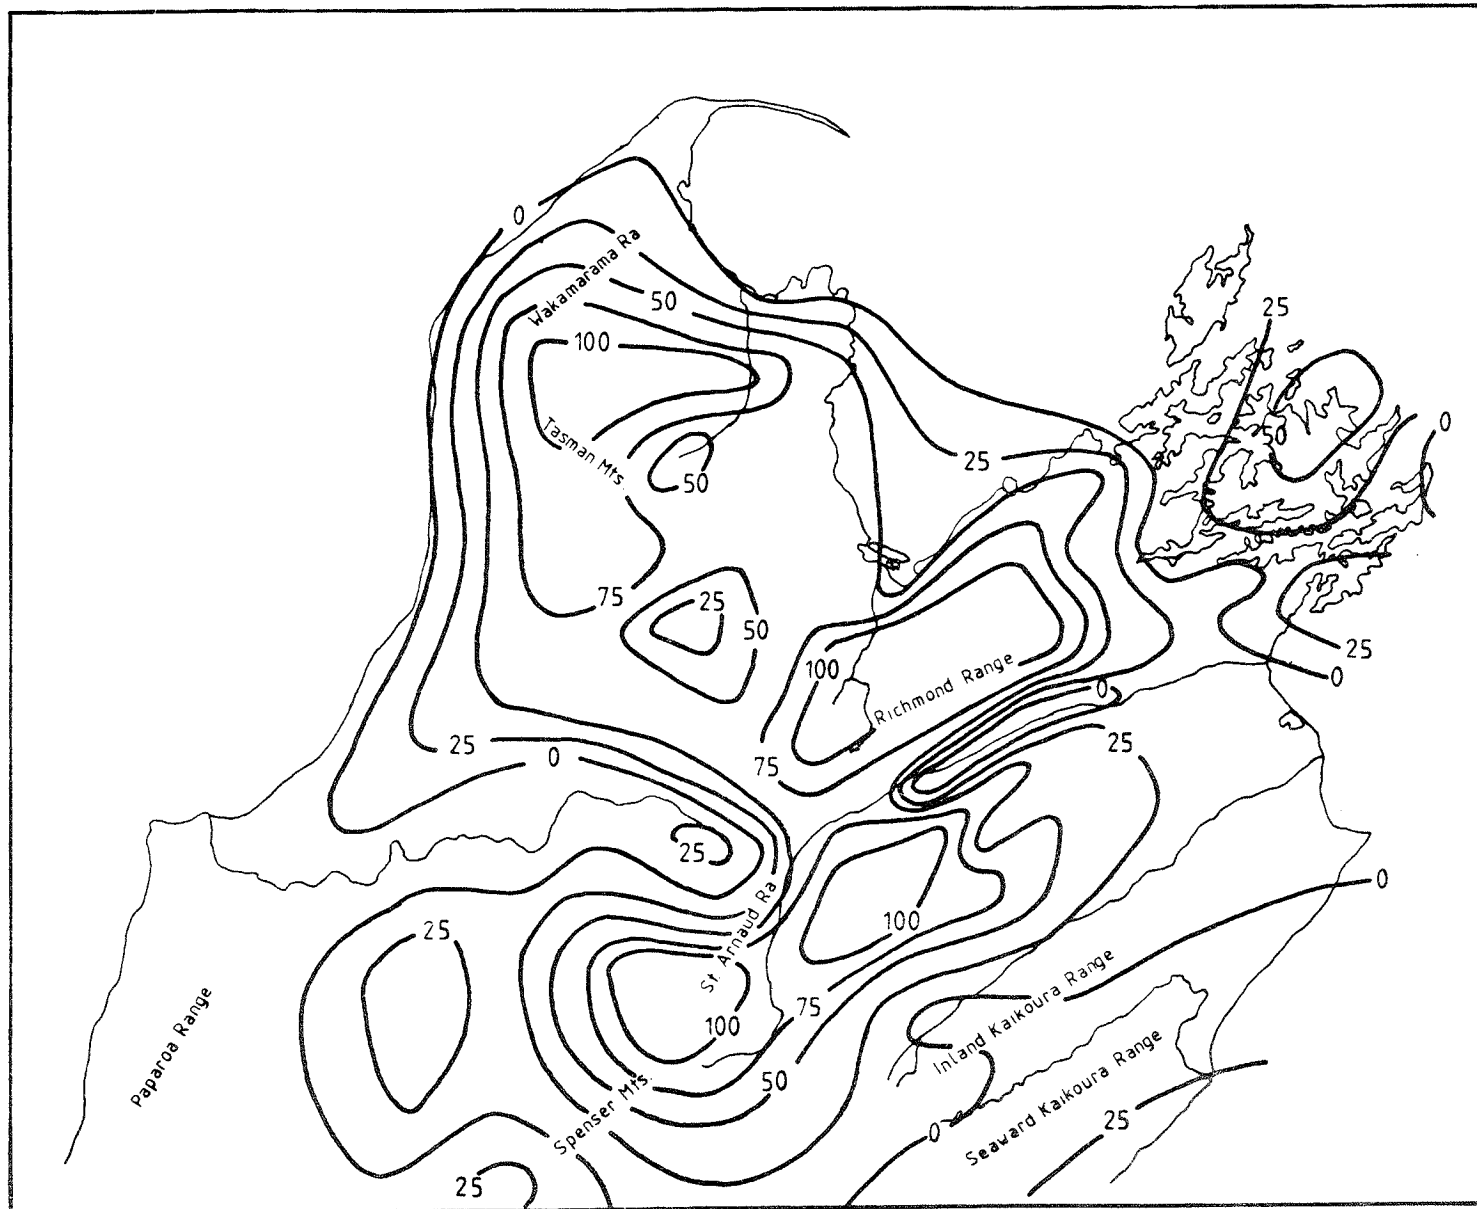
Fig. 13: 24 hour rainfalls of 9 July 1983 minus 24 hour rainfalls of 1 April 1975 (mm).

A comparison of the 24-hour rainfalls, 9 July 1983 minus 1 April 1975, has been made (Fig. 13) in order to highlight differences in the distribution and intensity of rainfall between the two events. Rainfall differences along the Wairau Valley vary from area to area; the rainfall recorded at Wairau Valley on the 9th of July 1983 was 30mm greater than that on the 1st of April 1975, while those at Birch Hill and Onamalutu were 33mm and 19mm respectively lower than in the 1975 event. The surrounding high country on the other hand appears to have experienced some 100 mm more rain during the July 1983 floods.
