Hawke's Bay Area Planning Study: Urban capability assessment

Eyles, G.O. *et al.* 1980: Hawke's Bay Area Planning Study: Urban capability assessment. Water & Soil Miscellaneous Publication No. 17. 1980. 26 p. 10 maps. ISSN 0110-4705

As part of the Hawke's Bay Area Planning Study, an urban capability assessment was prepared in August 1979, based on physical limitations to development of eleven urban site options on and adjacent to the Heretaunga Plains.

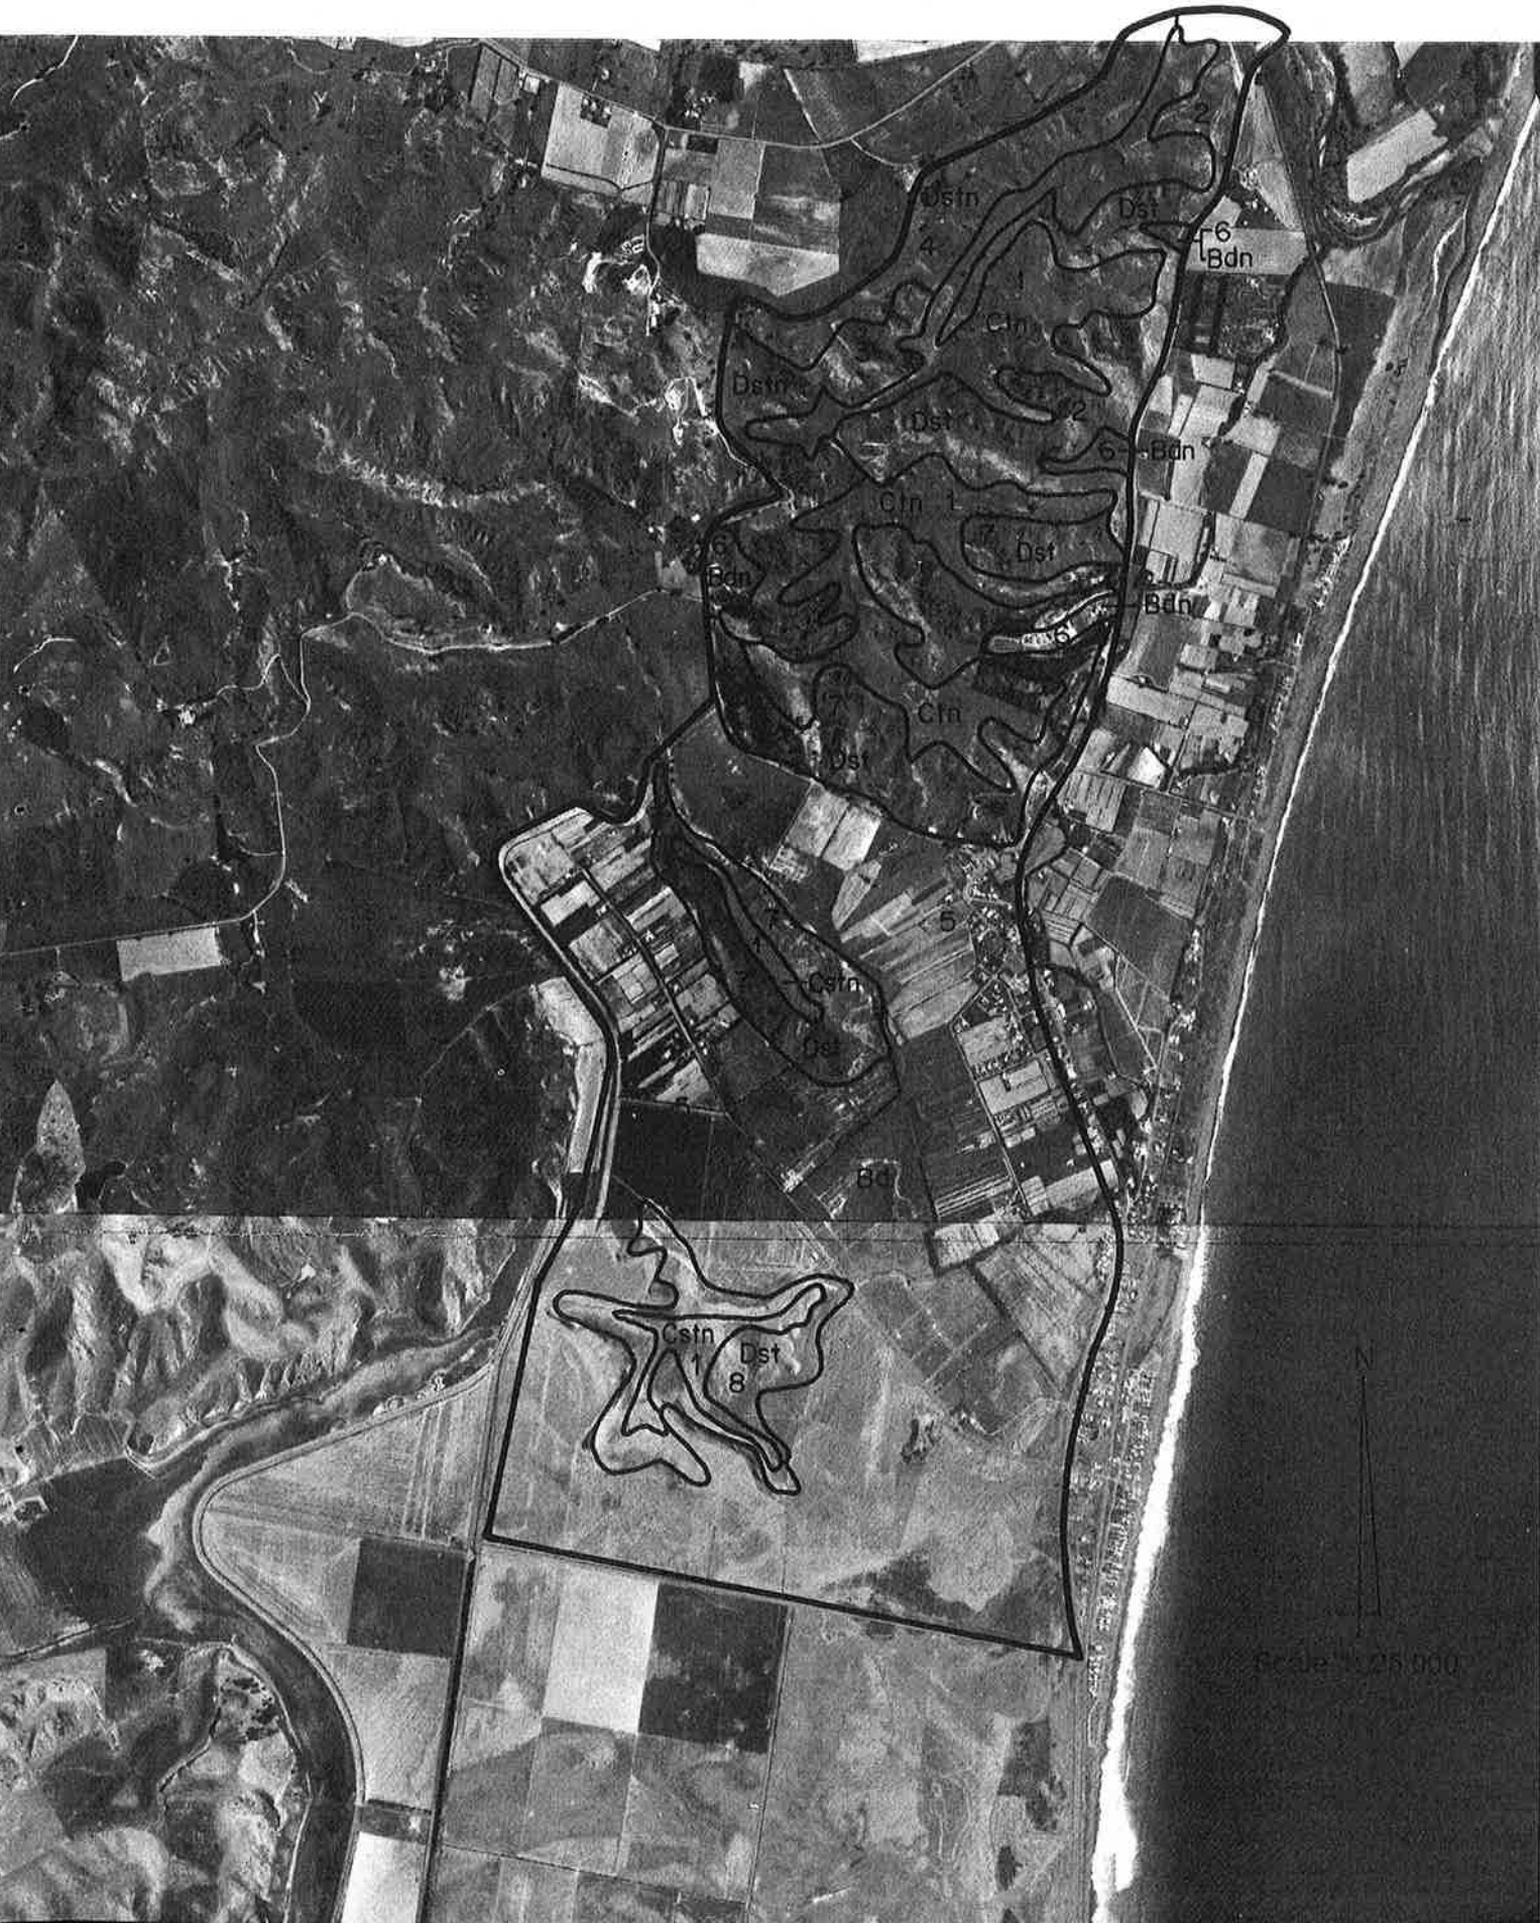
MAP 1

Bay View site option

The 1100 ha site lies 5 km west of Napier City. It is hill country, being a series of narrow, undulating ridges separated by steep-sided valleys. A wider central valley contains both swamp and free draining situations.

Evidence of the occasional historic slump and the unknown detail of the sedimentary sequence indicate a potential instability hazard to urban development, especially on steep slopes (i.e. >20°). Detailed lithologi-

cal mapping is required to fully understand the hazard. Foundation conditions on the loessial materials are adequate for single storey residential developments provided care is taken with drainage and compaction of fills. Compaction of backfill around buried service lines would probably require addition of traces of lime.

Class B — 32% of the site is class B with minor limitations to urban development. This is mainly confined to the undulating and gently rolling, loess mantled ridge crests and better drained valley bottom areas. Dominant subclass limitations are foundations (n) on the loess, drainage (d) and topography (t).

Class C — 20% of the site is class C with moderate to severe limitations. Dominant subclass limitations are topography (t), slope stability (s) and foundations (n) on the crests and drainage (d) on the lower valley bottoms.

Class D — 48% of the site is class D having very severe limitations. The dominant subclass limitations are topography (t), slope stability (s) and foundations (n).

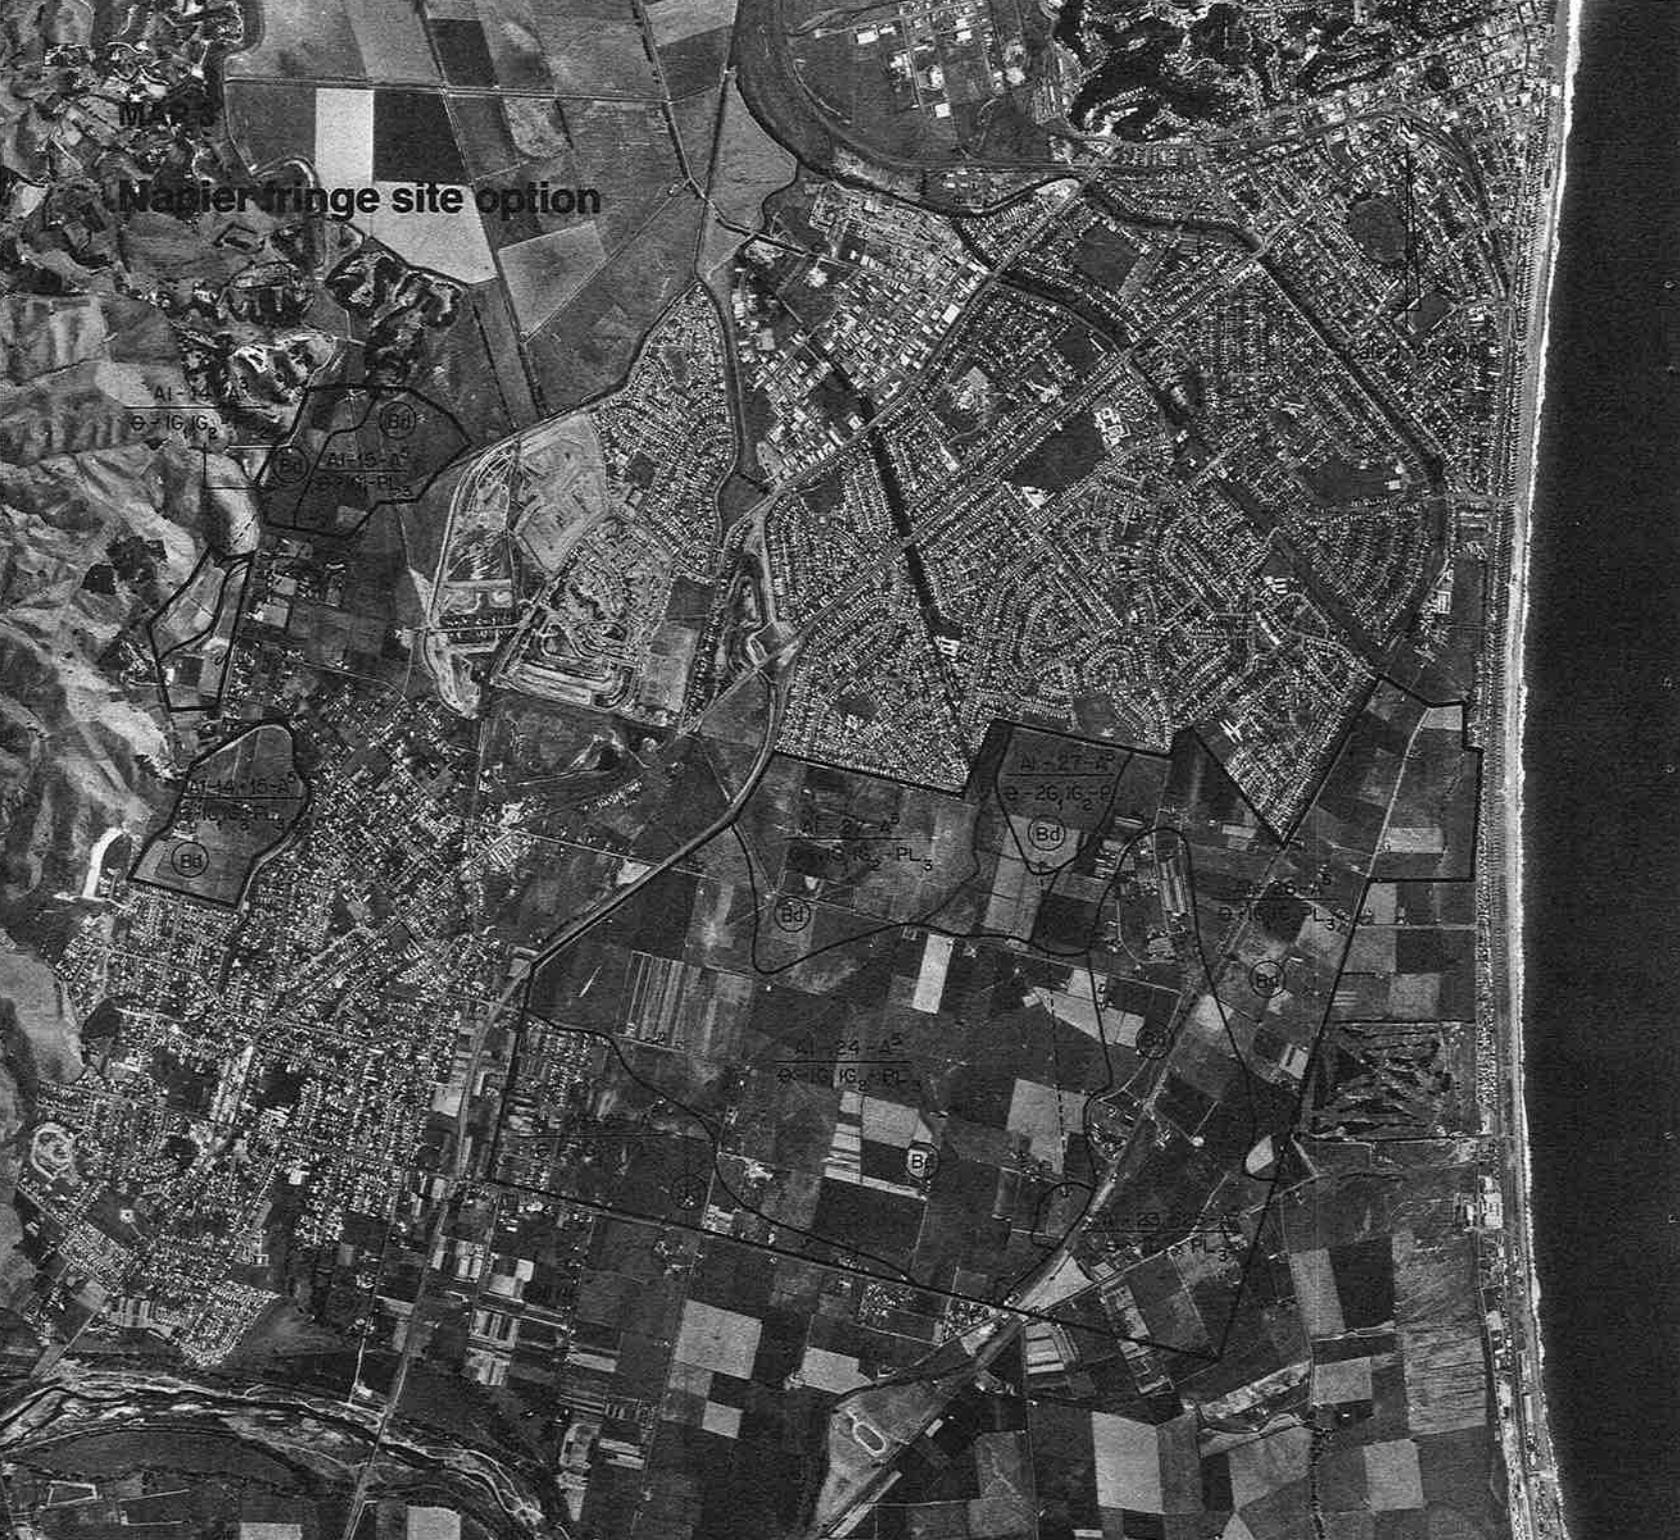
MAP 3

Magier fringe site option

Foundation conditions are adequate for single storey residential developments over most of the area. High rise or commercial buildings would require more detailed site investigation and appropriate design due to the compressible nature of the underlying material.

Class B — 100% of the site is class B. The major subclass limitation is drainage (d) with foundation (n) limitations also occurring throughout the site.

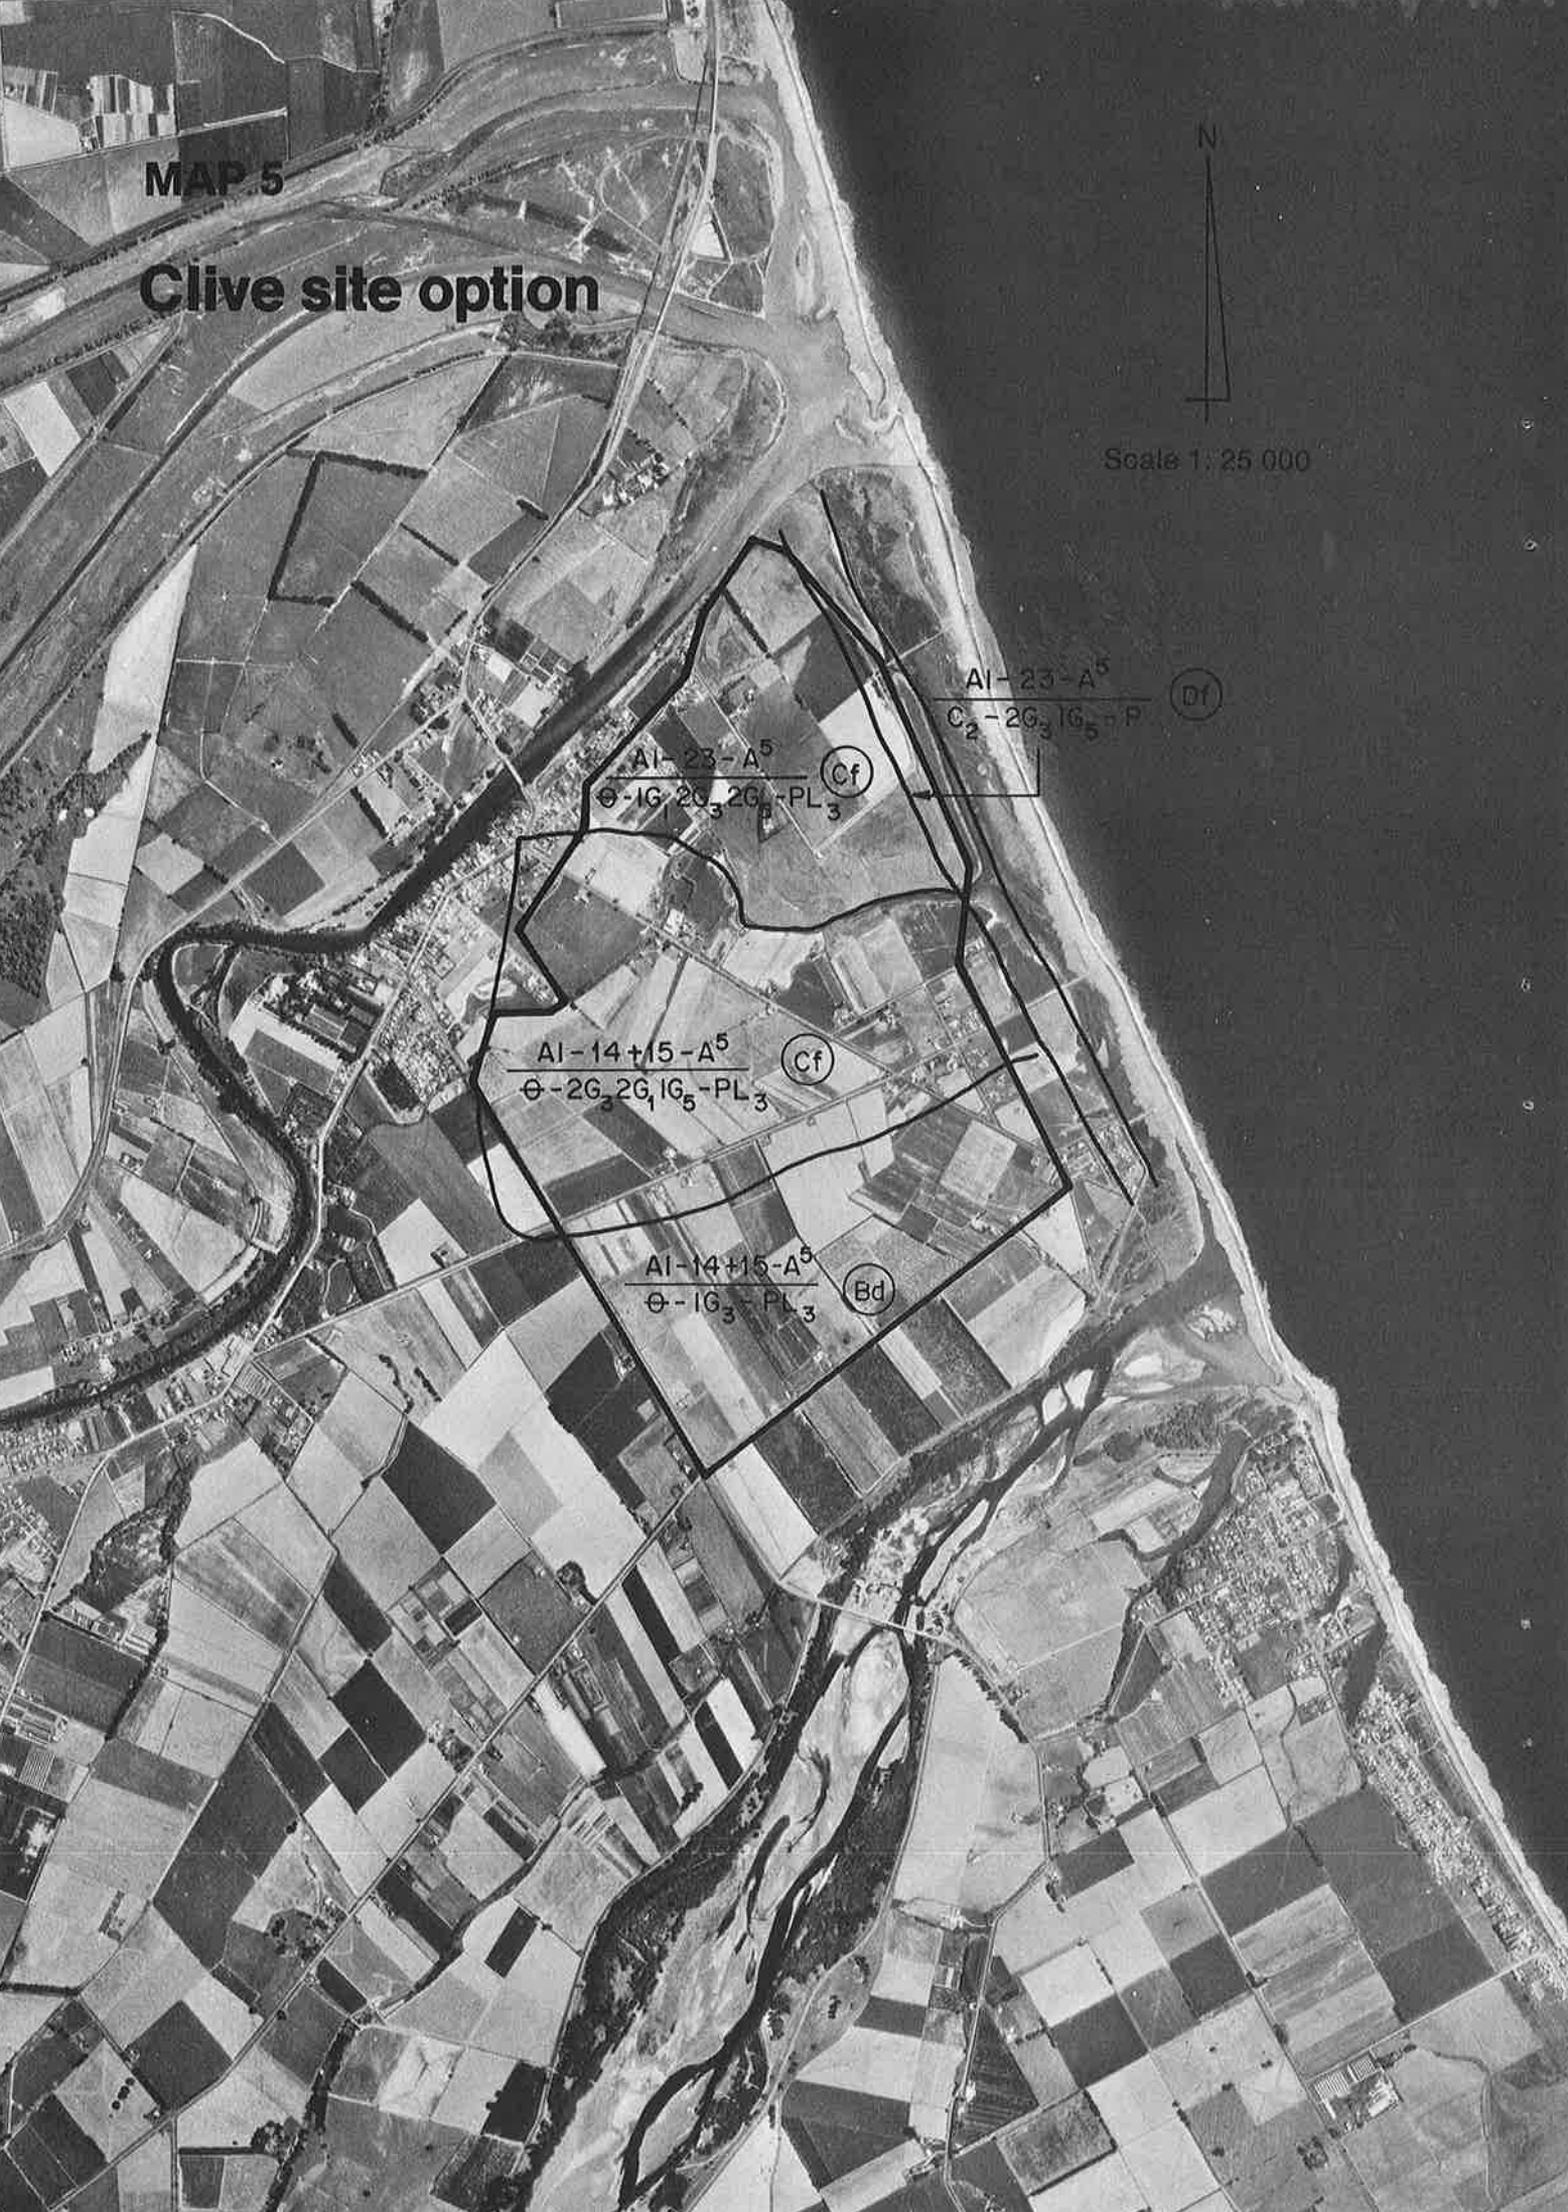
MAP 5

Clive site option

The site lies between the Tukituki and old Ngaruroro River course from Clive to the coast.

Foundation conditions are adequate for single storey residential development over most of the area. High rise or commercial buildings would require more detailed site investigations and appropriate design.
