Site HM1 – Waipa at Otewa

Hydrometric site number: 43481

Sampling Location: NZMS 260 S16: 157 235

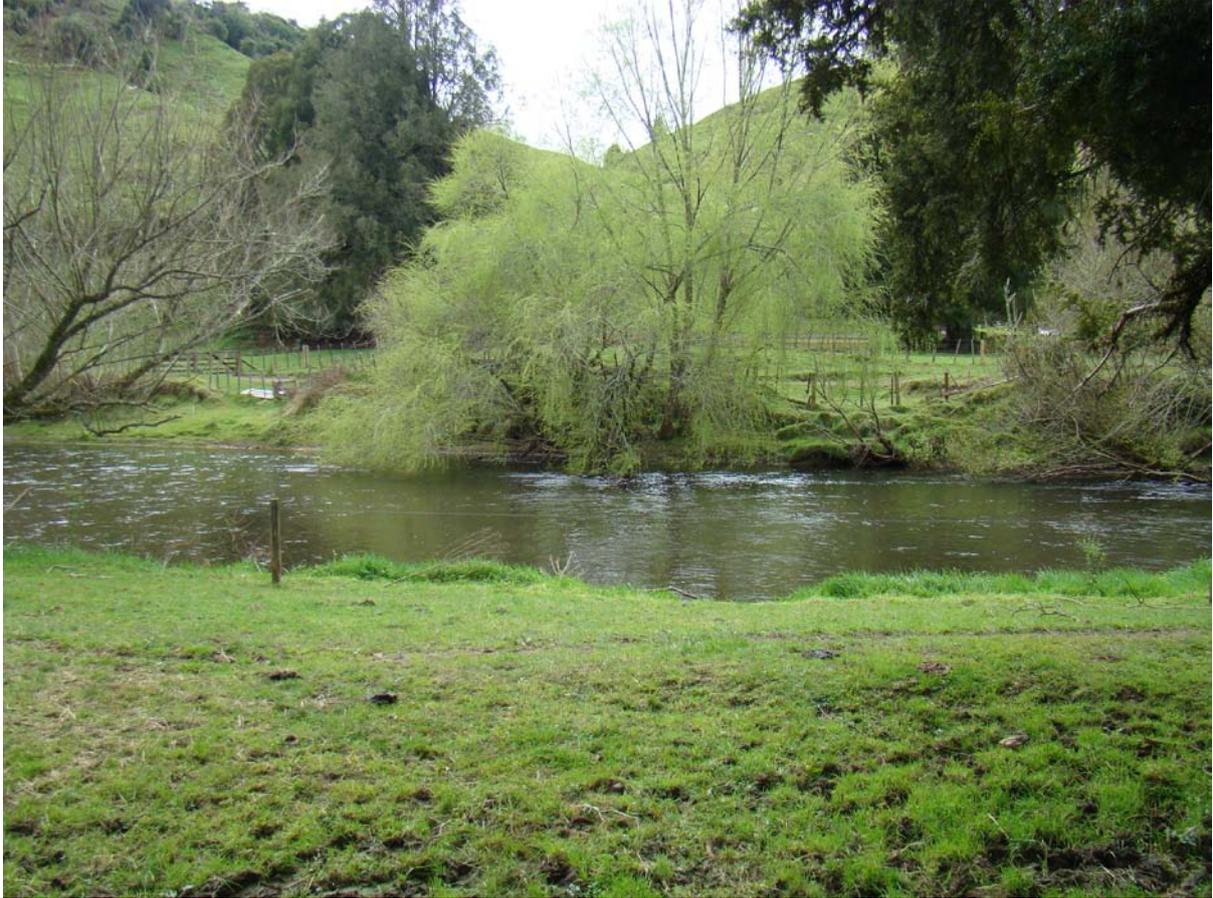
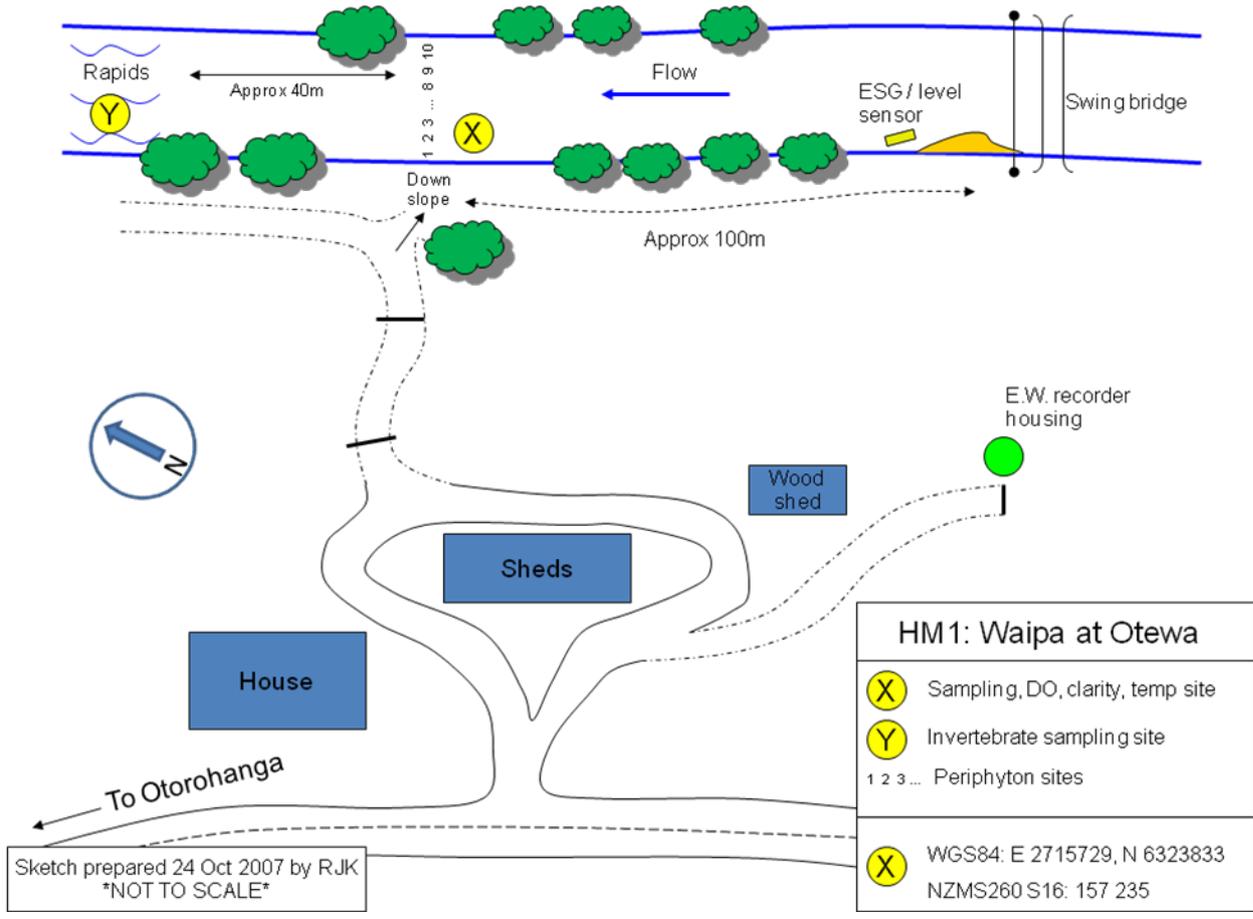
Site photo and sampling/assessment details

Sampling site: Between 1989 and 1996 was from or beneath the swing bridge. The present site is 100m downstream; this site was selected for its better year round access. Invertebrates are collected downstream (~40m) of the current water quality sampling site. From 13 November 2008, the DO meter changed from the original YSI model 58 to the HACH Model HQ40d. The new meter employs a luminescent probe technology and stirring of the sample is not required to get a final, stable reading.

Photo taken September 2007.
