# Waikato and Waipa Rivers Flood Event 6-16 July 2002

## Final Technical Report

Prepared by:  
Adam Munro

For:  
Environment Waikato  
PO Box 4010  
HAMILTON EAST

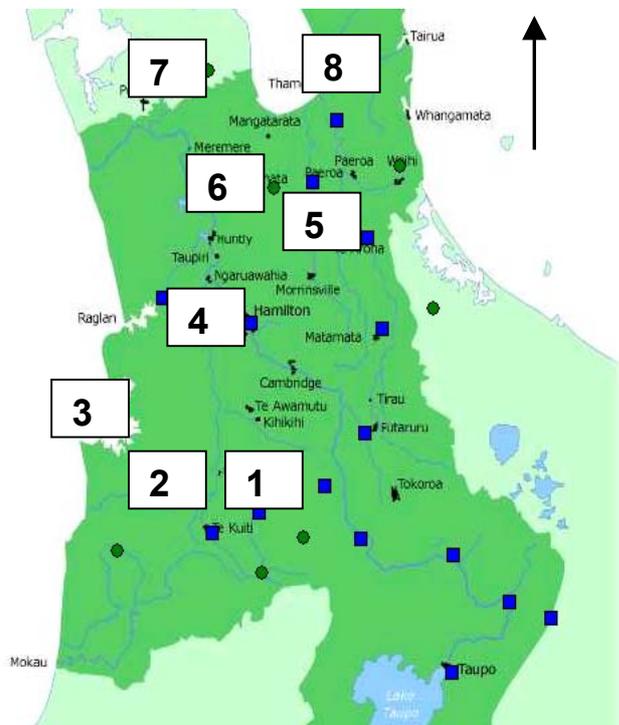
<b>Location (numbers correlate to map below)</b>	<b>Event Total 1 – 13 July</b>	<b>July Mean</b>	<b>+ / - Mean</b>
1. Ngaroma	240 mm	225 mm	+ 7%
2. Te Kuiti	156 mm	156 mm	equal
3. Kawhia	177 mm	149 mm	+ 19%
4. Hamilton	97 mm	123 mm	- 20%
5. Te Aroha	170 mm	150 mm	+ 13%
6. Maungakawa	130 mm	153 mm	- 15%
7. Mangatangi*	225 mm	235 mm	- 4%
8. Pinnacles	306 mm	490 mm	- 37%

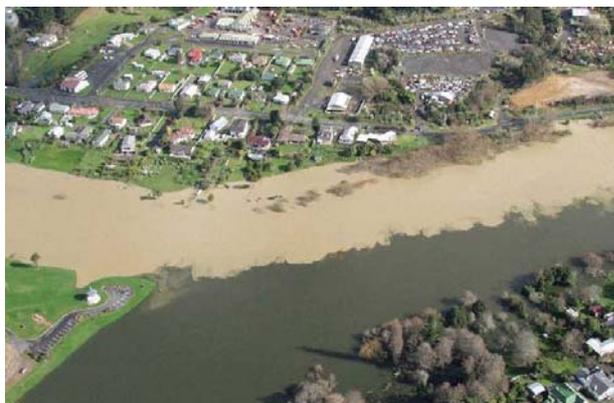
*Right: The Waikato and Waipa Rivers meeting at Ngaruawahia.*

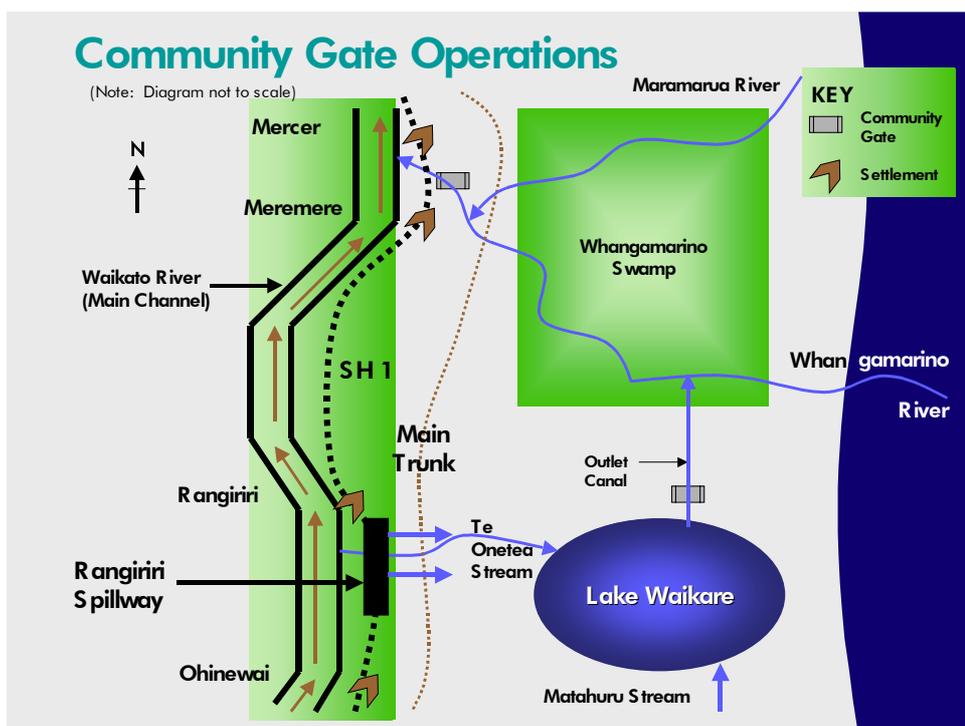
Figure 1: The location and operating design of the Lower Waikato Community Gates.

The Lake Waikare and Whangamarino gates are closed and opened in unison. However, while the Whangamarino gate is opened as soon as the river level drops below the wetland level, the Lake Waikare gates are opened and closed to control lake levels between R.L. 5.5 m and 5.65 m, depending on the season as set in a protocol. Figure 1 below shows the location of the community gates and water flow directions through the system.

The Te Onetea, Lake Waikare, and the Whangamarino Control gates (Figure 1) all performed well and were opened and closed in accordance with flood management guidelines. As a general rule, the Lake Waikare (northern outlet) and Whangamarino

control gates are closed when the level of the Waikato River is greater than the water level in the Whangamarino wetland. Closing the gates is necessary to prevent backflow from the river into the wetland. Under 'normal' flow conditions, when the river level is below the wetland level, the gates remain open and natural through flow occurs between Lake Waikare, the Whangamarino and the Waikato River.

The Whangamarino Control and Lake Waikare Gates were closed on Monday 8 July and re-opened at 8am on Sunday 14 July when the Waikato River level and the Whangamarino wetland level were equal – and were continuing to fall. The Te Onetea Gate closed automatically on Saturday 6 July when the Waikato River level exceeded 7.0 metres (RL). It didn't re-open until Tuesday 30 July when the level of Lake Waikare stabilised (that is, its level was consistently below the Waikato River level at Rangiriri).
