Alligator Weed Control 2005/2006

Prepared by:
Wendy Mead

For:
Environment Waikato
PO Box 4010
HAMILTON EAST

February 2007

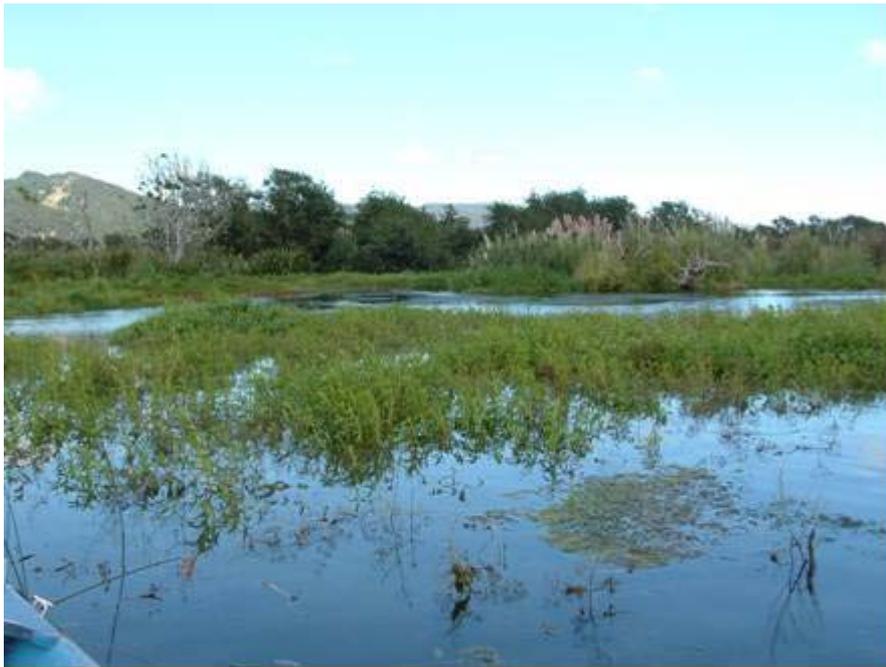
Figure 1: Aquatic alligator weed at 'the delta'

The Waikato River delta alligator weed site is the largest site and one of the most difficult to manage due to site characteristics. Low tide exposes alligator weed which is inaccessible at high tide and dictates when much of the control work can be carried out. Gun and hose work is often dirty and difficult because of the wet muddy soils and silt of the islands. The Waikato River delta infestation consists of alligator weed scattered across an area of approximately 200 hectares with the weed present on islands, along the River banks and as floating vegetation in the water.

To ensure control has been effective and an efficient use of resources, the focus has been to concentrate on particular areas and carry out extensive control in these areas while 'holding' infestations in other areas to reduce further spread. Control has consisted of both aerial herbicide application and gun and hose application from an airboat. Aerial work was carried out in November 2005 and August 2006. Approximately 70 hectares have now been treated aurally, mainly in the reed bed areas, but also down as far as Maioro Bay in the south west. Handgun spraying from the airboat was used to treat small amounts of regrowth that occurred after aerial treatments. Handgun spraying was also carried out at the Narrow Island, Hoods

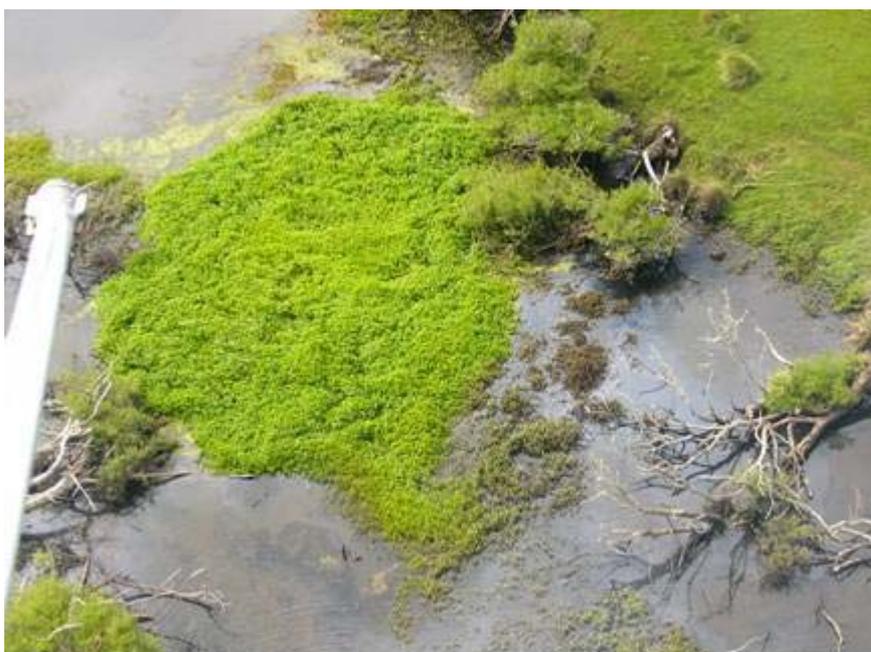
Scattered patches of alligator weed are present on the Waikato River between Ohinewai and the delta. In October 2005 a new infestation beside the River, adjacent to the Meremere speedway was found and treated. An aerial survey was carried out in November. Fifty alligator weed sites were found and treated along the River during March and April.

Figure 4: Large patch found during aerial survey

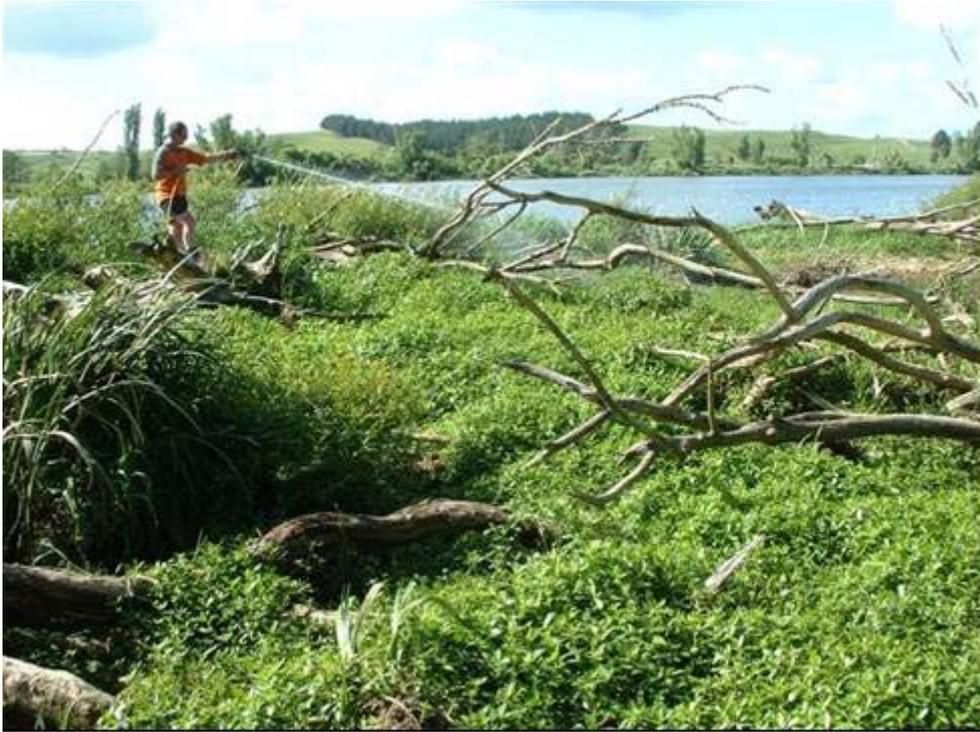
Figure 5: Spraying a riverside site

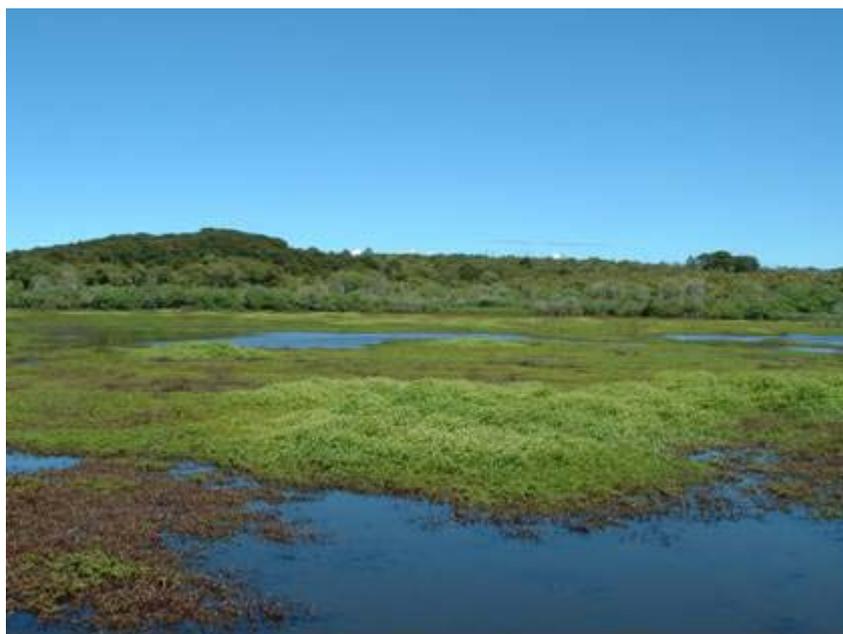
Alligator weed at Lake Whangape has been reduced from large floating mats when first discovered, to small scattered patches in 2005/2006. Control work on the Lake is hampered for much of the year due to extremely high levels of toxic algae or high water levels. Monitoring and surveillance of Lake Whangape and surrounding land was carried out in November and March, followed by aerial spraying of the Lake and spot spraying of adjacent land, also in March.

Figure 6: Lake Whangape infestation 2003

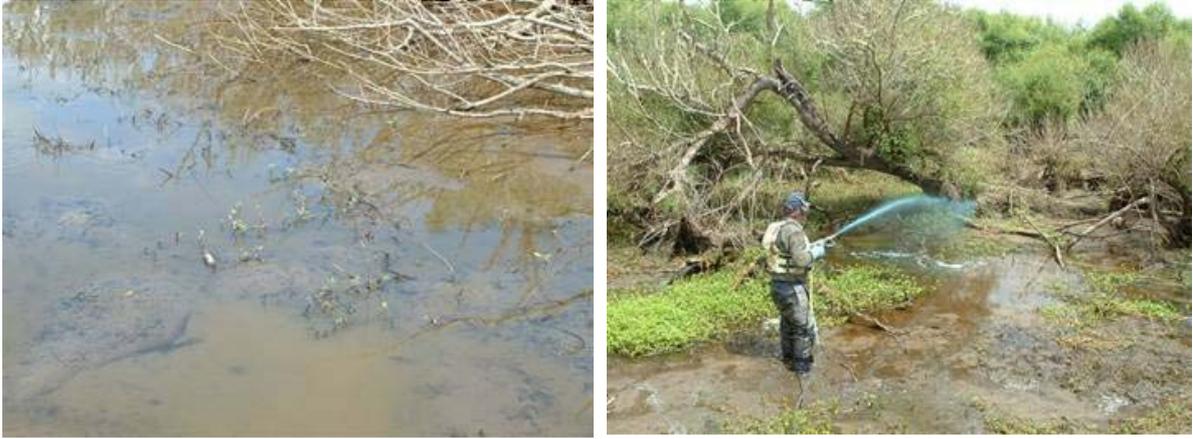
Figure 7: Lake Whangape 2006 – small patches

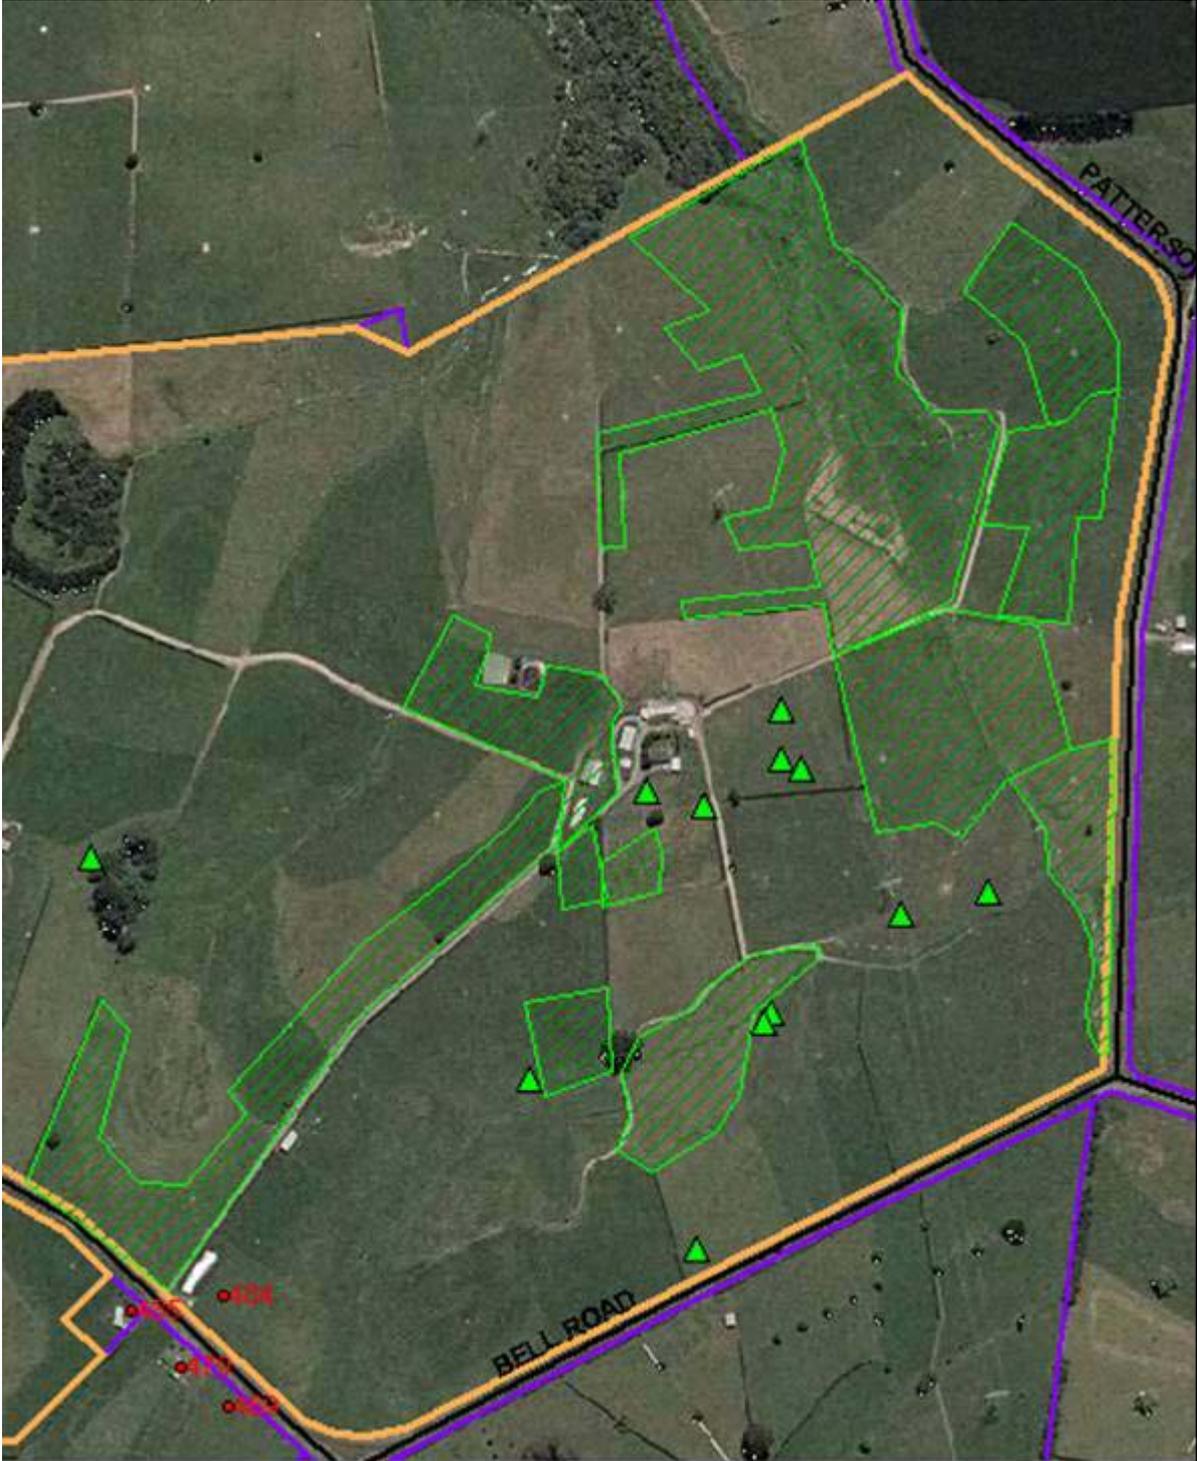
The Te Rore wetland area was treated aerially with metsulfuron in October 2005 and April 2006. Areas around the wetland and on banks above the screen were also treated with metsulfuron in April. A comprehensive survey for terrestrial alligator weed was carried out over the Lorimer property in February 2006. Alligator weed was found to be scattered at mostly low density over large parts of the farm. It appears to have been

spread by a range of factors including flood and movement by cattle and machinery. Turfworks sprayed accessible terrestrial infestations with Tordon brushkiller in March and May 2006 using boom sprayer and handgun. Also in May, wetter paddocks where land-based treatment was impractical were aerially treated with Tordon brushkiller.

Figure 8: Alligator weed infestations mapped on the Lorimer property

In addition to spray work, drainage work and clearance of willows was carried out in the wetland area using a digger in March 2006. Chris Hale spends a considerable amount of time on managing the Te Rore infestation including arranging aerial spraying, notification of neighbours, liaise with owners, sharemilker and Turfworks. All actions and visits are recorded by Chris Hale in EW's Biosecurity Information System (BIS).

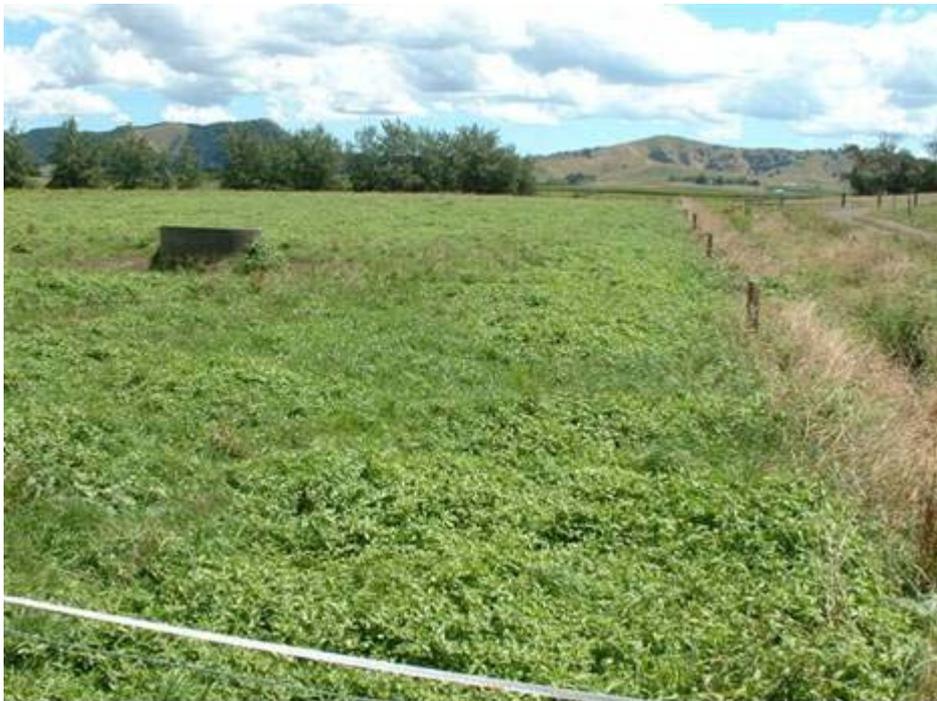
- Ohinewai – one infestation on two rural properties. Alligator weed is in paddocks and in a farm drain. A resource consent was obtained to enable metsulfuron to be used on aquatic alligator weed. This infestation may have established from a kumara planting in the paddock several years ago.

Figure 9: Alligator weed infestation on a Ohinewai farm

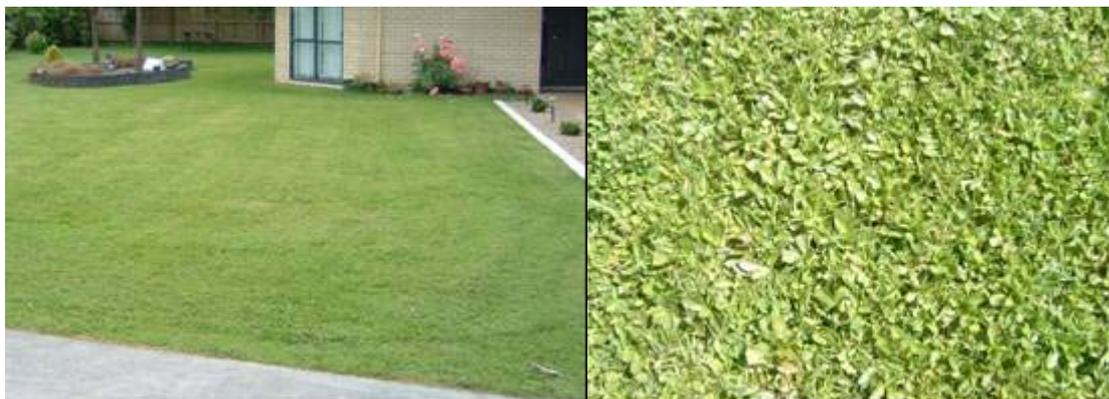
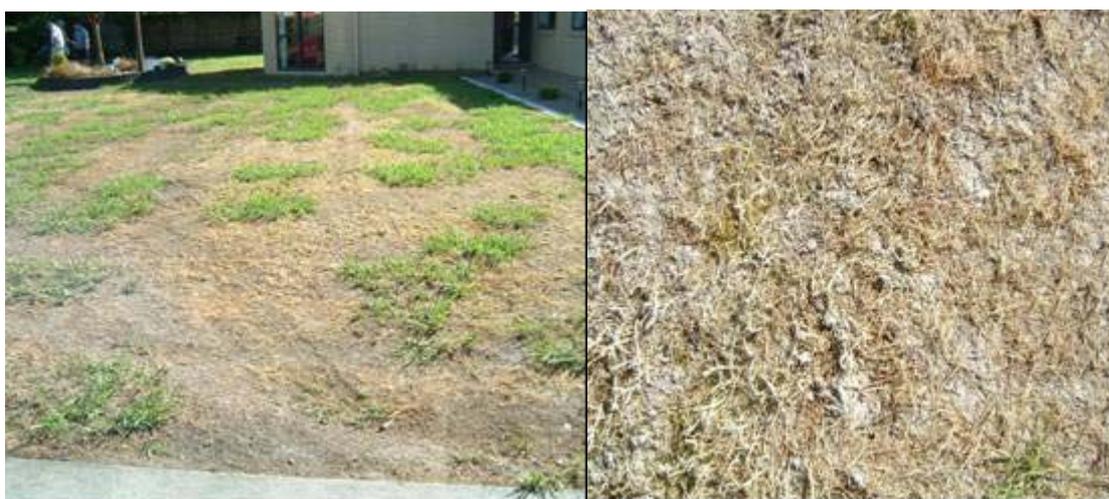
- Seven other infestations were confirmed over the summer of 2005/2006. Several were reported as a result of media coverage and advertising. The infestations are widely dispersed across the contract area and include sites at Morrinsville, Hinuera and Te Pahu. Most appear unrelated and it is not certain how they originated. Three were discovered after tracking soil movement related to a new reported site at Matangi. Hamilton infestations were also tracked from this soil movement. Some of the infestations have been established for several years and are expected to take several years to reduce to zero density. Good reductions have been achieved after initial control but regular follow-up is expected to be necessary. Infestations were controlled by Ben Parry, EW student and Turf Works.

Figure 10: Before and after control of alligator weed at Morrinsville
