# Waiau Lagoon

Broad Scale Habitat Mapping 2007/08

Environment  
Southland

September  
2008

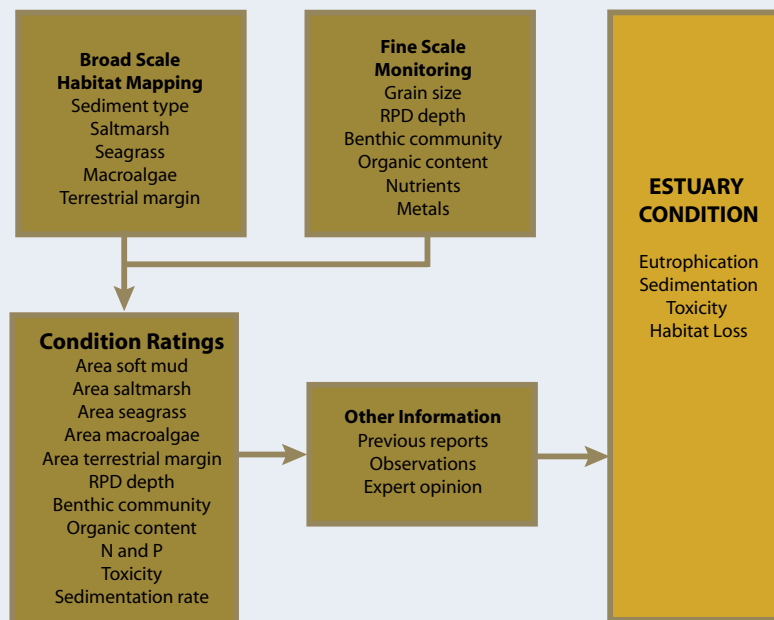
The outcome is a series of GIS-based habitat maps (often complex), that provide measures of the extent of different types of habitat cover. Taken in combination with fine scale physical, chemical and biological monitoring results, these measures are applied into different rating scales which are used alongside other relevant expert information to assess the condition of the estuary in relation to the key issues of sedimentation, eutrophication and habitat loss. Toxicity is addressed as part of fine scale monitoring, while disease risk is monitored and reported separately, principally through recreational water quality monitoring programmes. A summary of the approach is outlined in the figure below.

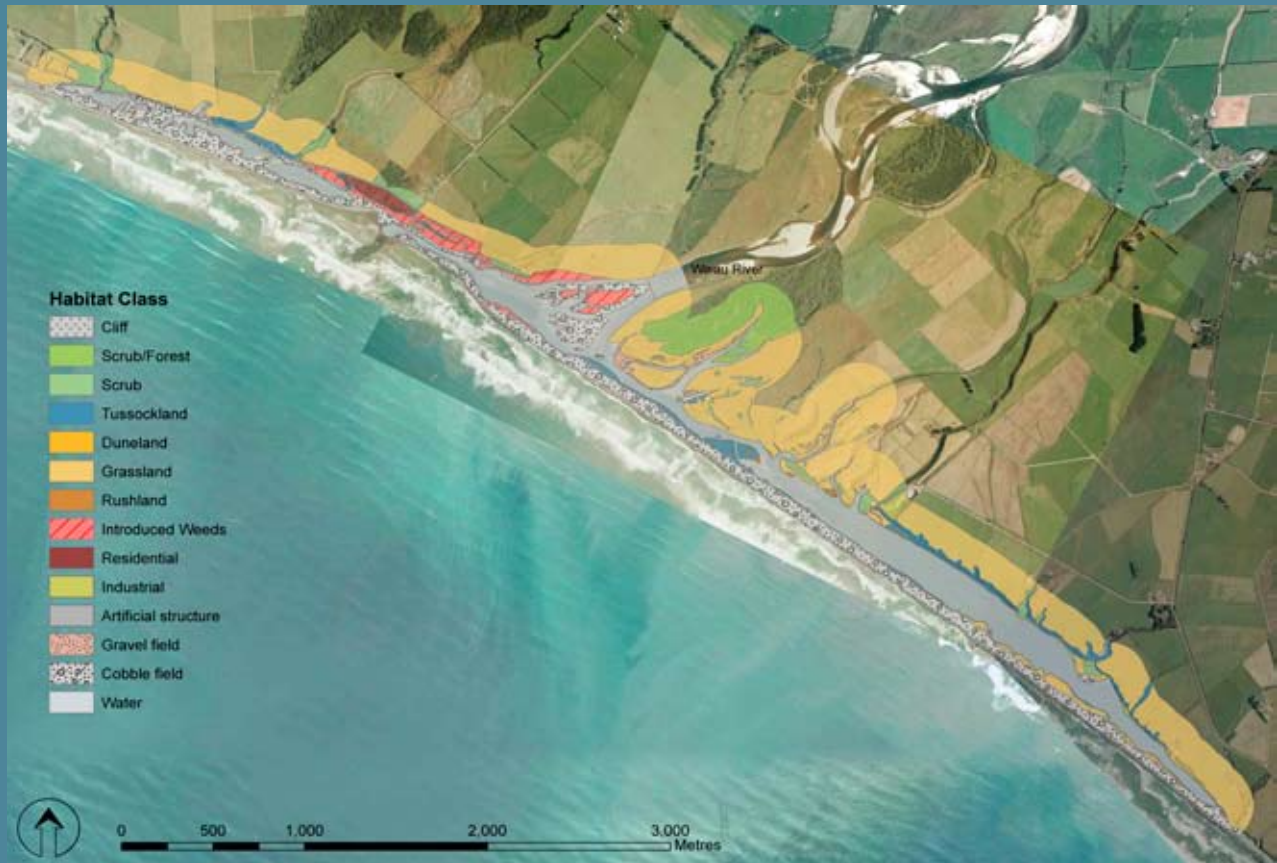
### Summary of the broad scale features of Waiau Estuary, February 2008.

The broad scale monitoring showed Waiau Estuary is a moderate sized (101ha) river mouth estuary, different from other small mouthed estuaries in the area in that it has a long shallow lagoon with a large subtidal component. Although the lagoon is relatively isolated from the main flow of the Waiau River (which tends to bypass it), it is nevertheless dominated by freshwater and the main river channel is generally well flushed. However, tidal seawater inflow also occurs and creates a salt wedge effect of denser saline water near the estuary bed.

Of the habitat types present in the Waiau, the vast majority of the area was subtidal 86ha (84%). The intertidal area was dominated by unvegetated cobble and gravel (13%). Salt-marsh occupied just 3.1ha (3%), and was mostly restricted to a narrow strip around the lagoon edge (dominated by rushland (mostly jointed wire rush) and tussockland (flax)). Macrophytes and macroalgae were not found in the intertidal area but were observed in the subtidal area.

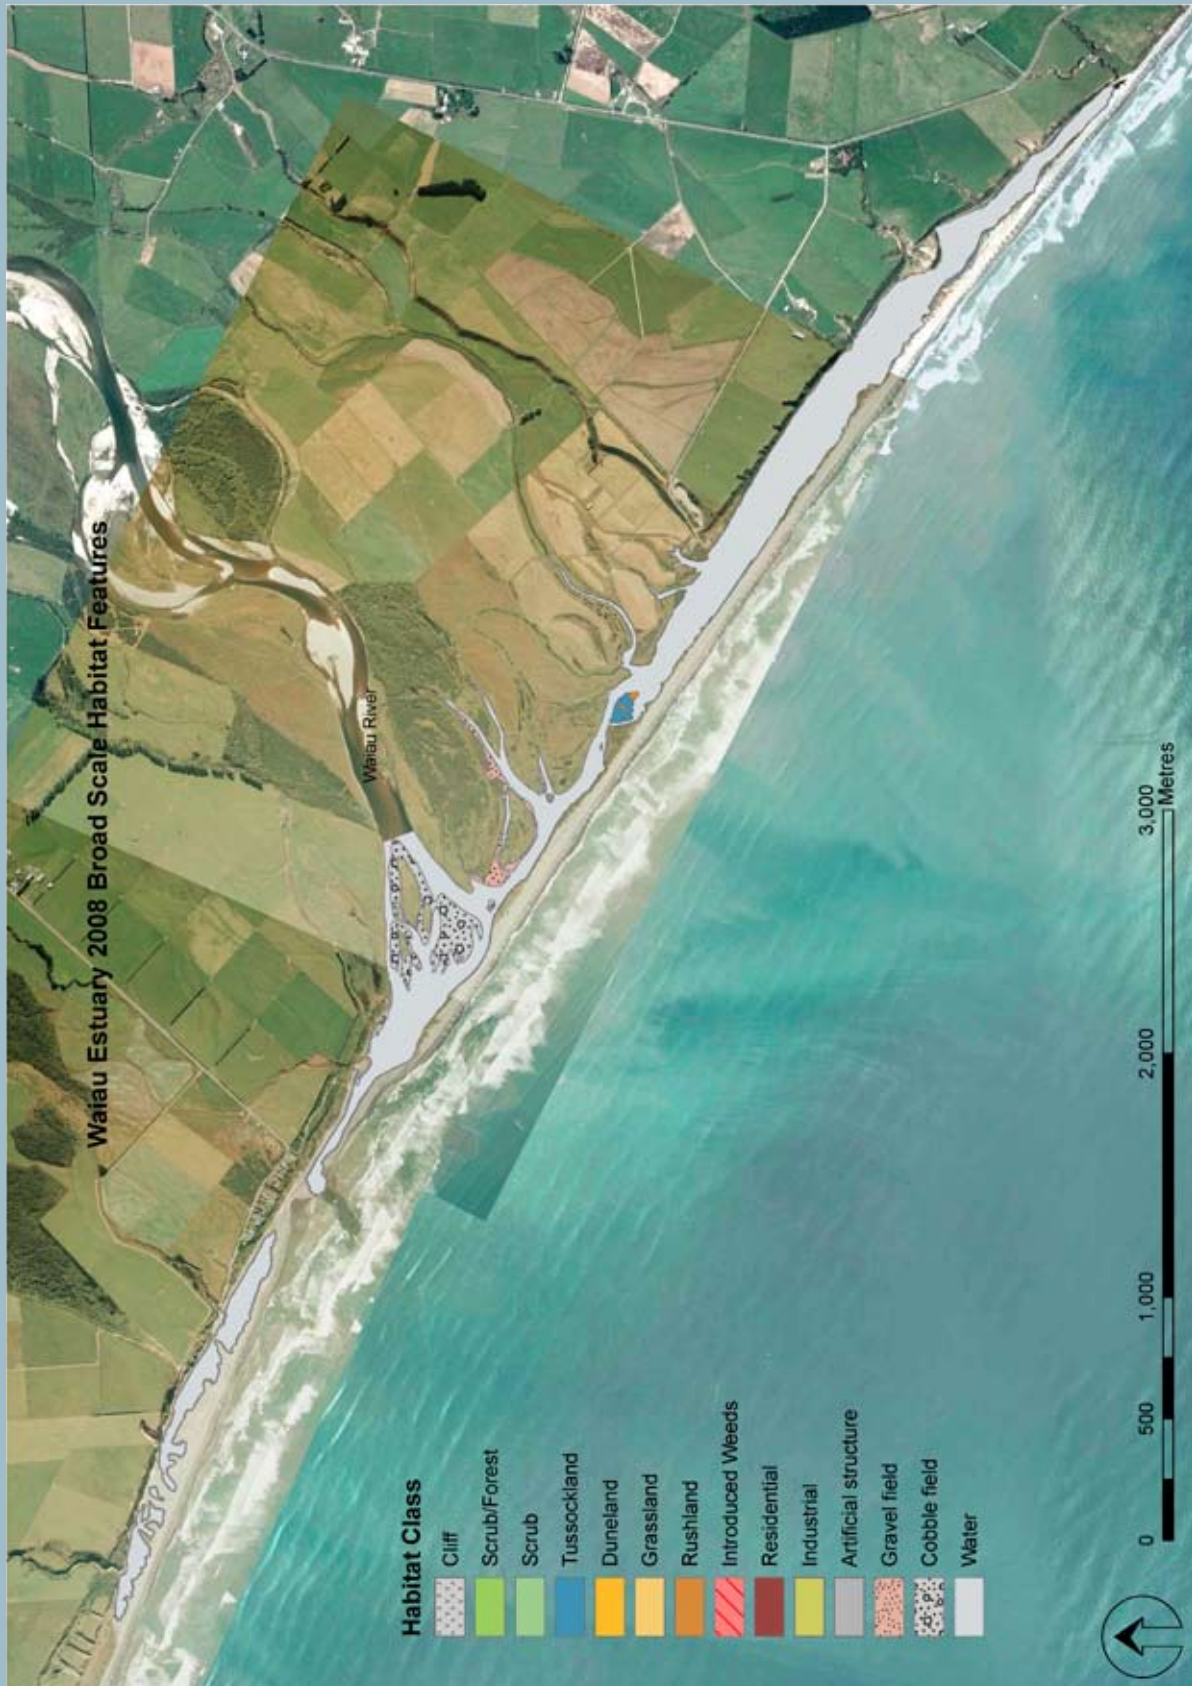
Figure 1. Map of Unvegetated Substrate and Saltmarsh Vegetation - Waiau Estuary, February 2008.

This section describes the dominant features of the estuary, which are summarised in Tables 4, 5, and 6, and Figures 1 and 2. At the end of the section, condition ratings are applied to each indicator, which are then evaluated along with other relevant expert information to assess the condition of the estuary in relation to the key issues of sedimentation, eutrophication and habitat loss.

The Waiau Estuary is a moderate sized estuary (101ha) at the mouth of the Waiau River, separated and protected from the sea by a large (5km) cobble spit. The vast majority of the estuary is located to the east of the river mouth where it stretches in a long (4km), narrow (~150m) and relatively shallow (mean depth ~2m) lagoon. The estuary is dominated by water (typical for river mouth estuaries), with 84% of the estuary submerged at low tide (Table 4, Figure 1, top photo), and although this high submerged proportion is due primarily to the physical structure of the estuary, it also reflects the loss of saltmarsh surrounding the lagoon through drainage and reclamation (much has been converted to farmland).

Saltmarsh vegetation (vegetation able to tolerate saline conditions and where terrestrial plants are unable to survive) is summarised in Tables 4 and 5, with the broad vegetation class shown in Figure 1. Overall, there was very little saltmarsh around the lagoon, most in a narrow strip (~1-2m) at the edge of the estuary, where rushland (jointed wire rush - *Apodasmia (Leptocarpus) similis*) dominated, with tussockland (mostly flax - *Phormium tenax*) generally slightly higher up the shore between the rushland and surrounding pasture. The largest vegetated areas were located on small islets in the central eastern side of the lagoon (Figure 1, lower photo). The narrow extent of saltmarsh vegetation can be attributed predominantly to drainage of wetland areas to create pasture, combined with the freshwater dominance of the estuary, meaning many terrestrial plants are able to establish to the waters edge. No vegetation was present around the edges of the ponds to the west of the estuary.
