MISCELLANEOUS PUBLICATION

LANDSLIP AND FLOODING HAZARDS IN EASTBOURNE BOROUGH

a guide for planning

**NATIONAL WATER AND SOIL
CONSERVATION ORGANISATION**

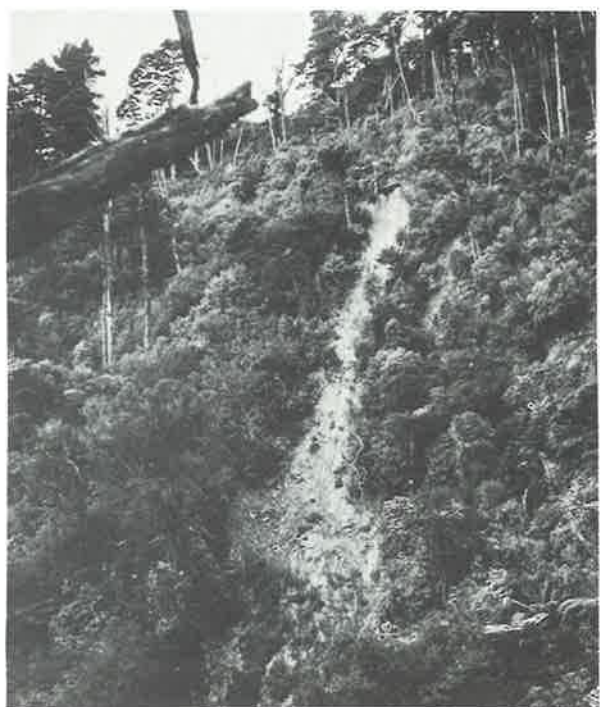
Photo 4—Slip face showing fill material on original soil surface (marked by hammer).

In the face of several slips old buried soils (see Photo 4) were found, in some cases indicating prior movement. This was confirmed by the presence of bent trees that had previously been moved to a horizontal position and then grown upright again.

Unnecessary overburden on steep slopes, such as felled trees, general rubbish (old car parts, timber, bricks, scrap iron, etc.) and soil was a contributory factor in 24 slope failures (see Photos 4 and 6).

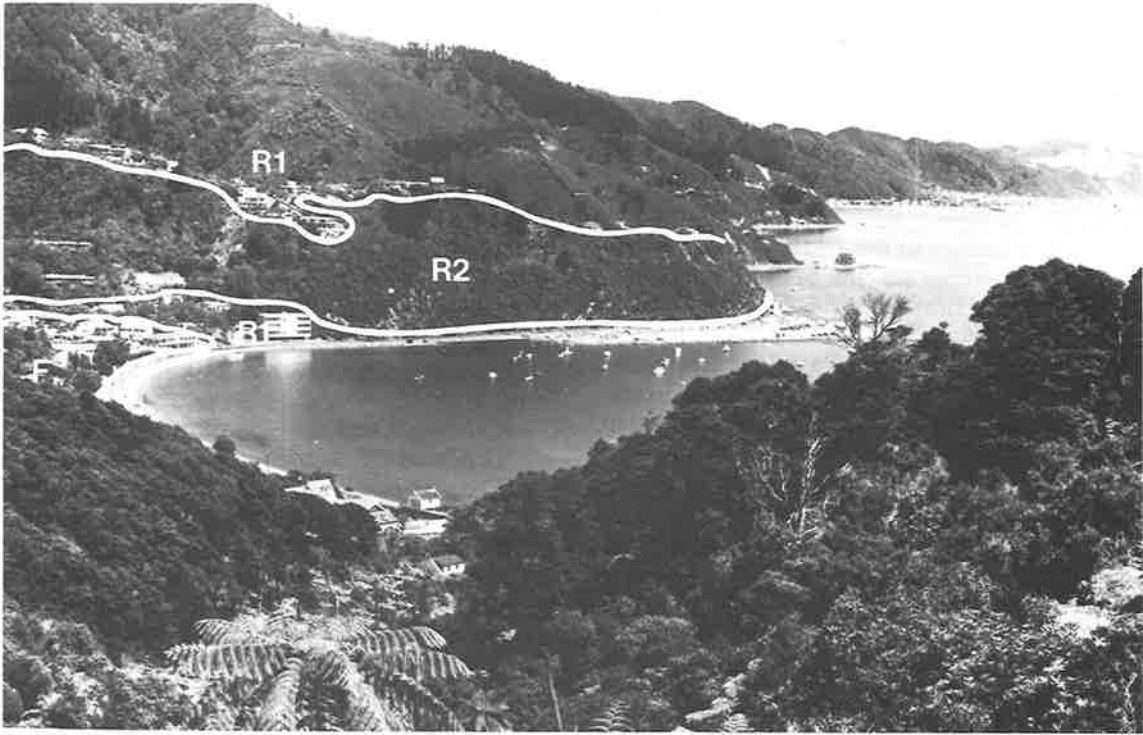
One hundred and twenty slips were measured (Map 1), the majority being located on slopes with a westerly aspect as was expected considering the general orientation of the borough (see Photo 8).

Photo 8—View of Eastbourne looking south from Point Howard, showing the coastal cliff, interglacial marine terraces, steep natural slopes, beech forest, gorse, and pine plantation. Also showing urban suitability classes.

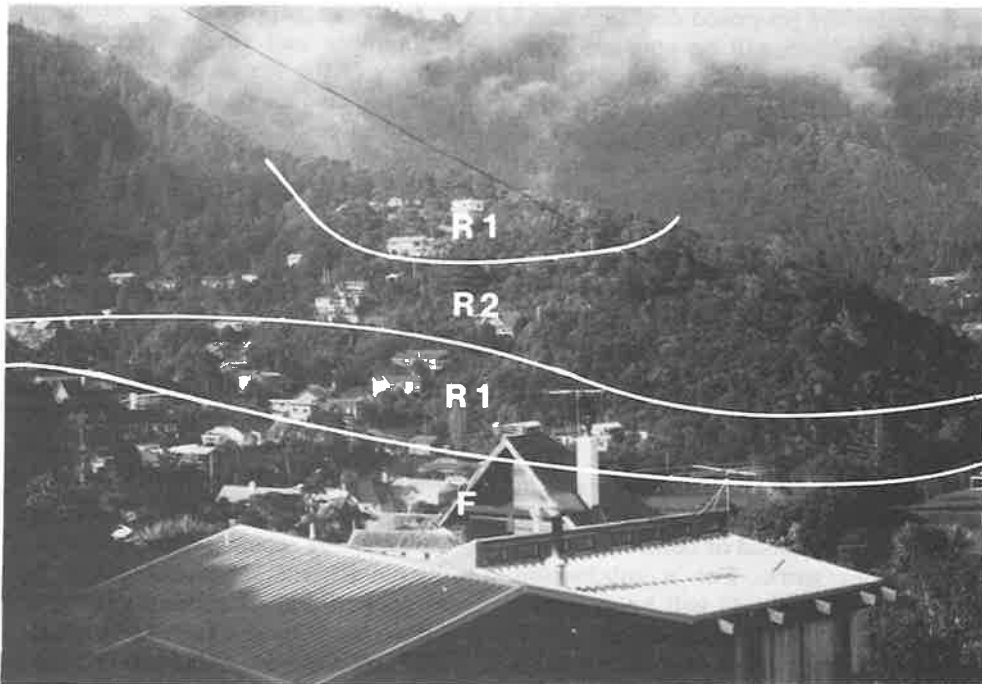
Photo 9—Urban suitability classes in part of Days Bay.
