Estuarine Vegetation Survey – Tairua Harbour

June 2008

Prepared by:
Meg Graeme M.Sc (Marine Science)
Natural Solutions – Marine and Terrestrial Ecologists Ltd

For:
Environment Waikato
PO Box 4010
HAMILTON EAST

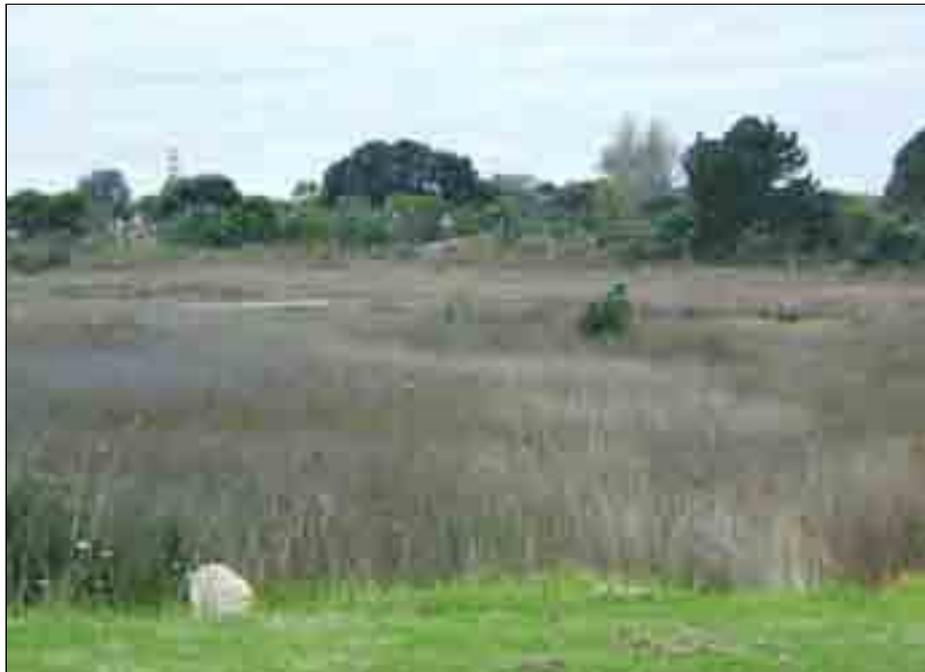
Figure 2: Coastal wetland scrub still exists along the sand dune edge of the eastern side of Grahams Stream and along the upper edges of the stream. Sea rush and small patches of oioi dominate the tidal flats with saltwater paspalum present along the stream banks. This is a repeat of the 1998 photo [37].

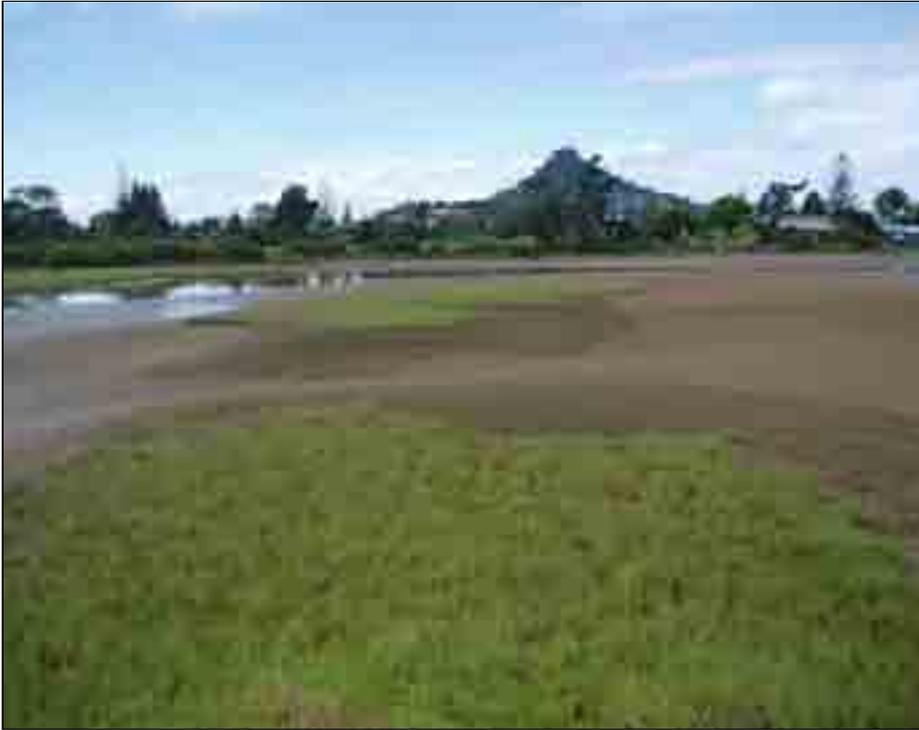
Figure 4: Saltwater paspalum and sea primrose beds (darker green) intermingle along a side creek near the mouth of the Pepe Stream.

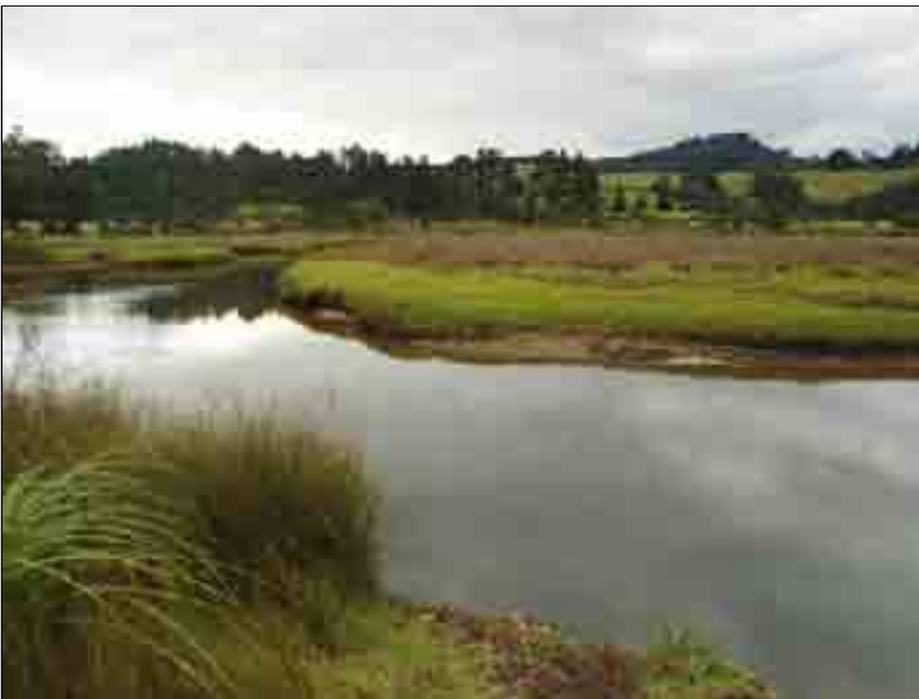
Figure 5: This photo is taken from the old motor camp looking over Pepe Stream towards the golf course, in the vicinity of the 1998 photo [38]. Saltwater paspalum dominates the edges of the stream with sea rush beds behind (and saltmarsh ribbonwood out of the picture to the left).

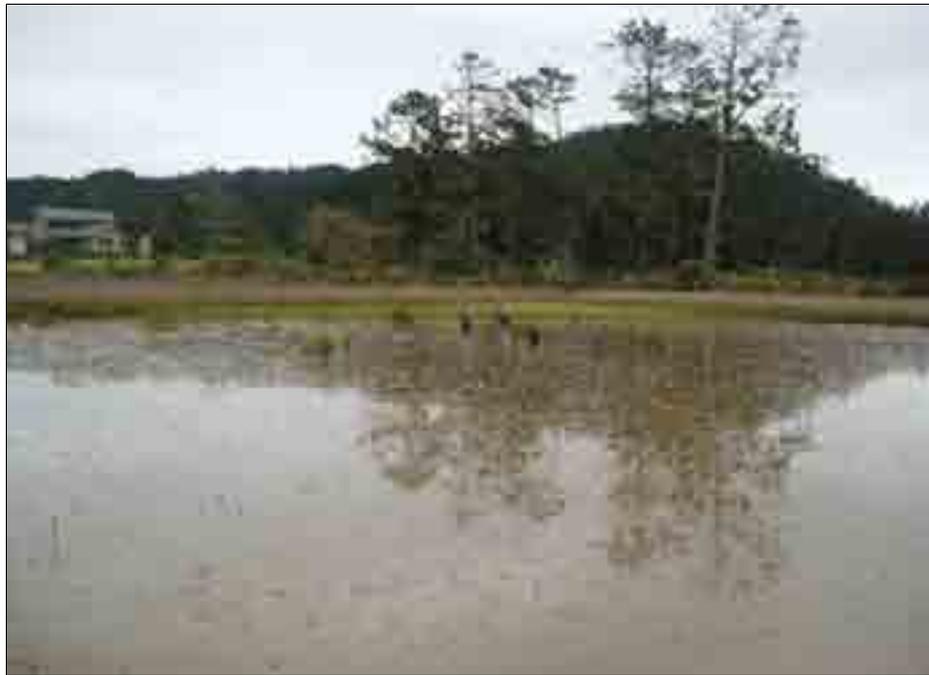
Figure 6: The former Pinelea motor camp has been subdivided for housing. An esplanade reserve now extends in front of the new housing out to the spit with the pines (Pepe Stream behind). A patch of saltwater paspalum edges the saltmarsh and a few scattered small mangroves are present on the mudflats.

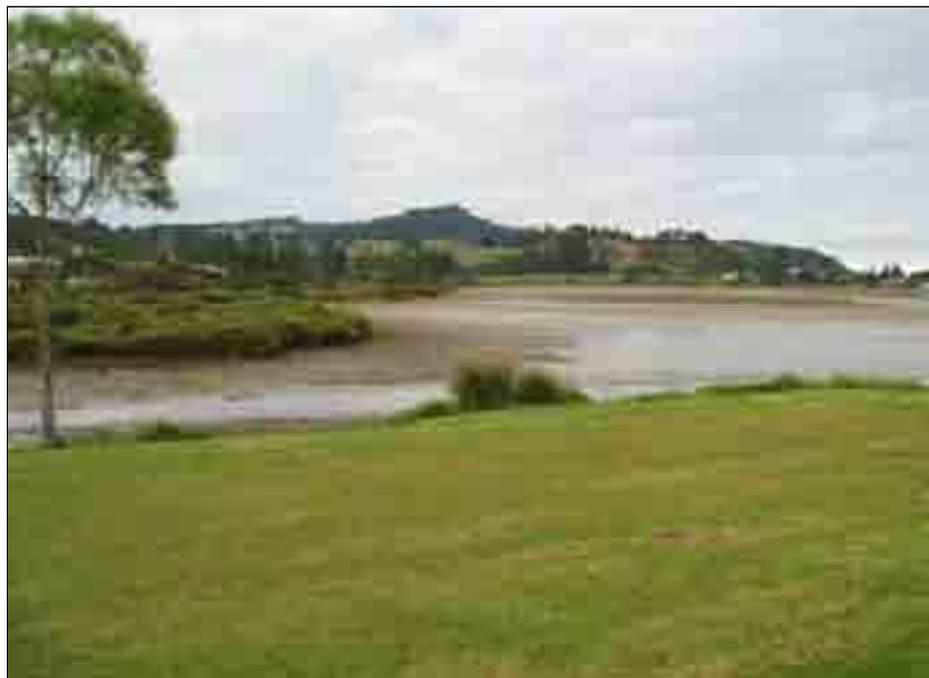
Figure 7: A view over the Pepe embayment showing seagrass fringing mangroves. This photo was taken from a Pepe Road park seat.

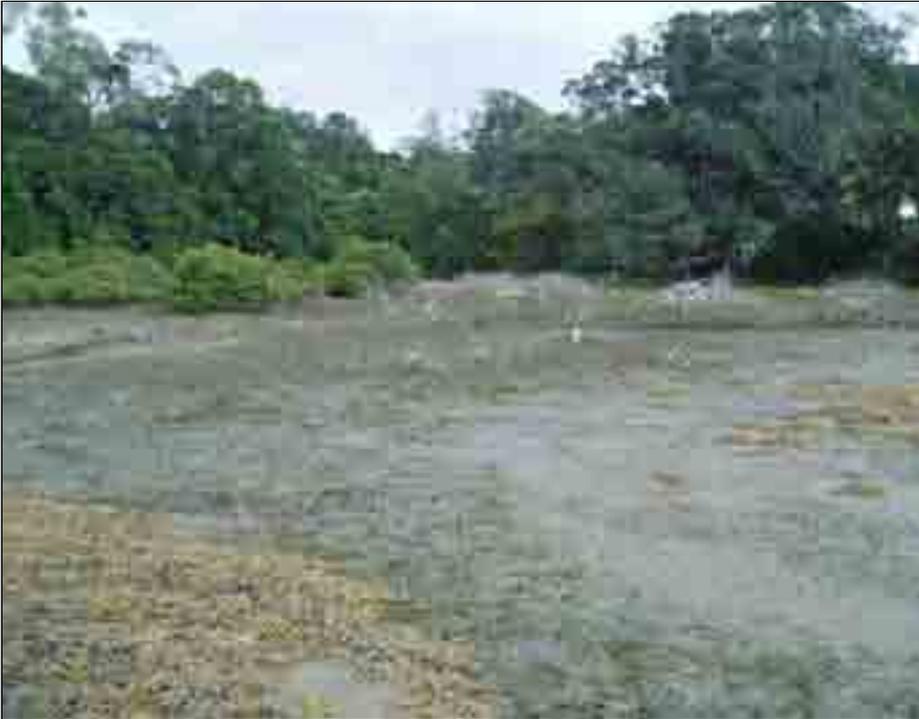
Saltwater paspalum lines the shoreline of the southern part of Tairua town. Mangroves aren't encountered until the small creek below the **Tairua school** grounds (Figure 8). Some mangroves have been chopped down here. The flats out from the school are either dominated by seagrass on soft sediments or *Hormosira* seaweed (Neptunes necklace) on exposed bedrock.

Figure 8: There is a variety of estuarine vegetation below the Tairua School. Mangroves fringe the stream mouth and foreshore (although some large trees have been cut down). *Hormosira* seaweed grows on exposed bedrock and seagrass dominates the soft mud.

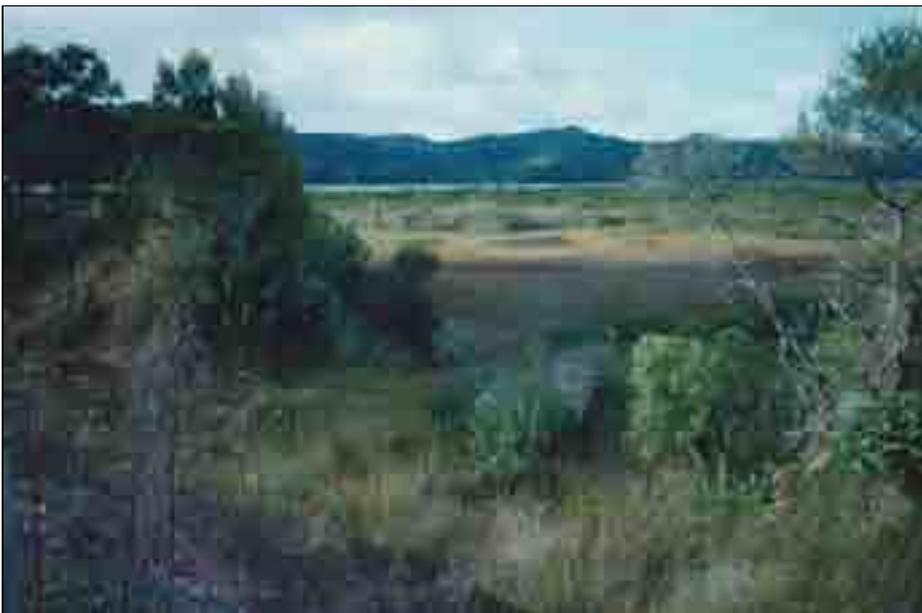
Figure 9: This view over the saltmarsh and outer mangrove band is taken from the newly-aligned edge of SH 25 (a near repeat of 1998 photo [40]).

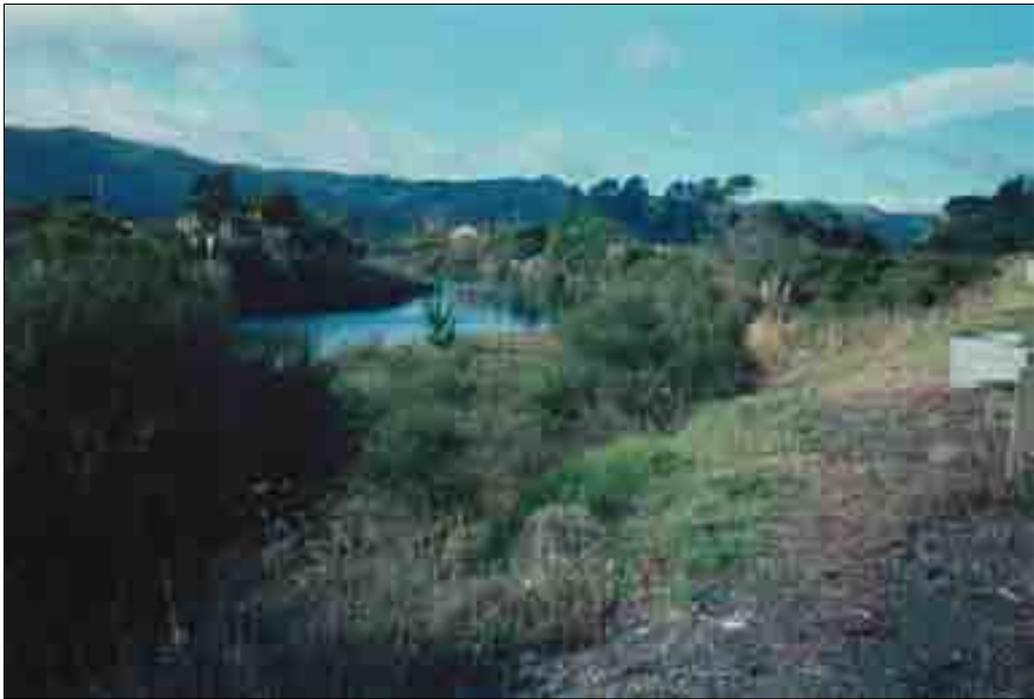
Figure 13: A view of Oturu stream from the realigned SH25. The old road was further inland and constructed over freshwater manuka/tangle fern wetland at the time of the 1998 photo [42].

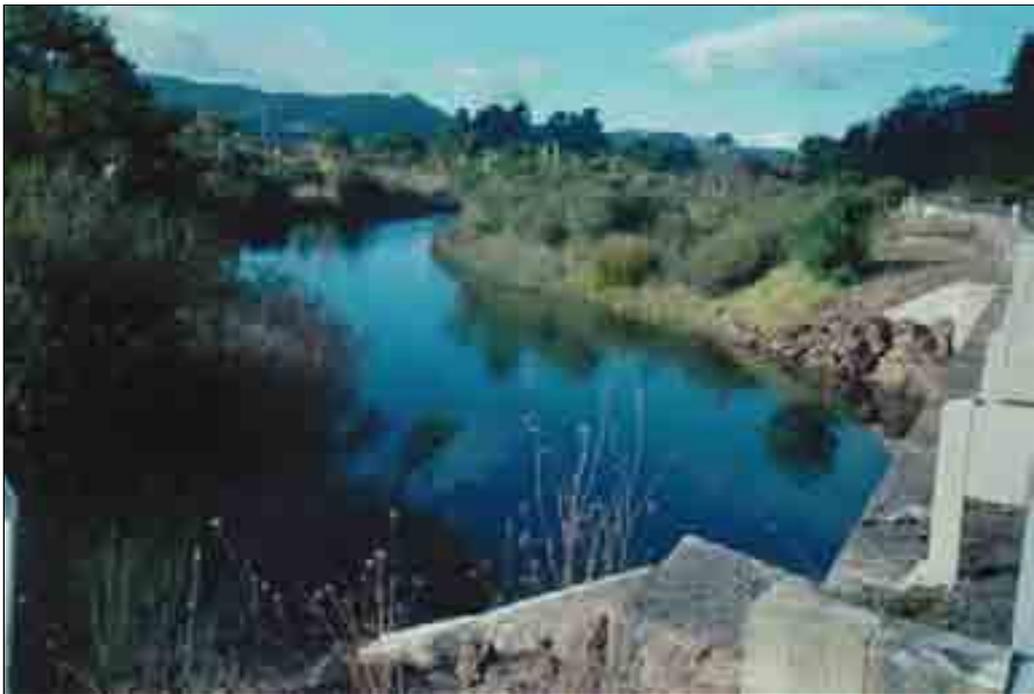
Figure 14: Another view looking down Oturu Stream from the realigned SH25 bridge.

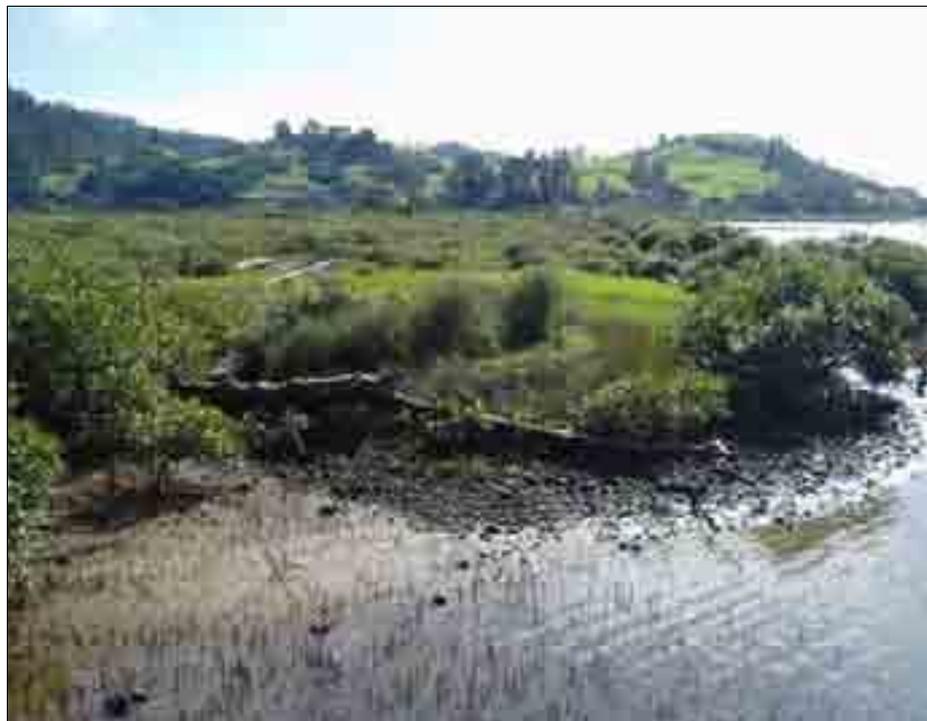
Figure 16: This photo is a repeat view of the 1998 photo [46] overlooking the Oturu embayment from Green Point.

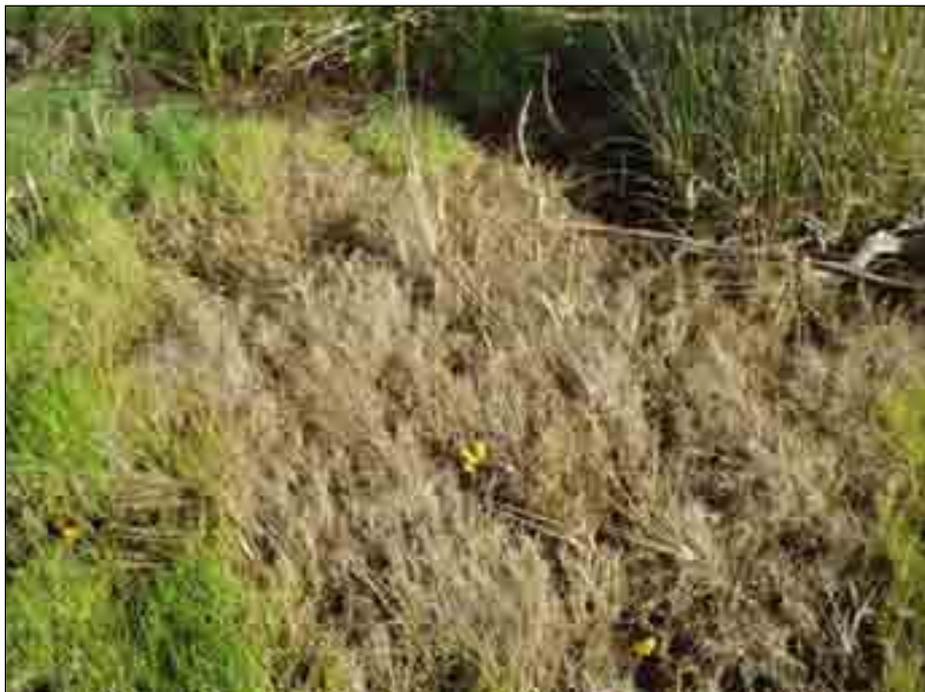
Figure 21: This sprayed patch of spartina shows that the herbicide Gallant is just as effective in controlling saltwater paspalum.

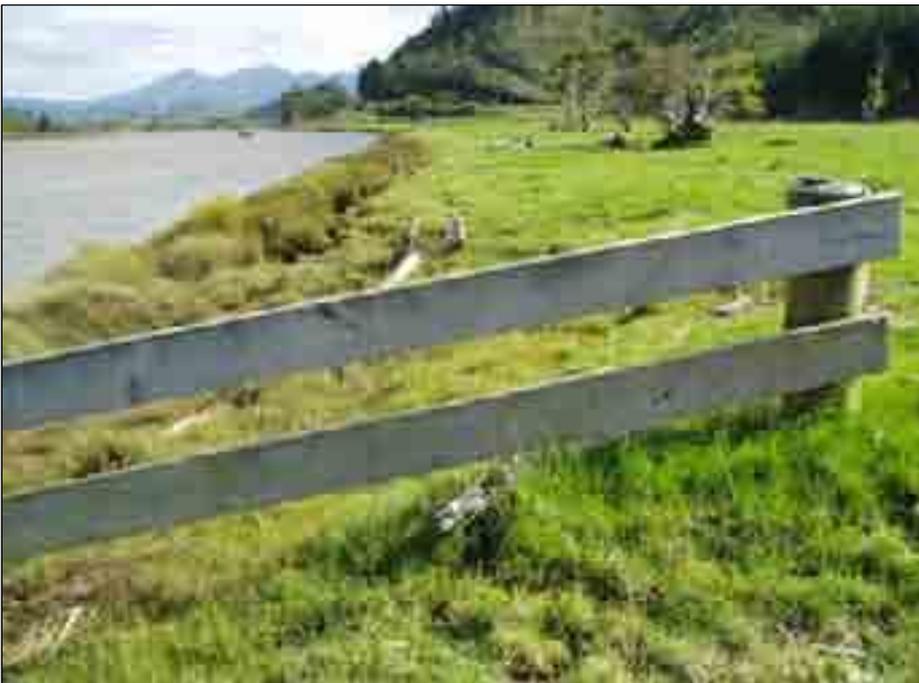
Figure 23: A view looking upstream from the photo point of Figure 22 above.

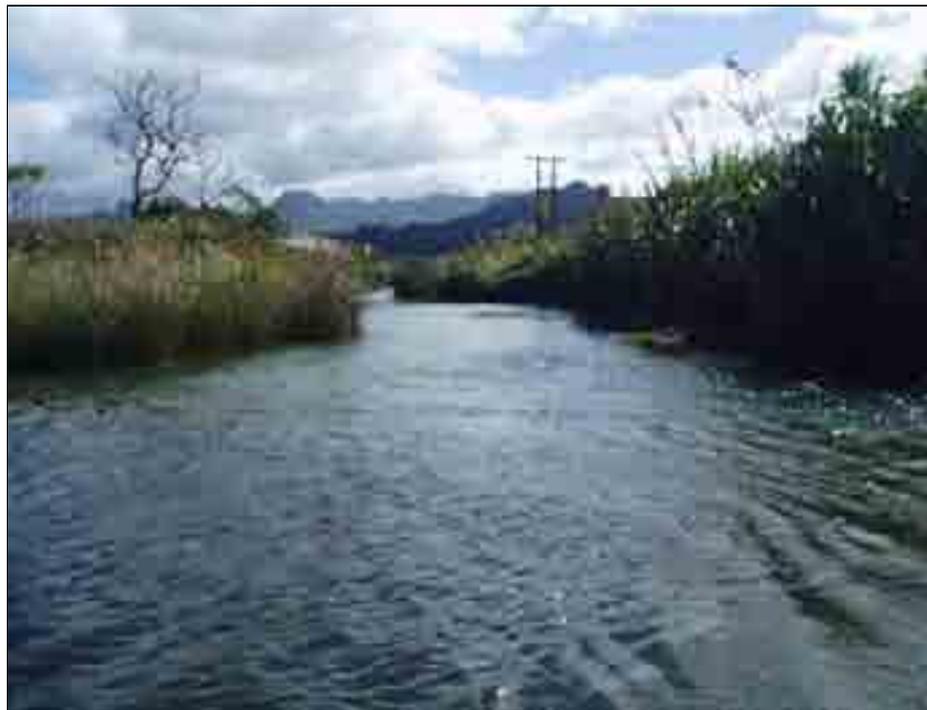
Figure 25: Vegetation along the stream mouth of Woody Stream includes flax, raupo, swamp coprosma, lake clubrush as well as the estuarine species’ saltwater paspalum and saltmarsh ribbonwood.

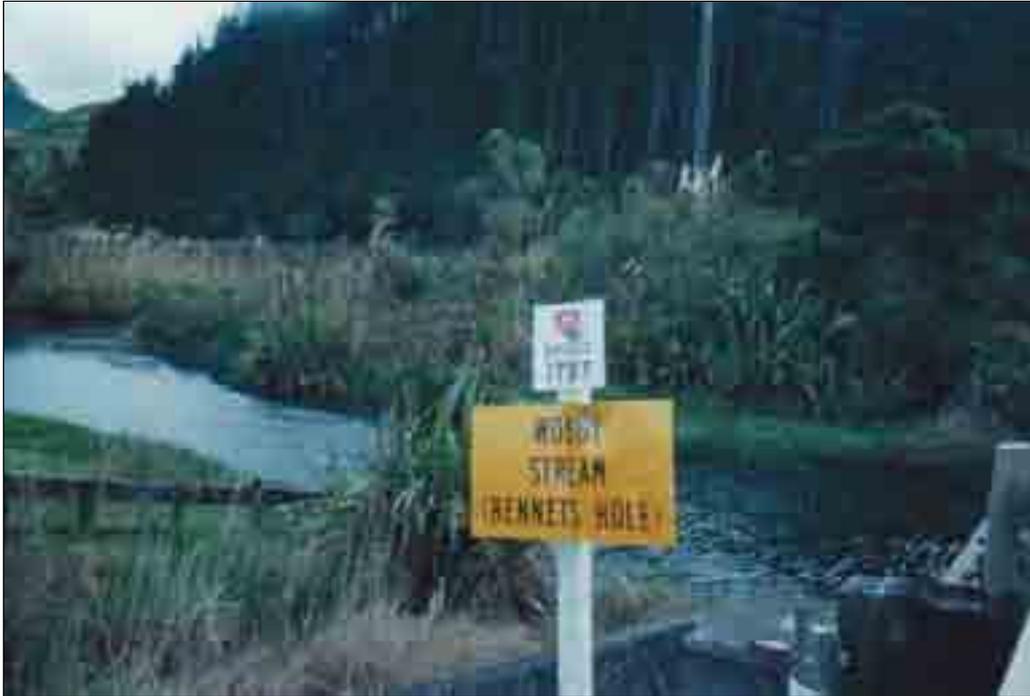
Figure 26: A view upstream of Woody Stream from the State Highway 25 bridge. This is a repeat of the 1998 photo [50].

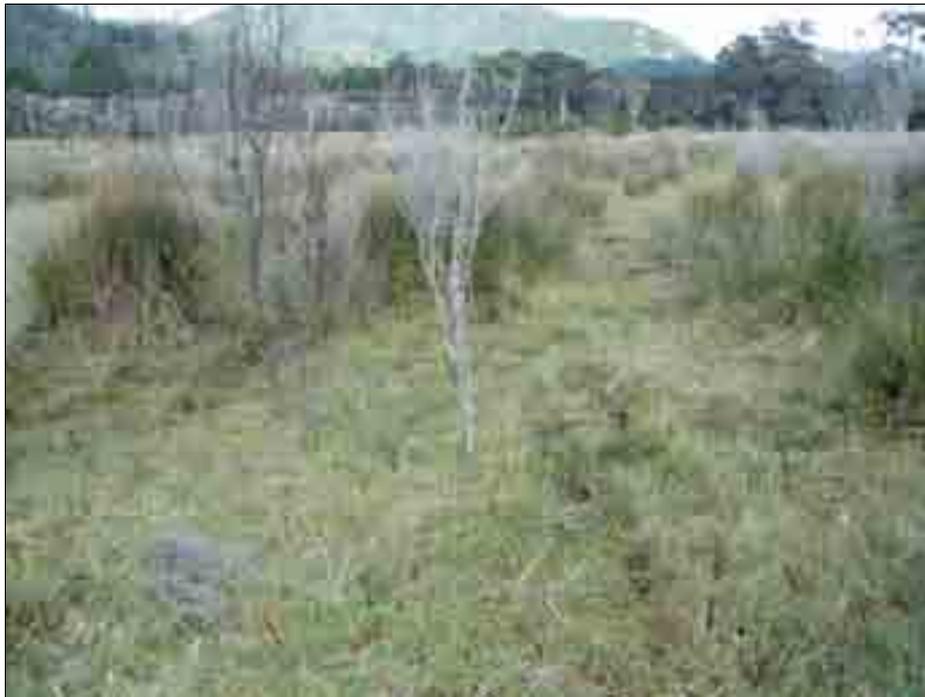
Figure 28: Low-lying floodplain beside the river with grazed saltwater paspalum, sea rush and manuka.

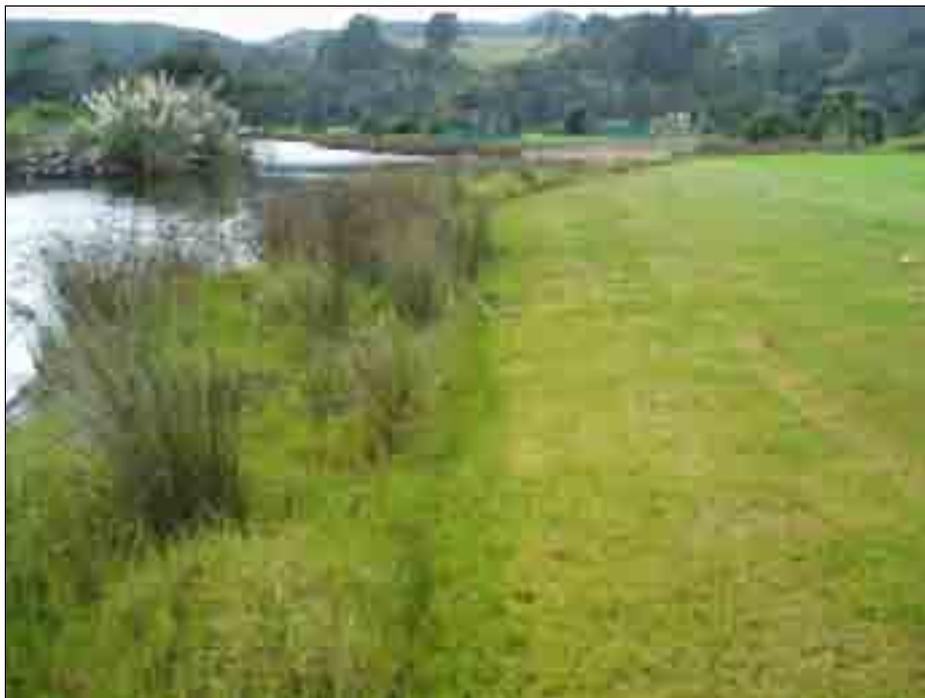
Figure 29: A new canal development formed from floodplain similar to that pictured above. Sea rush and saltwater paspalum line the new canal edges. Remuremu was found amongst the saltwater paspalum.

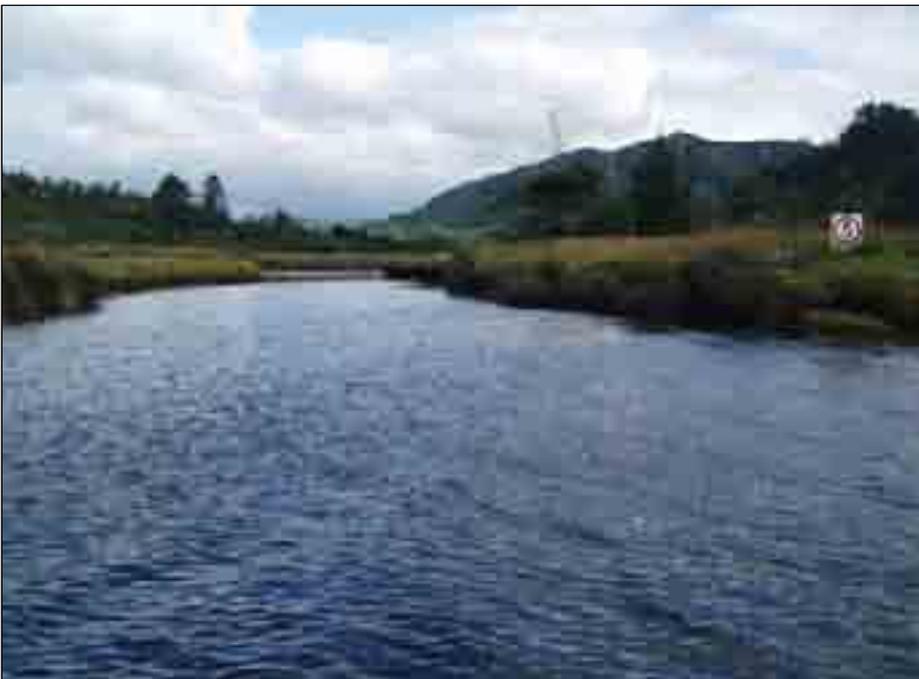
Figure 31: The stream mouth of Duck Creek is dominated by saltwater paspalum, sea rush and oioi. Saltmarsh ribbonwood is also common.

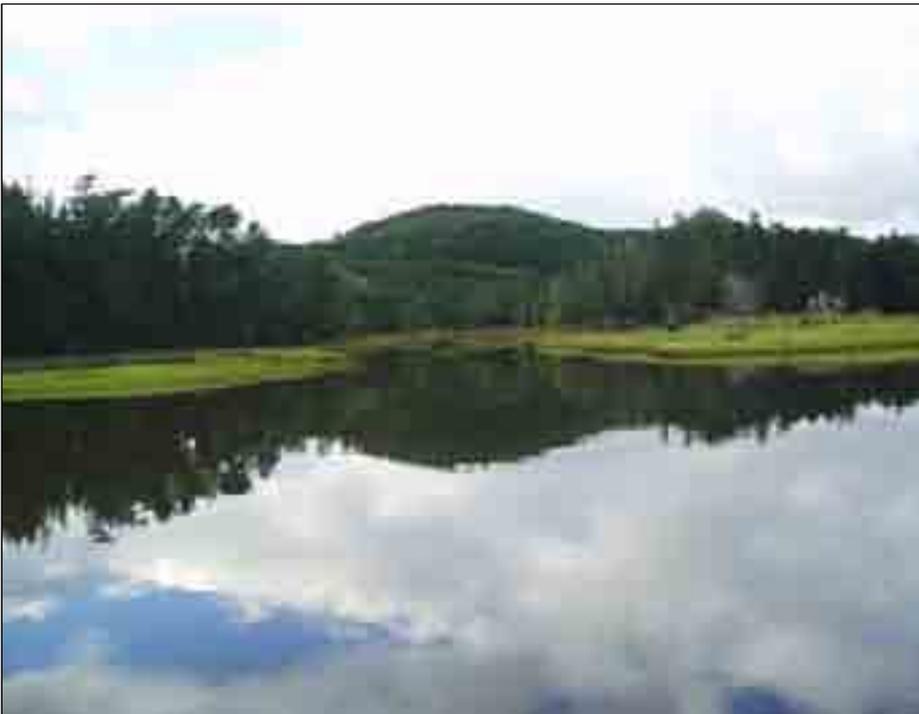
Figure 35: Saltwater paspalum at the mouth of Gumdiggers Gully stream.

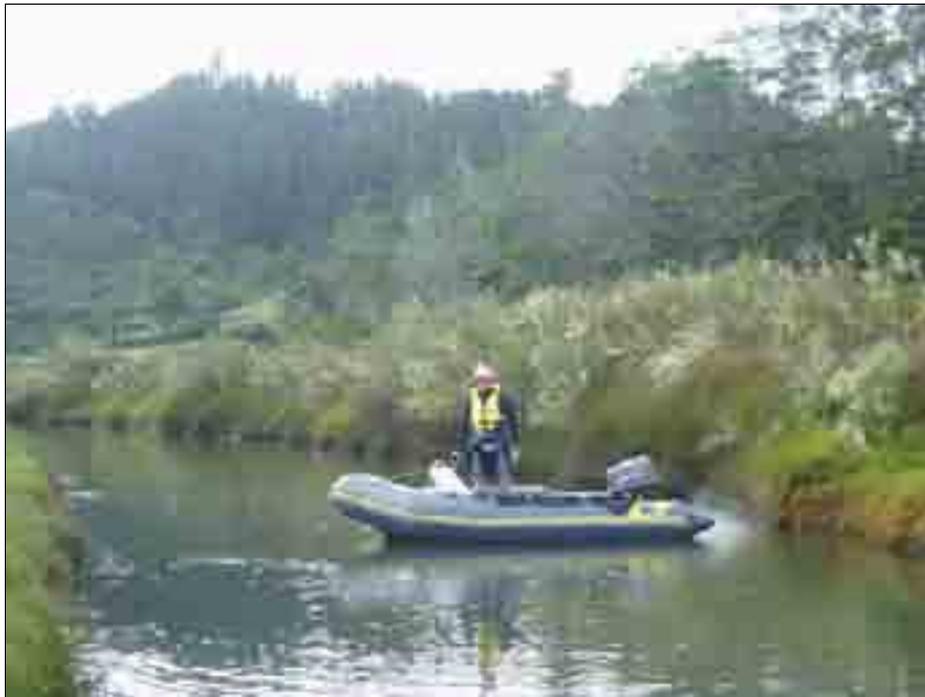
Figure 36: A repeat of the 1998 photo [54] showing dense saltmarsh ribbonwood lining Gumdiggers Creek as well as oioi and saltwater paspalum. Fernbird and banded rail are present in this wetland.

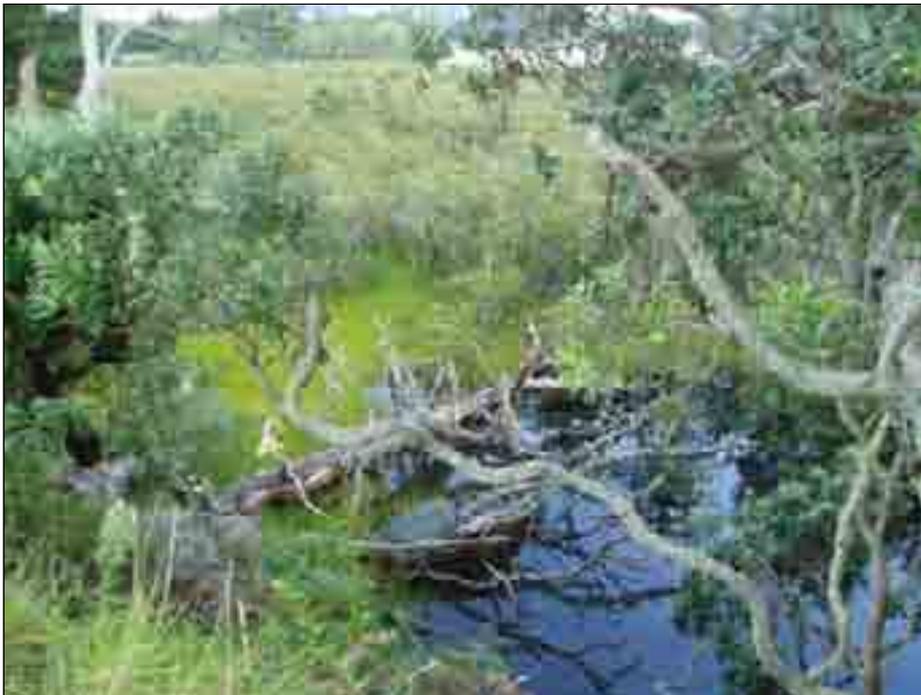
Figure 38: The thick saltwater paspalum band shown above ends in line with the Tangitarori Lane straight. A banded rail was seen running into the mangroves.

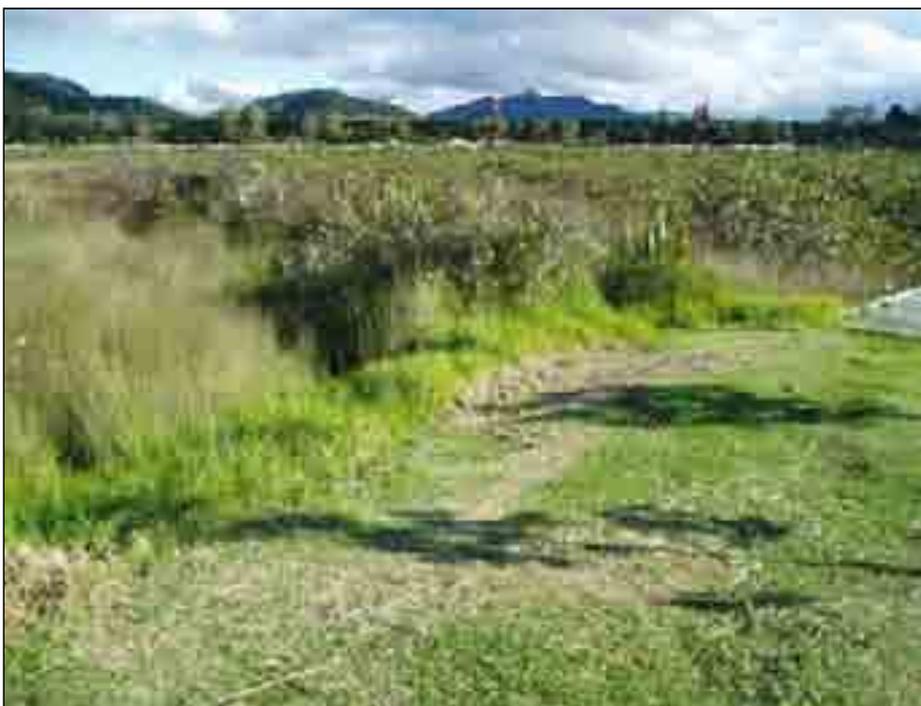
Figure 39: This view shows the estuarine vegetation immediately upstream of the north-eastern end of the Tangitarori wetland boardwalk. The light yellow-green grass is saltwater paspalum.

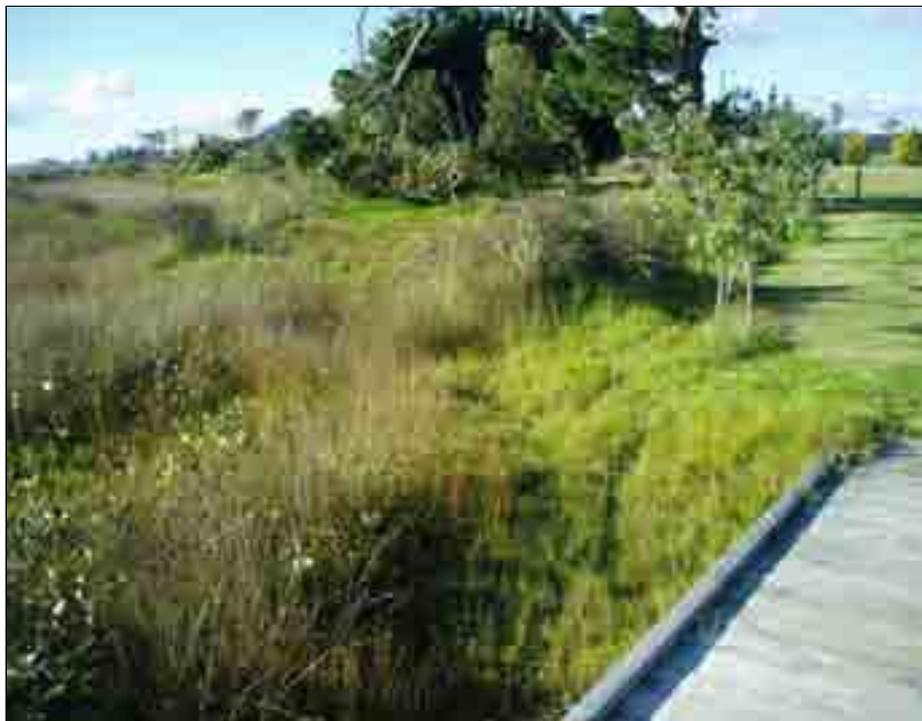
Figure 40: This view is of the estuarine vegetation immediately downstream of the north-eastern end of the Tangitarori wetland boardwalk.

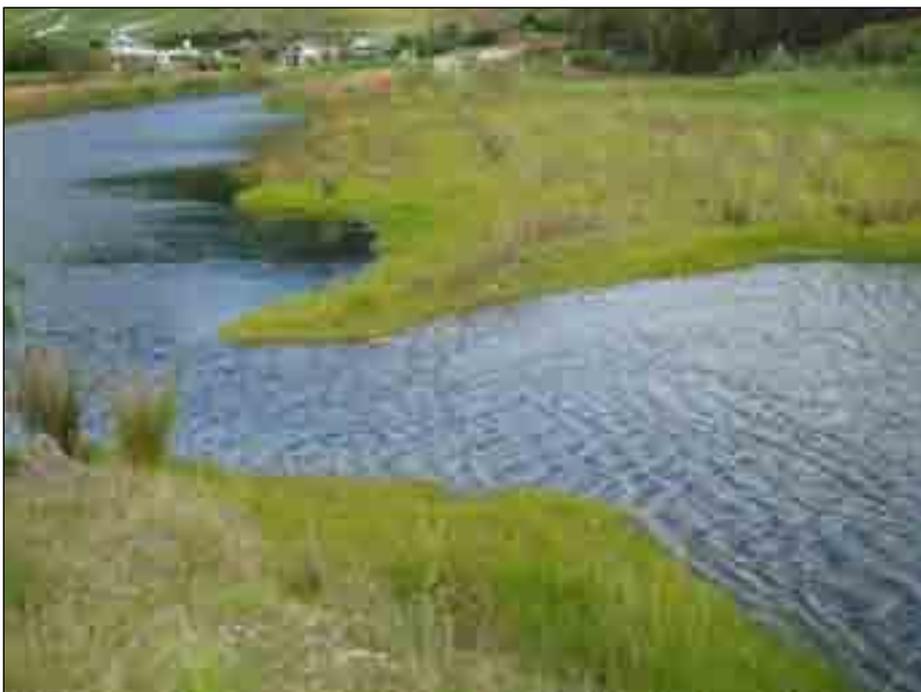
Figure 43: Saltwater paspalum dominates the edge of this new 'undeveloped' canal, with sea rush and raupo scattered amongst it.

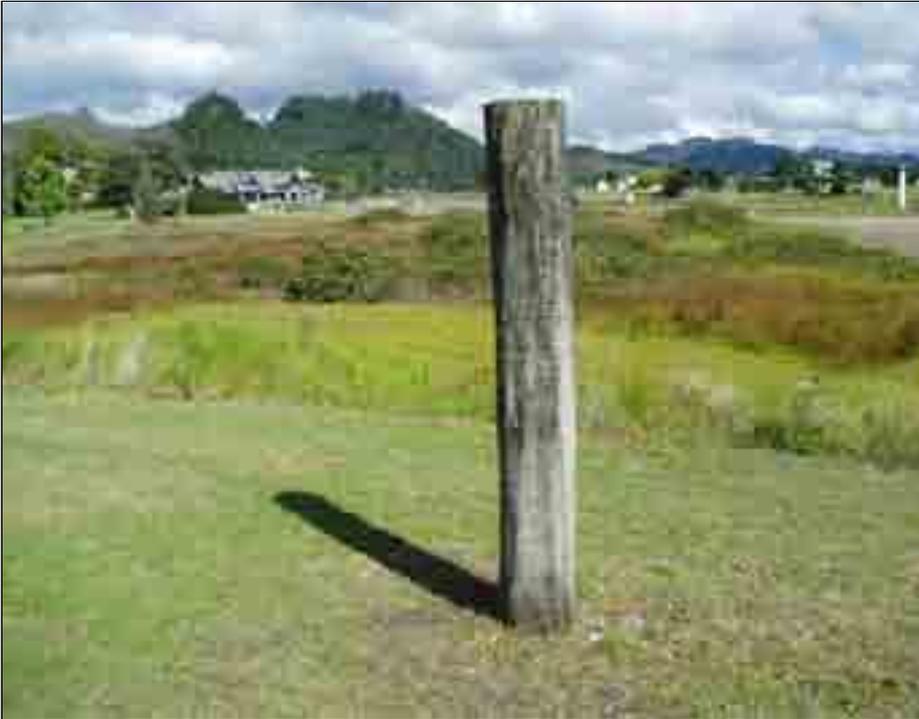
Figure 46: This view shows the estuarine vegetation north of the Waterways entrance channel (note the channel navigation marker in the right background). Species visible here are mangroves, sea rush, oioi and saltwater paspalum.

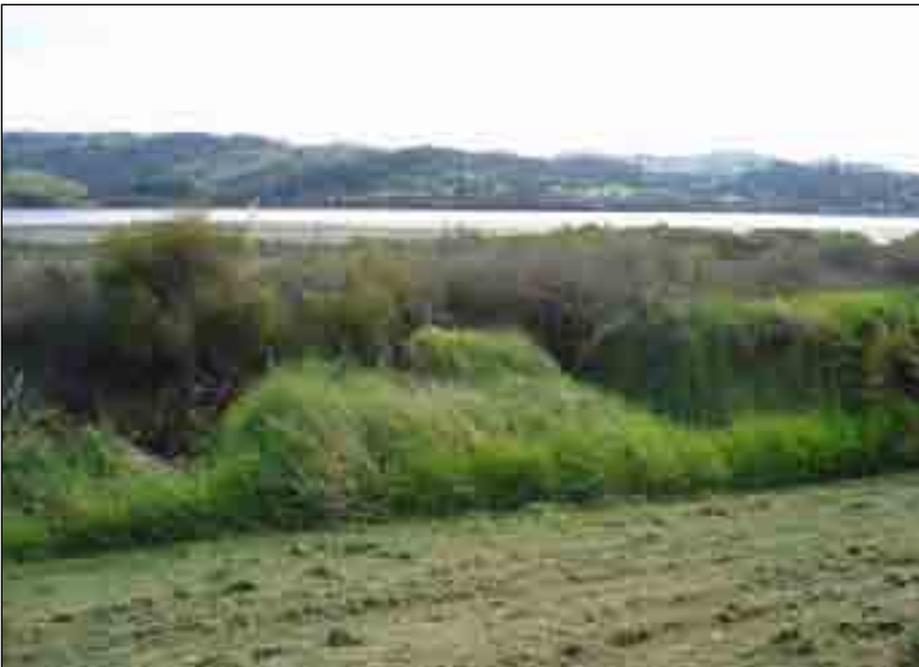
Figure 47: A thin band of saltmarsh ribbonwood intermingled with scattered coastal shrub daisy, manuka and flax grades down into sea rush and then to mangroves. Some of the seaward mangroves have been cut down. Seagrass is visible on the mud flats.

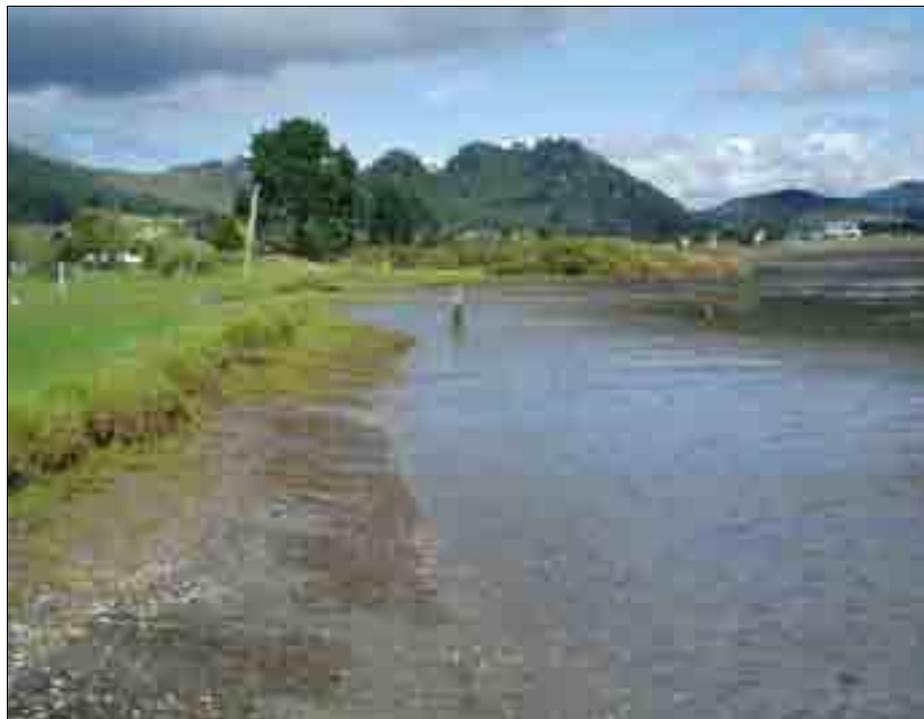
Figure 48: This view shows the saltwater paspalum edge to the lower harbour. In the background is the downstream limit of the saltmarsh and mangrove communities on the eastern side of the Tairua Harbour. A banded rail was seen amongst the mangroves. Some of the seaward mangroves have been cut down.

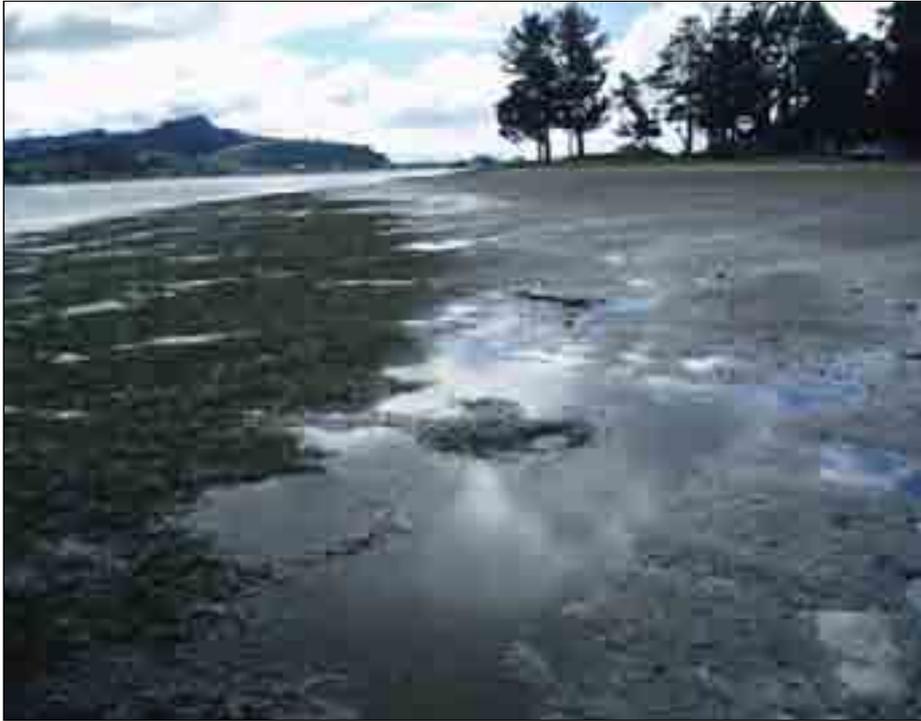
Figure 50: A view looking north over intertidal (and some subtidal) seagrass towards Pleasant Point. Saltwater paspalum lines the foreshore.
