**FISH PASSAGE PROBLEMS
AND OPTIONS FOR FISH PASSAGE AT MARAROA WEIR**

REPORT PREPARED FOR THE ELECTRICITY CORPORATION OF NEW
ZEALAND

CHARLES MITCHELL & ASSOCIATES

August 1994

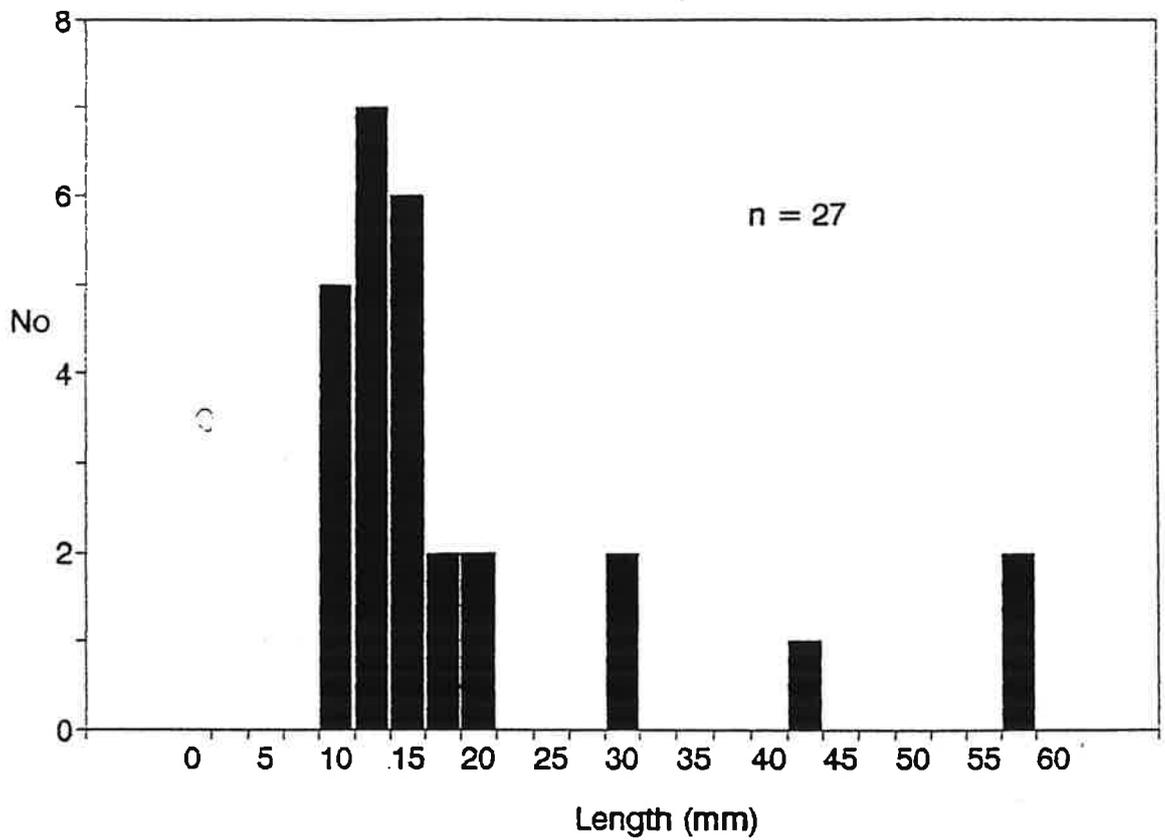
Six fine mesh fyke nets (3mm. & 6mm. stretched mesh) were set overnight at the base of the weir. A catch of 27 elvers and small eels (plus three large common bullies) were taken at the site of the exit from the fish pass, although the exit was buried by large quantities of shingle. The only species of eel caught was *Anguilla dieffenbachii*, which was to be expected, considering the dominance of this species in the upper Waiau system (Mitchell & Davis-Te Maire 1994). Eels from 11-56 cm. long were caught. Most were in the size range 11-21 cm. (Fig 3) and could be called elvers. It was interesting that all these eels had empty guts. It could be expected that the larger eels had been attracted into the nets to feed upon the smaller ones, but this was not the case. This lack of feeding may be common for upstream migrating eels, or perhaps it is a result of crowding below the weir and the general stress faced by these eels. Perhaps they were concentrated within an area that was inherently unfavorable for eels to live in. Analysis of growth rates of eels from the Waiau River found the growth rates of this sample to be the poorest in the catchment (Mitchell & Davis-Te Maire 1994).

Fig 3. Size frequency of longfinned eels (*Anguilla dieffenbachii*) caught immediately below the Mararoa Weir (26/1/94).

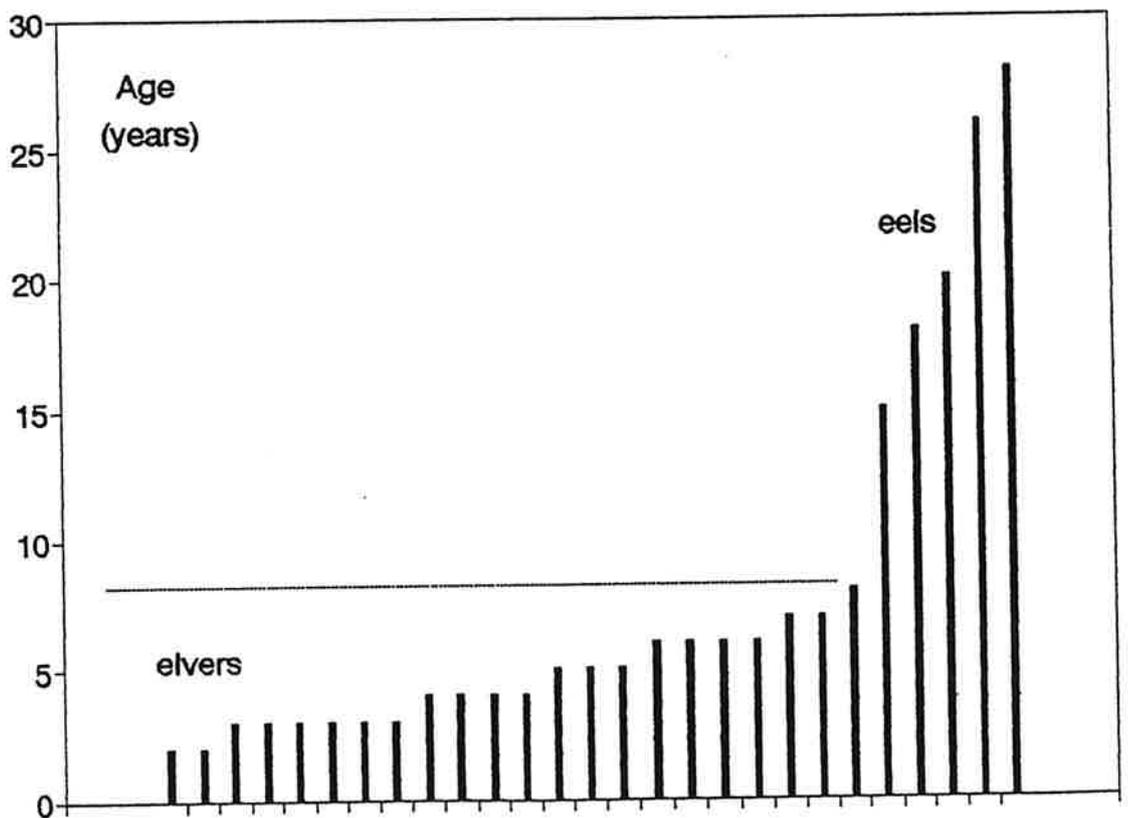
Otolith aging of these eels showed that the elvers ranged in age from 2 to 8 years. Larger eels were from 15 to 28 years old (Fig 4).

Fig 4. Ages of longfinned eels (*Anguilla dieffenbachii*) caught immediately below Mararoa Weir (26/1/94).
