Riparian characteristics of pastoral waterways in the Waikato region, 2002-2017

M. Norris¹, H. Jones¹, M. Kimberley², D. Borman¹

November 2020

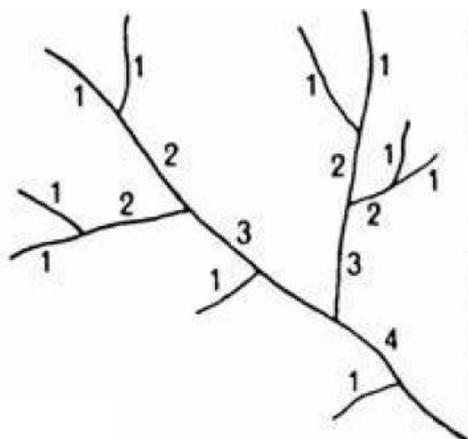
Stream order, as a representation of stream size, was described using the Strahler system of ranking stream channels. The Strahler system ranks streams on a scale from 1 to 7 based on the number and size of tributaries contributing flow to a given stretch of waterway. The larger the stream order (Strahler) number, the larger the stream or river (Figure 2; Selby, 1985). Drains were differentiated from other waterways for the purposes of the survey by using a stream order designation of zero (Hill & Kelly, 2002). For analysis of stock exclusion results with respect to Plan Change 1 regulations (Waikato Regional Council, 2020), drains were further separated into narrow (< 2 m) and wide (\geq 2 m) drain classes

Figure 2. Strahler order (Selby, 1985).

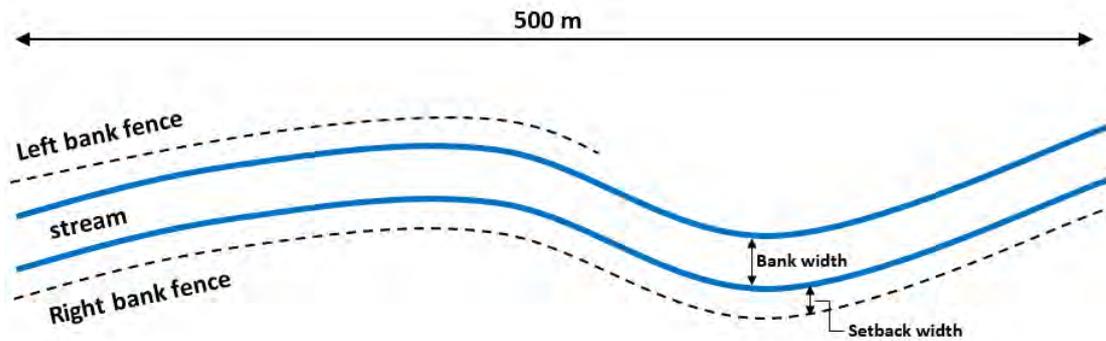
The diagram presented in Figure 3 illustrates the concepts of stream length, bank length and fencing configuration. Stream length and bank length, in particular, are central to the presentation of the survey results as most characteristics are reported as a proportion of stream or bank length.

Figure 3. A stylised example of a stream reach that illustrates the concepts of stream length, bank length and fencing configuration (based on Storey, 2010, p.8). Bank width and setback width concepts are also included for reference.

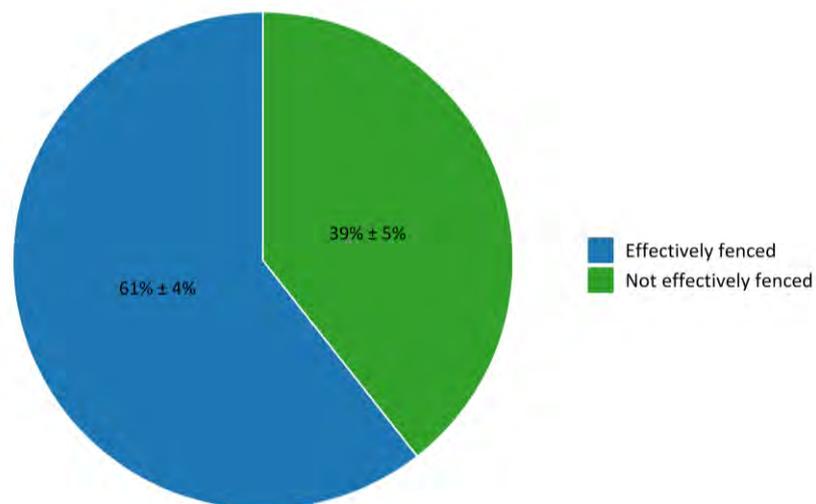
Approximately two thirds (61%) of the surveyed bank length of sampled waterways across the Waikato region in 2017 was found to be effectively fenced (Figure 4). Effective fencing was defined as that which is sufficient to prevent stock access to the waterway and is adjacent to riparian margins. The remainder of the bank length (39%) was either not fenced at all or ineffectively fenced.

Figure 4. Average proportion of bank length effectively fenced and not effectively fenced across the Waikato region in 2017 (n = 432). Error terms represent the 95% confidence interval about the average.

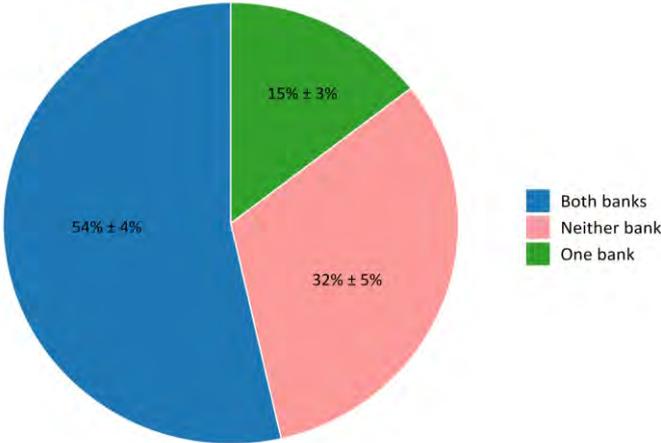
Figure 5. Average proportion of stream length effectively fenced on one bank, both banks or neither bank across the Waikato region in 2017 (n = 429). Error terms represent the 95% confidence interval about the average.

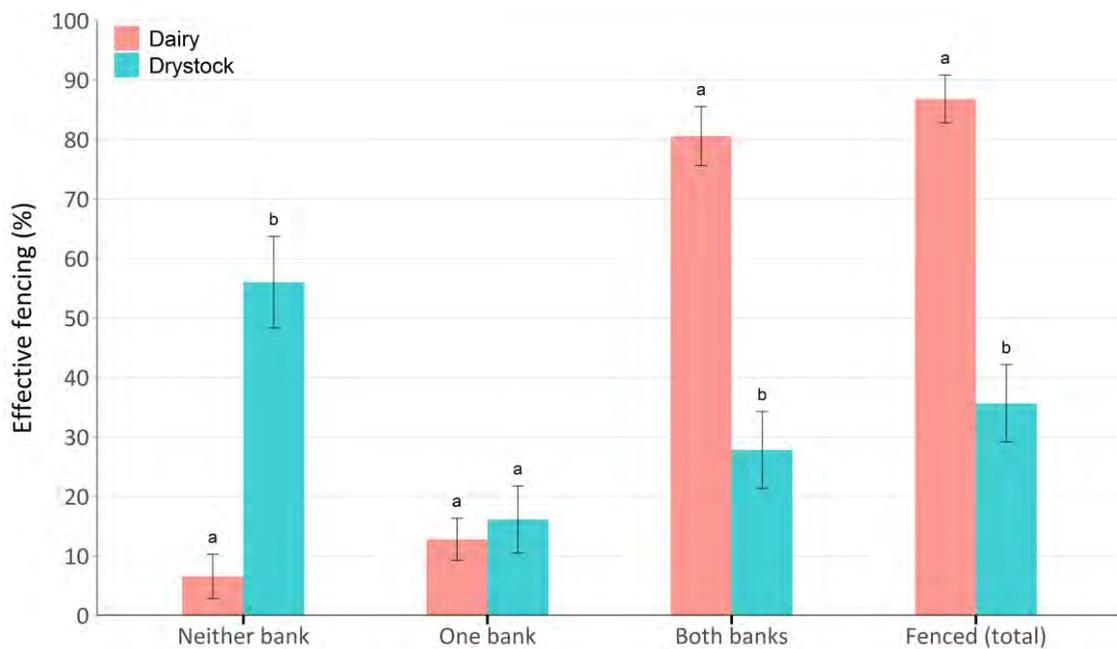
Figure 6. Average proportion of bank length effectively fenced (total) and average proportion of stream length effectively fenced on one bank, both banks, or neither bank within land use types across the Waikato region in 2017. Error bars represent the 95% confidence interval about the average. Within each category, averages carrying the same letter are not significantly different ($\alpha = 0.05$).

In 2017, the amount of total stock access observed was significantly less for dairy (26% of bank length) than for drystock (75% of bank length) (Figure 13; $t = 12.0$, $p < 0.0001$). This was also the case for each individual stock access category (i.e. past, recent, and current). For recent and current stock access categories, percentage access values were about three times greater for drystock compared to dairy. This result is consistent with differences in the amount of effective fencing between dairy and drystock land uses (Figure 6).

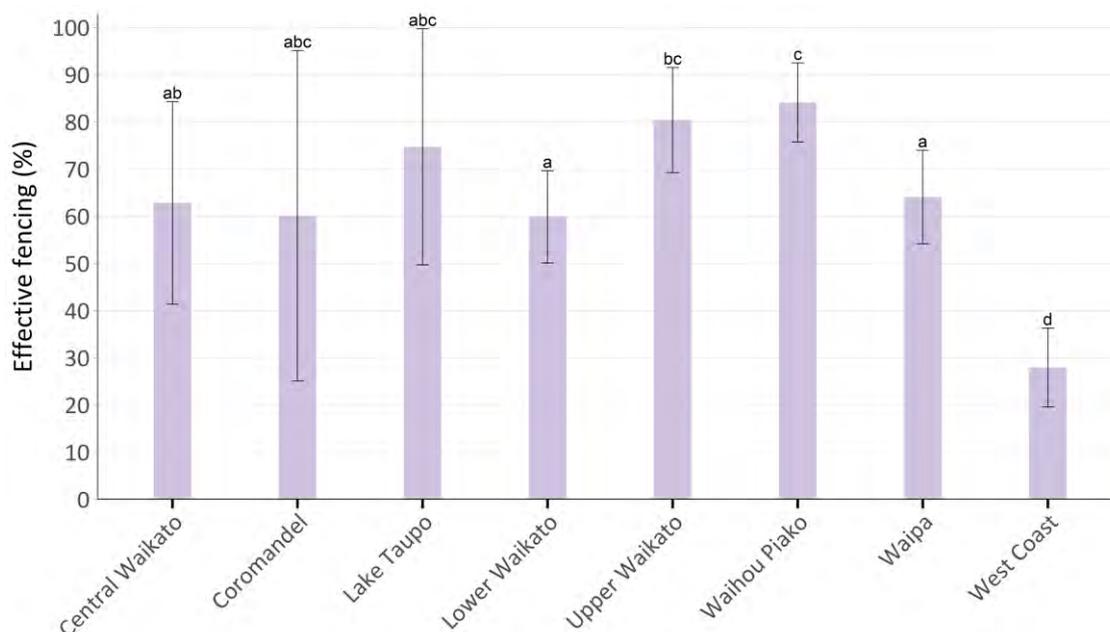
Figure 7. Average proportion of bank length effectively fenced within each management zone in 2017. Error bars represent the 95% confidence interval about the average. Averages carrying the same letter are not significantly different ($\alpha = 0.05$).

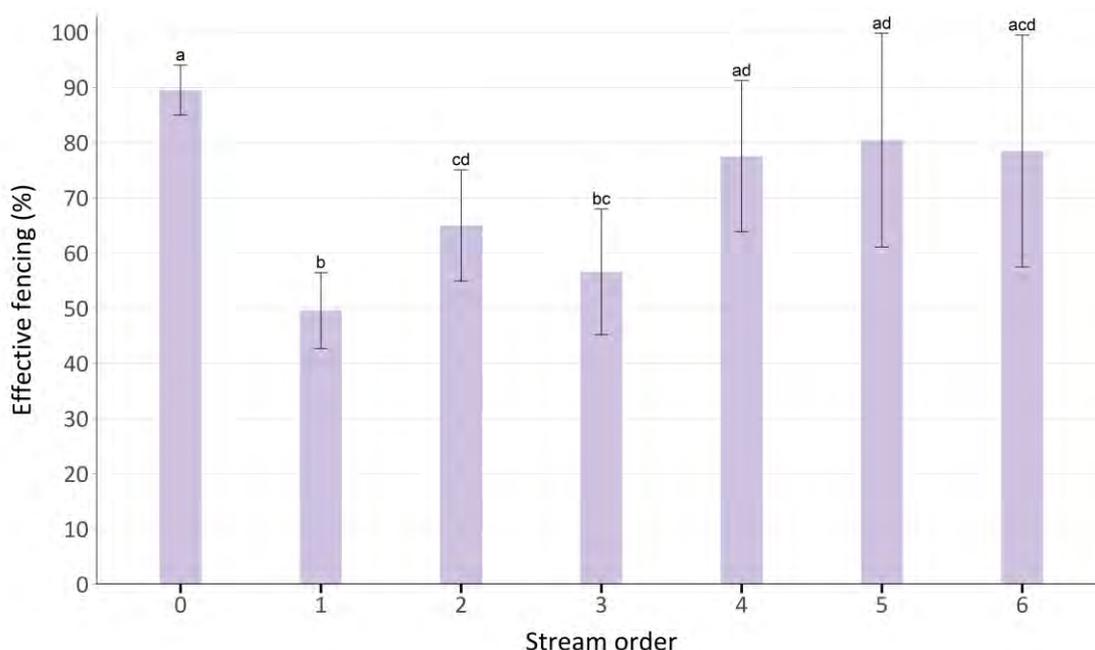
Figure 8. Average proportion of bank length effectively fenced within each stream order in 2017. Stream order 0 represents drains. Error bars represent the 95% confidence interval about the average. Averages carrying the same letter are not significantly different ($\alpha = 0.05$).

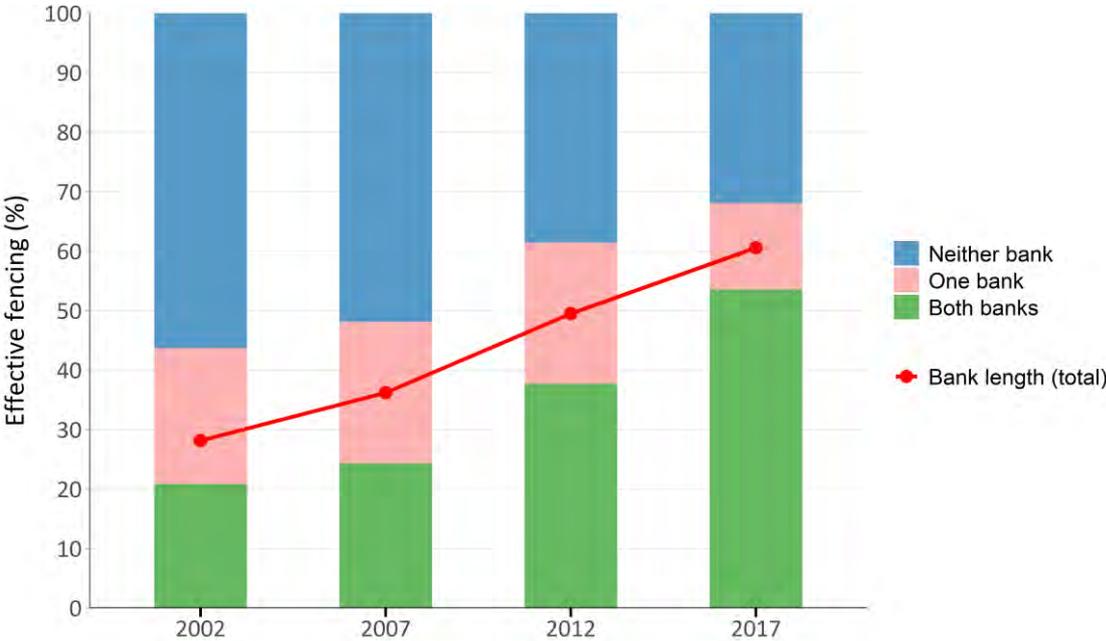
Figure 9. Average proportion of bank length (total) and stream length (one bank, both banks, or neither bank) effectively fenced for each the four survey years (2002, 2007, 2012 and 2017).

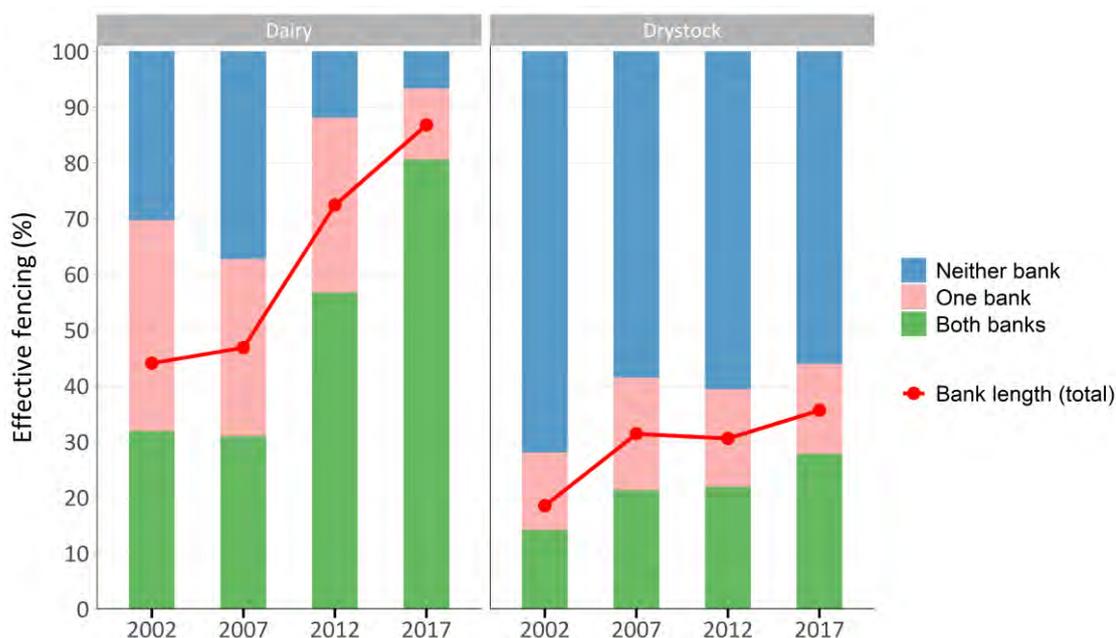
Figure 10. Average proportion of bank length (total) and stream length (one bank, both banks or neither bank) effectively fenced within land use types at the four survey periods (2002, 2007, 2012 and 2017).

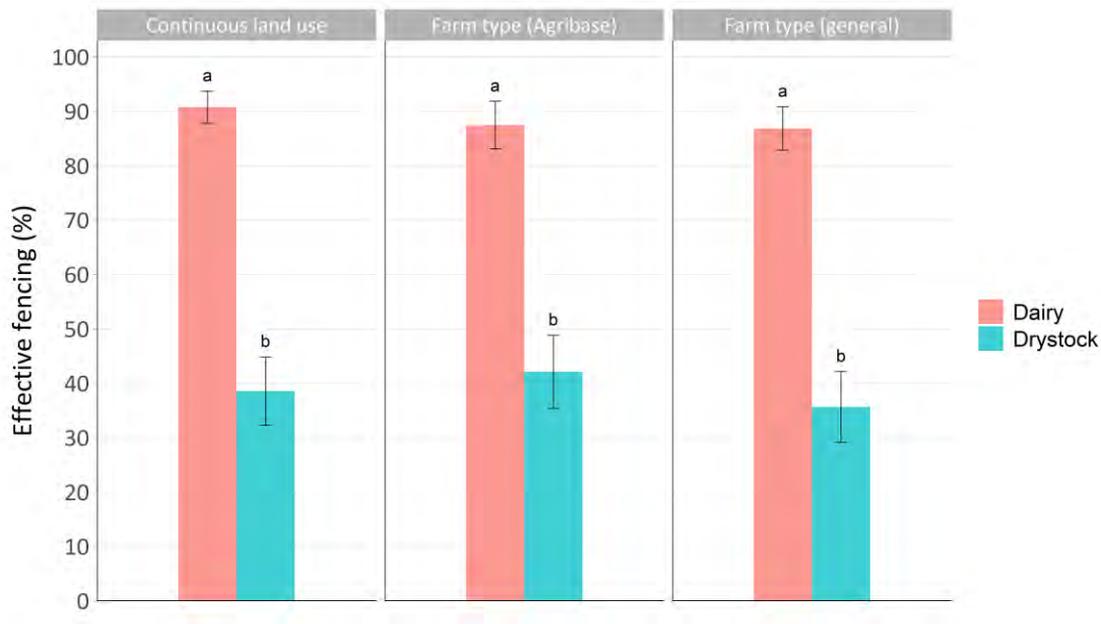
Figure 11. Average proportion of bank length (total) effectively fenced in 2017 calculated with three land use classification systems including continuous land use (recorded with a handheld GPS), Agribase™ defined land use, and the general land use classification system outlined in Section 2.3.2. Error bars represent the 95% confidence interval about the average. Within each land use category, averages carrying the same letter are not significantly different ($\alpha = 0.05$).

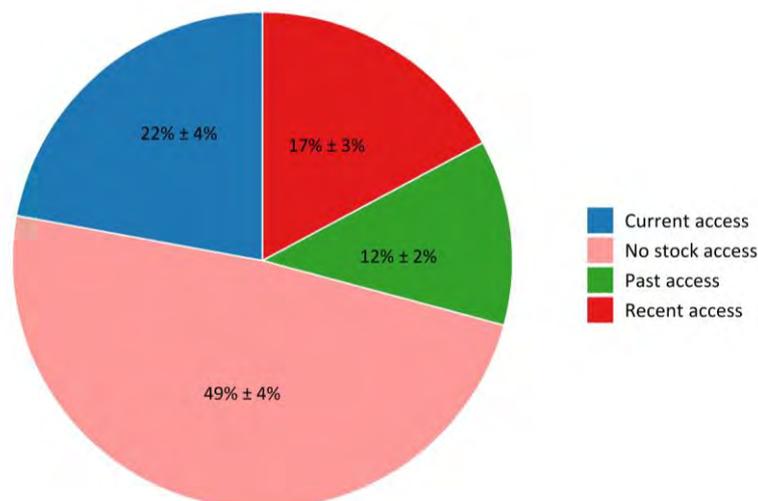
On average, 49% of surveyed bank length across the Waikato region in 2017 showed no evidence of stock access (Figure 12). The remaining 51% of bank length showed some evidence of either past, recent or current stock access (stock access types are defined in Table 3). Current stock access, affecting 22% of bank length, refers to stock observed within the waterway or the adjacent riparian margin at the time the survey was undertaken. Across the region, there was a difference of about 10% between the amount of stock access observed (approximately 50% of bank length) and the amount of effective fencing (approximately 60% of bank length). This implies for about 10% of bank length, stock access to the riparian margin occurred in the presence of effective fencing. While this may have occurred in some instances (e.g. stock bypassing fencing structures through gates), it may also reflect the presence of new fencing. Indeed, the amount of effective fencing (61%) corresponded well to the percentage of bank with no stock access (49%) when percent past access (12%) was included.

Figure 12. Average proportion of bank length with no stock access and past, recent, or current stock access observed across the Waikato region in 2017 (n = 432). Error terms represent the 95% confidence interval about the average.

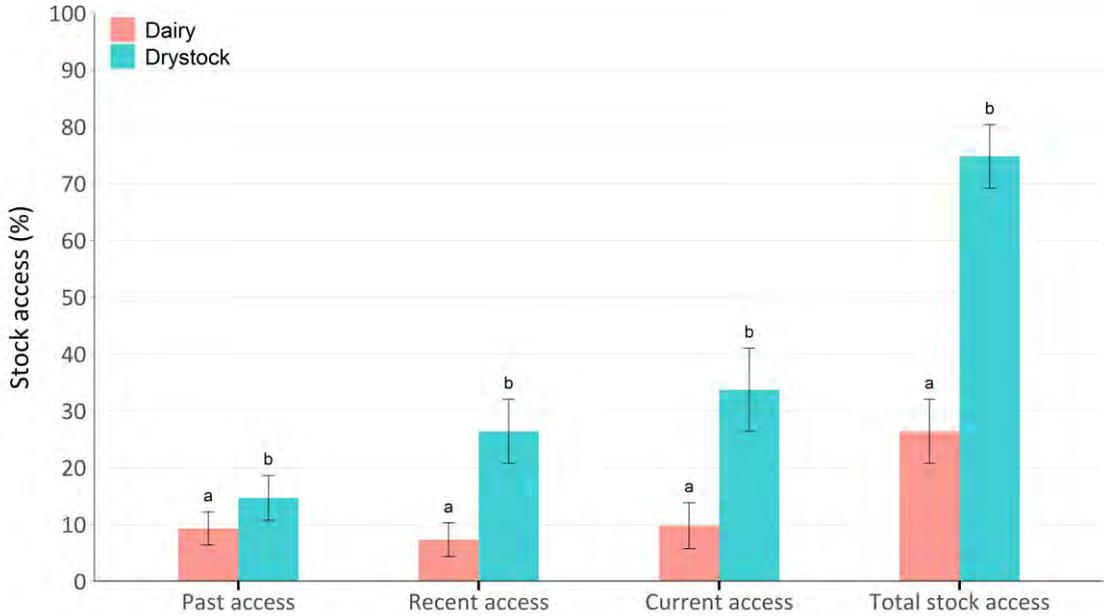
Figure 13. Average proportion of bank length with total stock access and (constituent) past, recent or current stock access observed across the Waikato region in 2017. Error bars represent the 95% confidence interval about the average. Within each category, averages carrying the same letter are not significantly different ($\alpha = 0.05$).

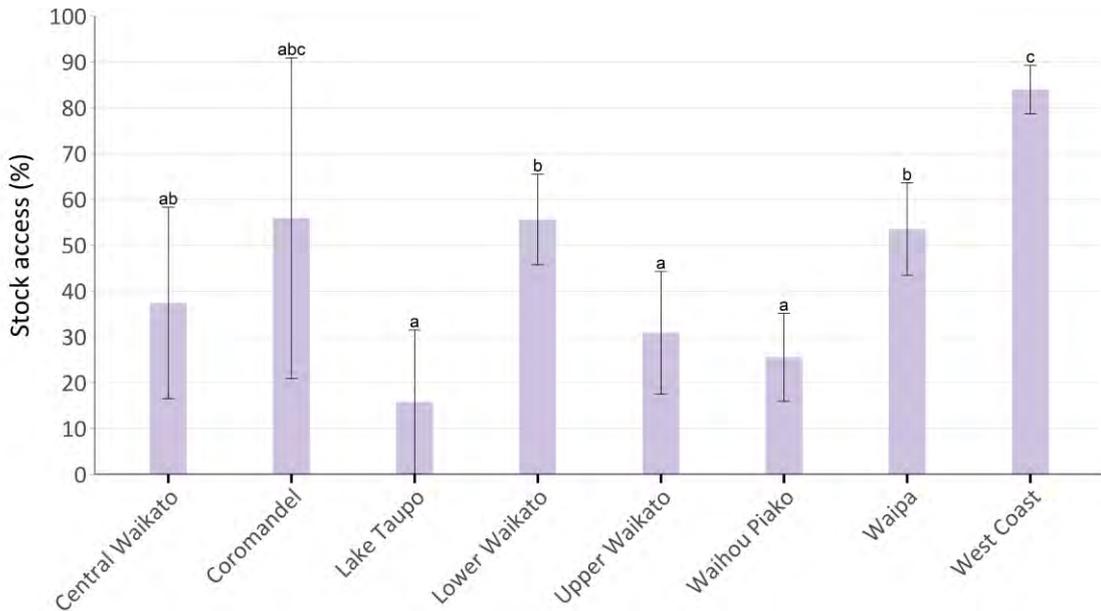
Figure 14. Average proportion of bank length with observed stock access within each management zone in 2017. Error bars represent the 95% confidence interval about the average. Averages carrying the same letter are not significantly different ($\alpha = 0.05$).

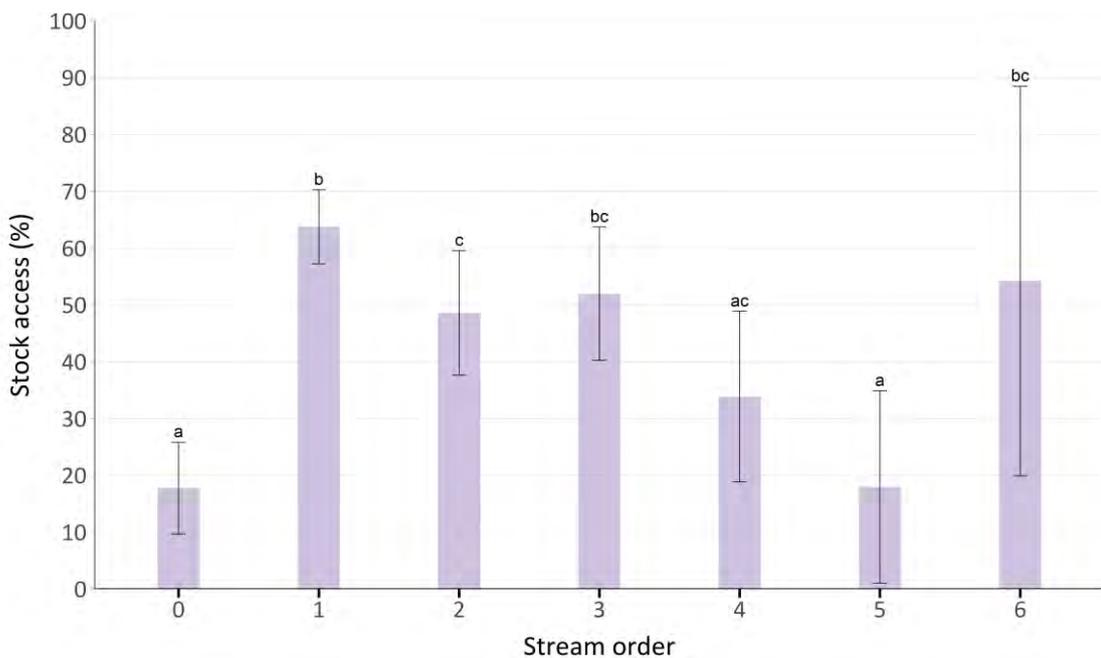
Figure 15. Average proportion of bank length with observed stock access within each stream order in 2017. Stream order 0 represents drains. Error bars represent the 95% confidence interval about the average. Averages carrying the same letter are not significantly different ($\alpha = 0.05$).

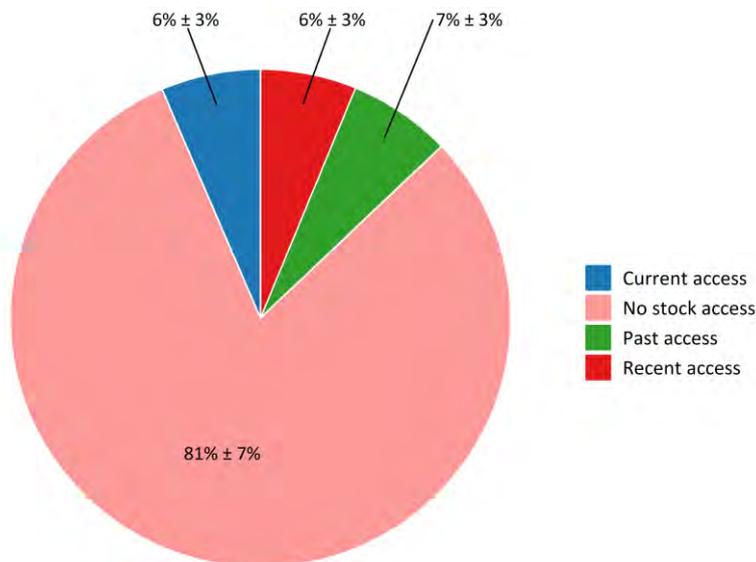
Figure 16. Average proportion of bank length with no stock access and past, recent, or current stock access observed at Dairying and Clean Stream Accord qualifying sites (n = 146) across the Waikato region in 2017. Error terms represent the 95% confidence interval about the average.

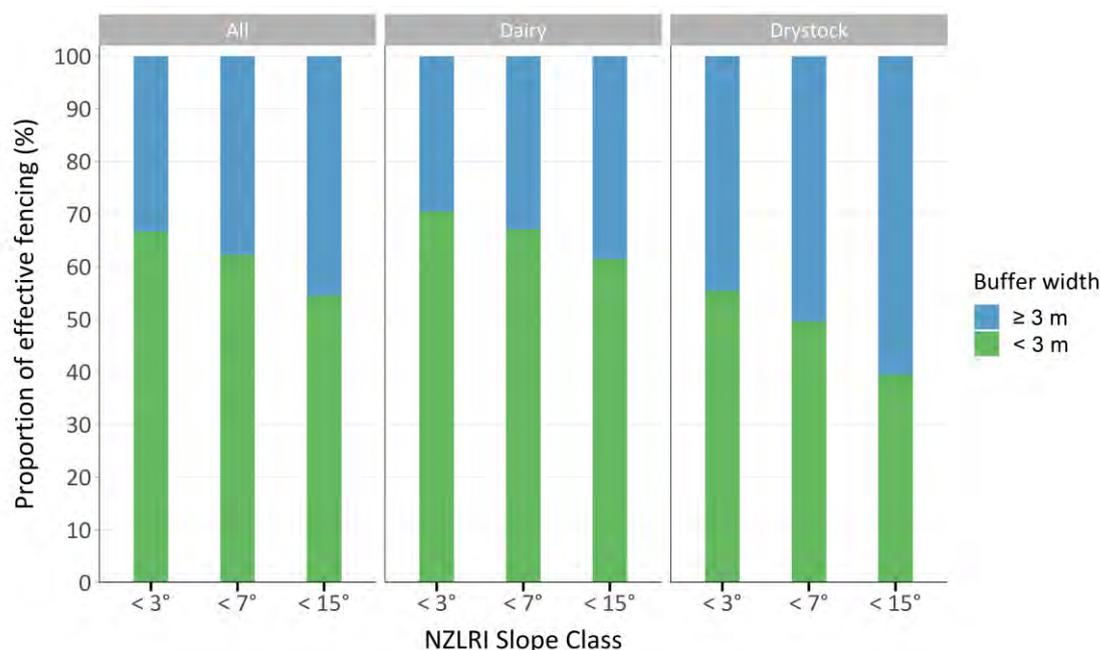
Figure 17. Proportion of effective fencing associated with two vegetation buffer width categories (< 3 m and ≥ 3 m) across three New Zealand Land Resource Inventory (NZLRI) slope classes (< 3°, < 7° and < 15°) for pastoral land use in 2017. Data is for the assessment of fencing setback requirements (low-slope scenarios) under the proposed national stock exclusion regulations (see Table 13 for land use specifications).

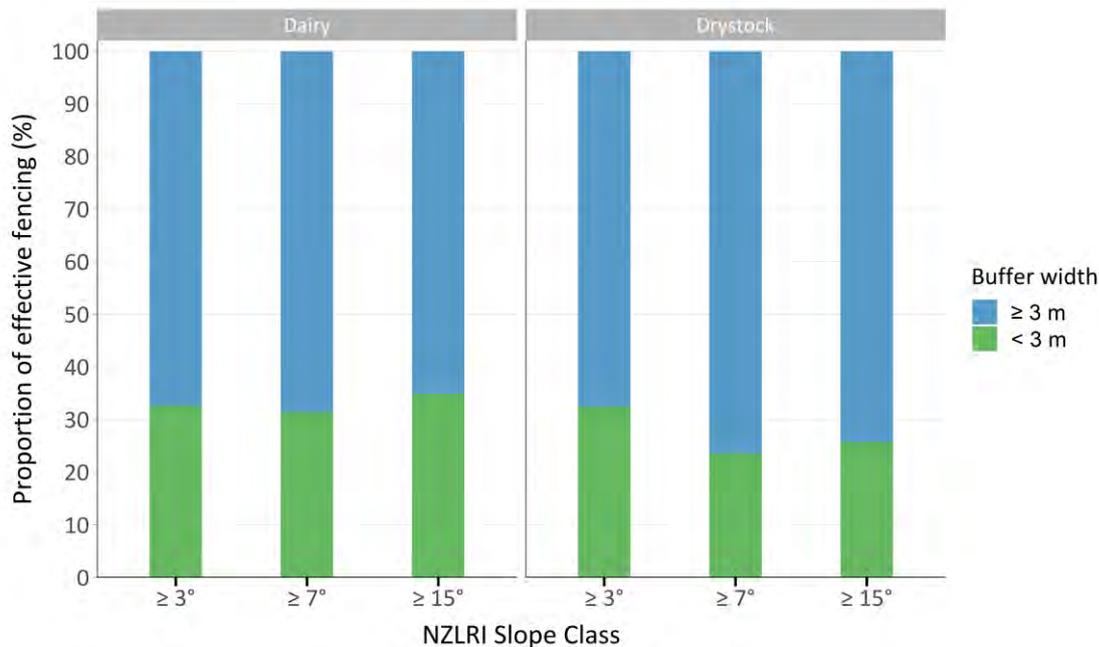
Figure 18. Proportion of effective fencing associated with two vegetation buffer width categories (< 3 m and ≥ 3 m) across three New Zealand Land Resource Inventory (NZLRI) slope classes (≥ 3°, ≥ 7° and ≥ 15°) for dairy and drystock land uses in 2017. Data is for the assessment of fencing setback requirements (non-low slope scenarios) under the proposed national stock exclusion regulations (see Table 14 for land use specifications).

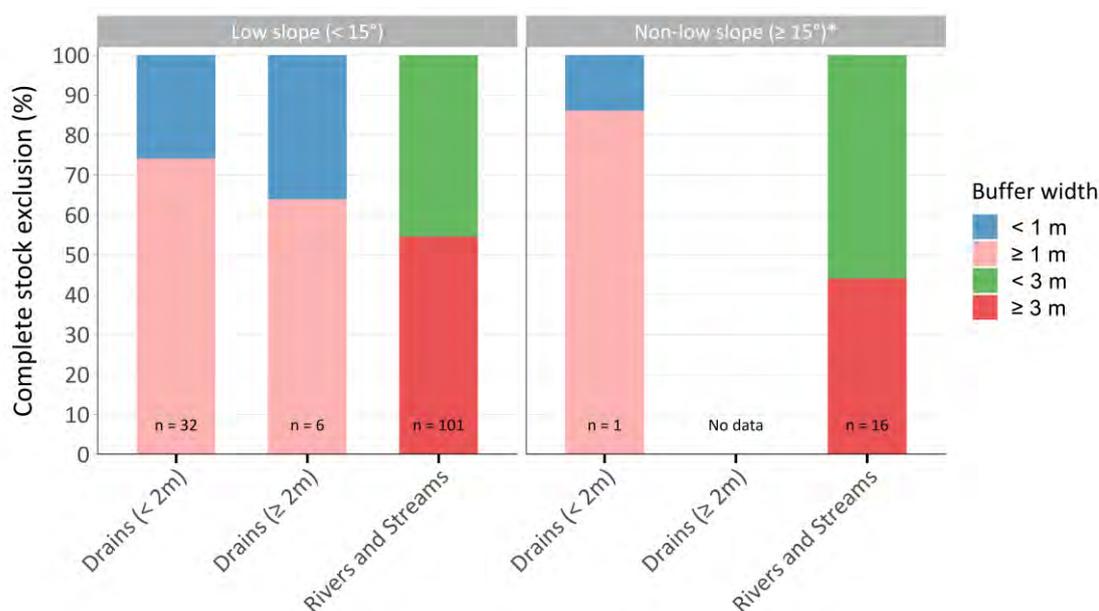
Figure 19. Proportion of complete stock exclusion (effective fencing or forest/scrub or deep channel morphology) associated with varying vegetation buffer width categories for drains (Strahler order 0; channel width < 2 m and channel width ≥ 2 m) and rivers and streams (Strahler orders 1 – 6) for low-slope (< 15°) and non-low slope (> 15°), high stock intensity (*) scenarios. Data is for the assessment of fencing setback requirements (low-slope and non-low slope) as outlined in Schedule C of Plan Change 1 (Waikato Regional Council, 2020). The number of survey samples (n) within each slope and watercourse category is provided for reference.

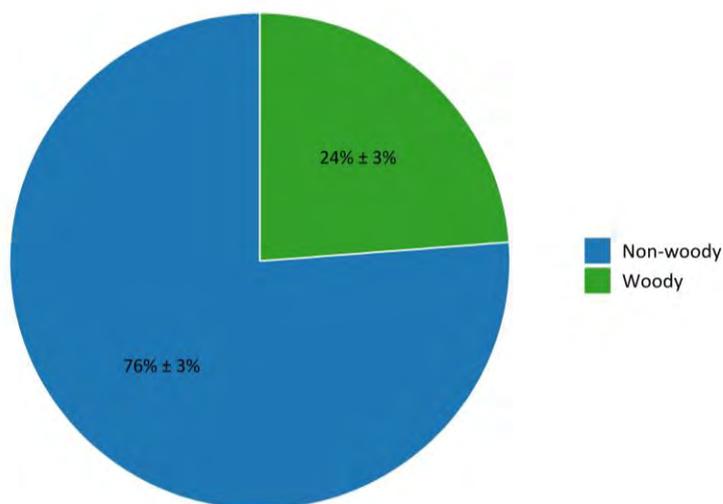
Figure 20. Average proportion of bank length with woody and non-woody vegetation across the Waikato region in 2017 (n = 432). Error terms represent the 95% confidence interval about the average.

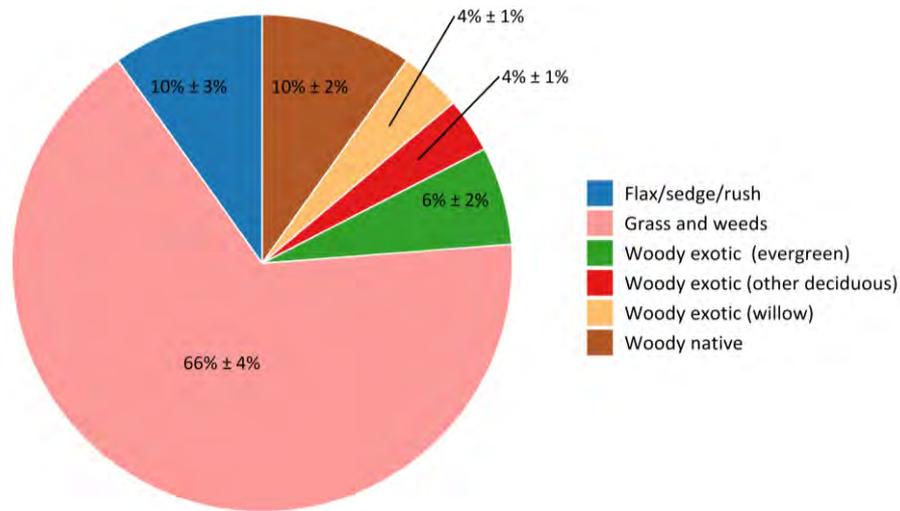
Figure 21. Average proportion of bank length occupied by individual vegetation types across the Waikato region in 2017 (n = 432). Error terms represent the 95% confidence interval about the average.

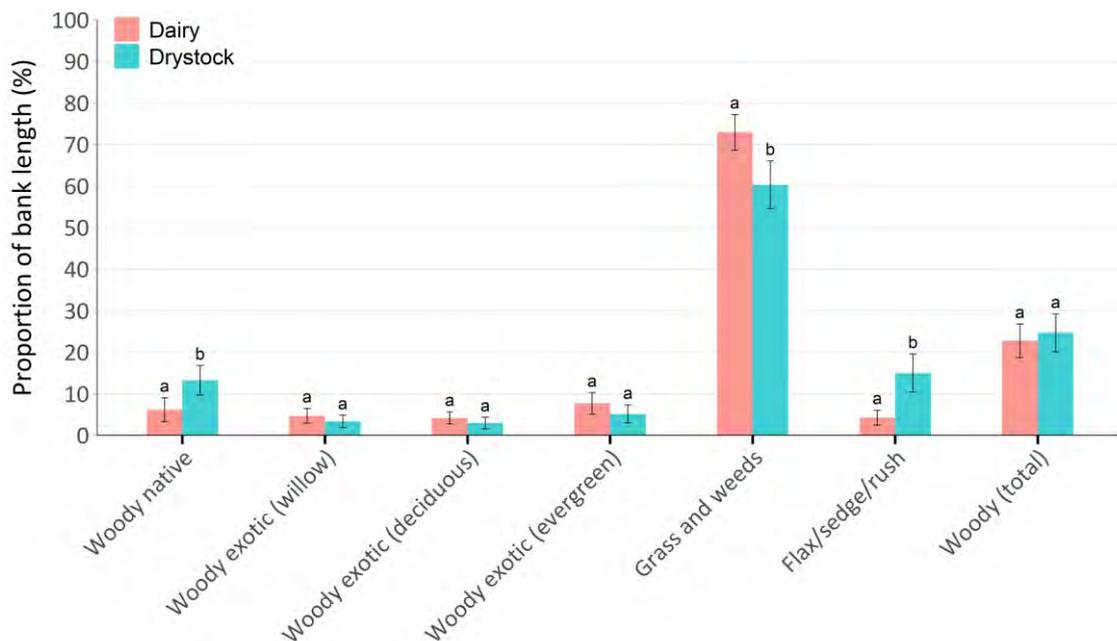
Figure 22. Average proportion of bank length occupied by individual vegetation types across the Waikato region in 2017. Error terms represent the 95% confidence interval about the average. Within each category, averages carrying the same letter are not significantly different ($\alpha = 0.05$).

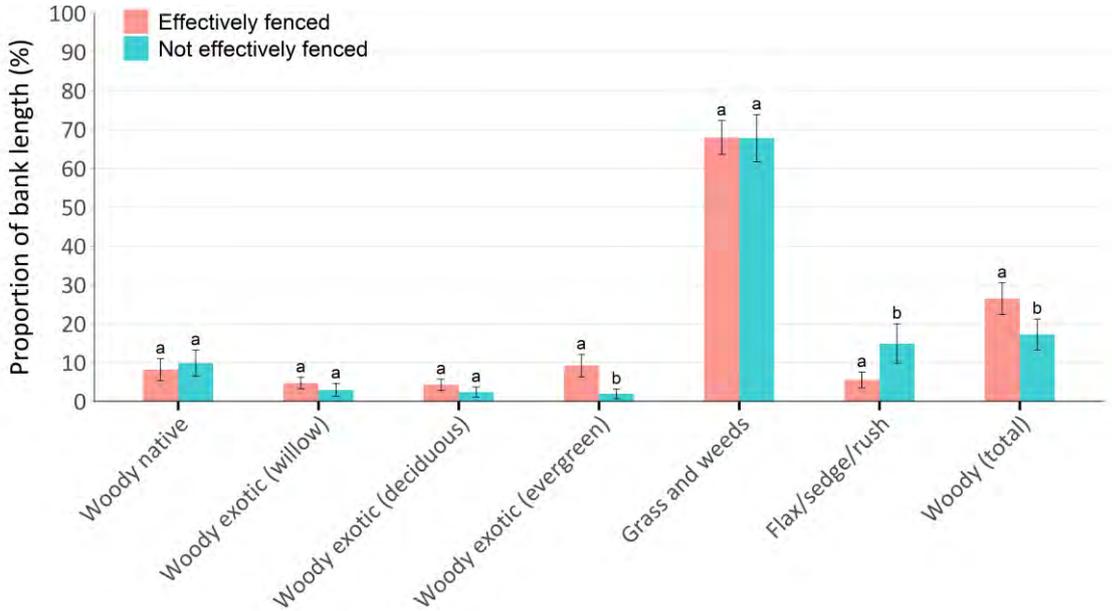
Figure 23. Average proportion of effectively fenced or not effectively fenced bank length occupied by woody vegetation (total) and individual vegetation types across the Waikato region in 2017. Error bars represent the 95% confidence interval about the average. Within each category, averages carrying the same letter are not significantly different ($\alpha = 0.05$).

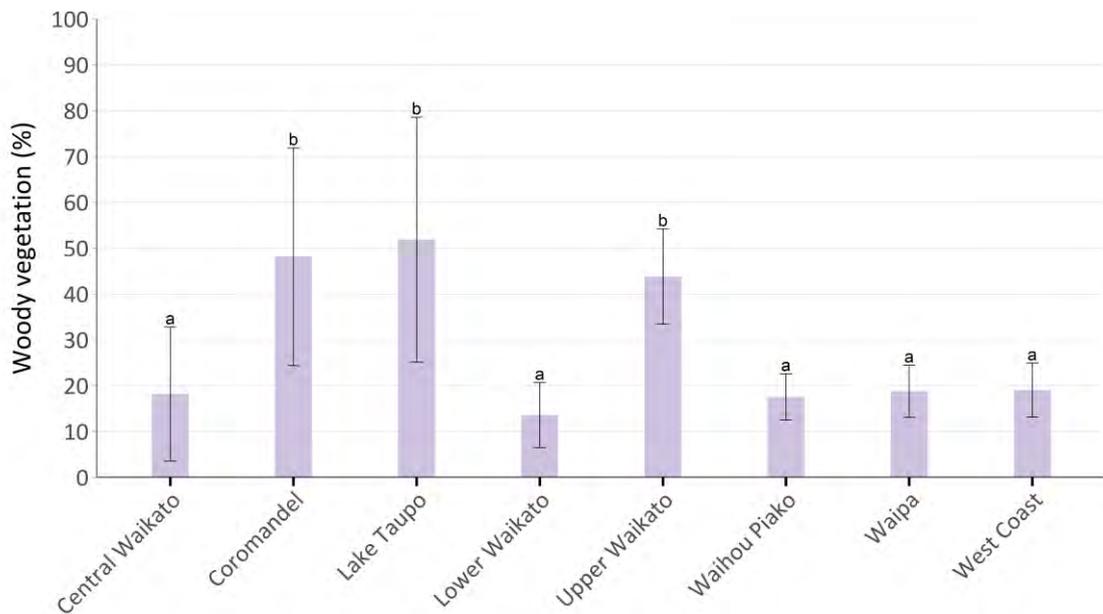
Figure 24. Average proportion of bank length occupied by woody vegetation within each management zone in 2017. Error bars represent the 95% confidence interval about the average. Averages carrying the same letter are not significantly different ($\alpha = 0.05$).

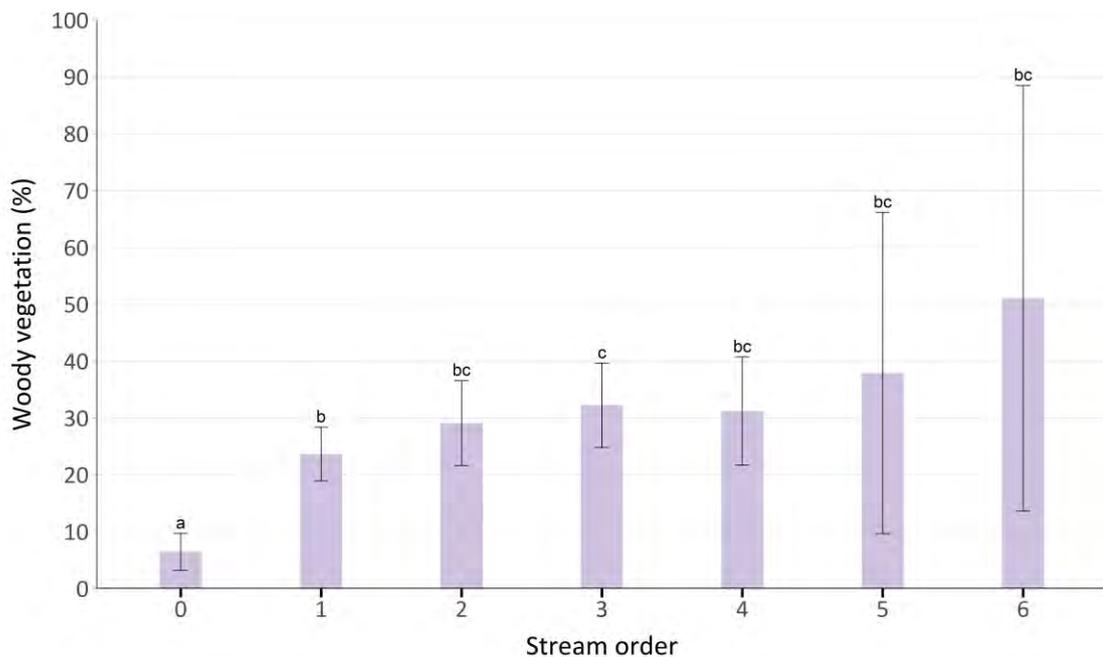
Figure 25. Average proportion of bank length occupied by woody vegetation within each stream order in 2017. Stream order 0 represents drains. Error bars represent the 95% confidence interval about the average. Averages carrying the same letter are not significantly different ($\alpha = 0.05$).

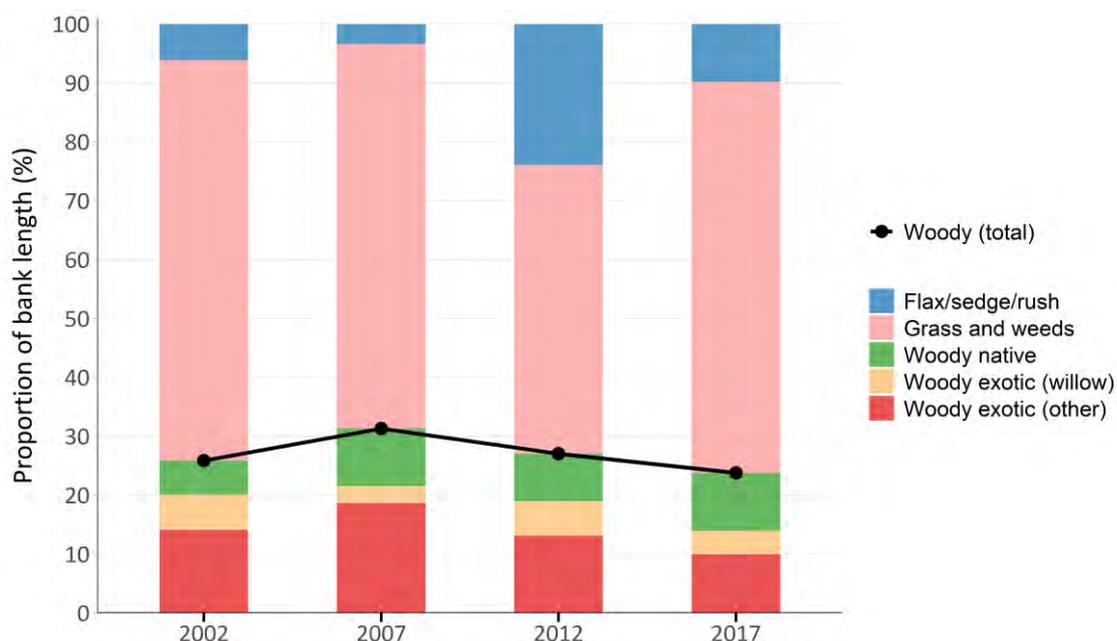
Figure 26. Average proportion of bank length (total) occupied by woody vegetation and individual vegetation types at the four survey periods (2002, 2007, 2012 and 2017).

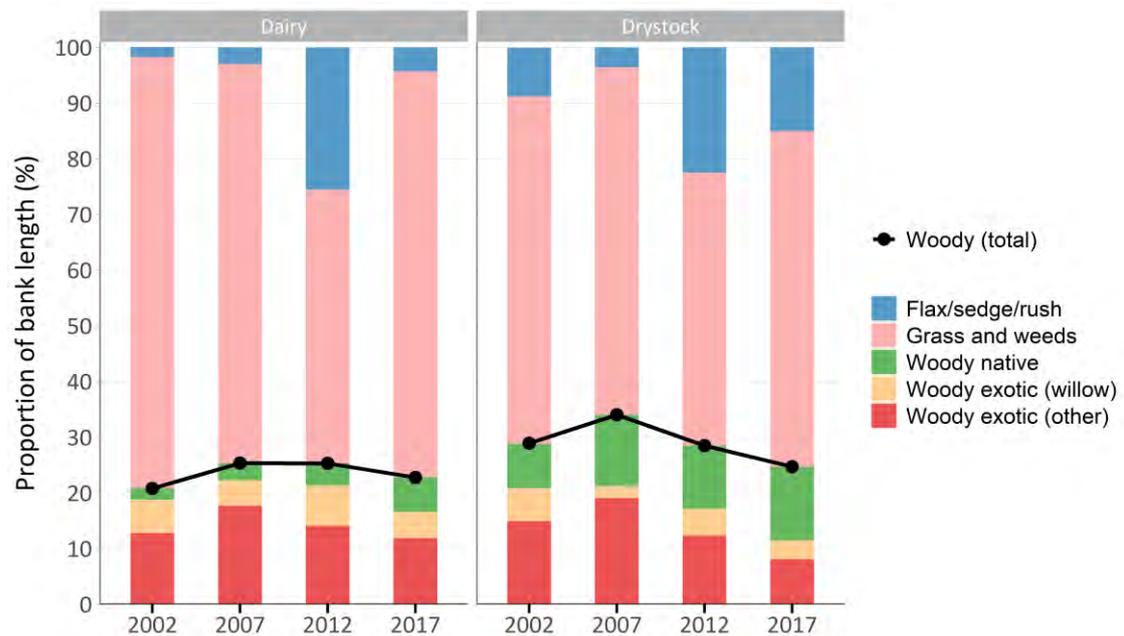
Figure 27. Average proportion of bank length (total) occupied by woody vegetation and individual vegetation types within land use types at the four survey periods (2002, 2007, 2012 and 2017).

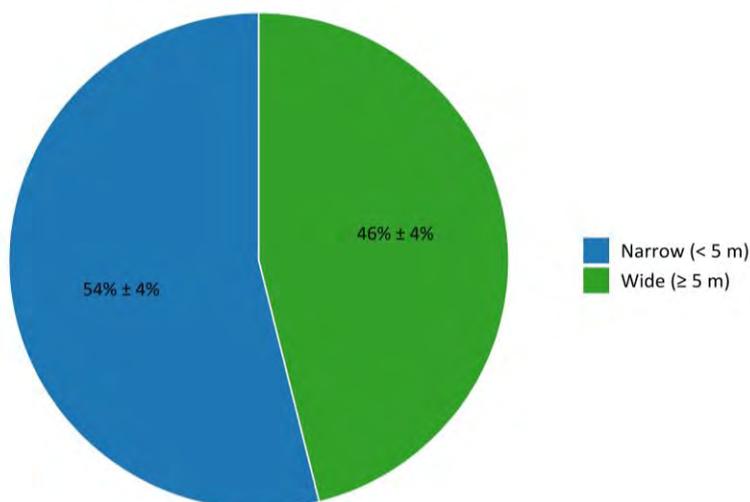
Figure 28. Average proportion of bank length with narrow (< 5 m) and wide (≥ 5 m) buffer widths across the Waikato region in 2017 (n = 432). Error terms represent the 95% confidence interval about the average.

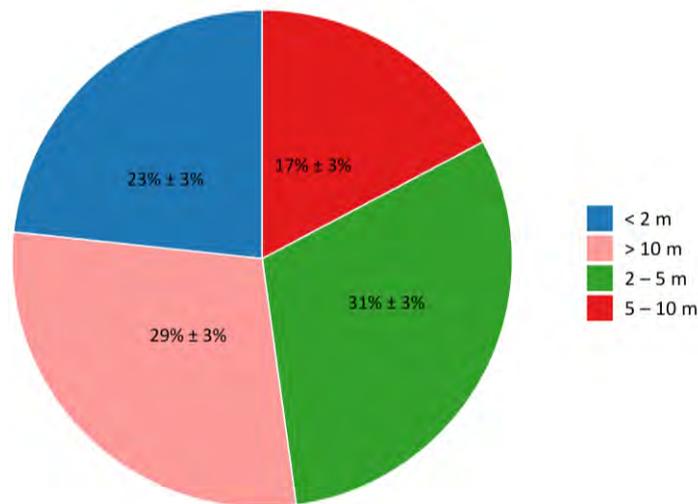
Figure 29. Average proportion of bank length by individual buffer width category across the Waikato region in 2017 (n = 432). Error terms represent the 95% confidence interval about the average.

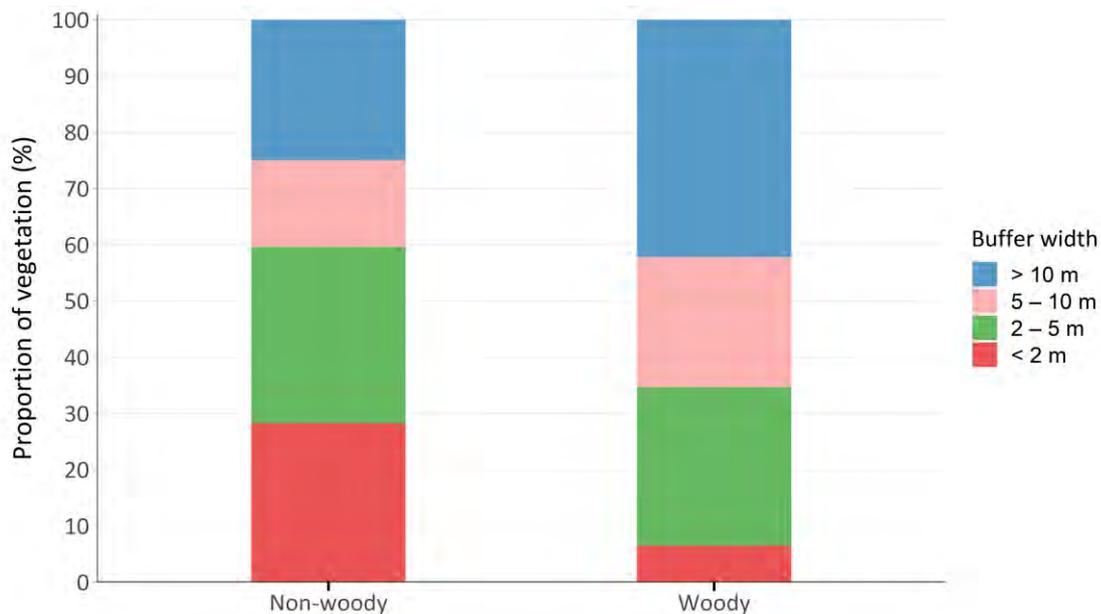
Figure 30. Average proportion of non-woody and woody vegetation located within individual buffer width categories across the Waikato region in 2017.

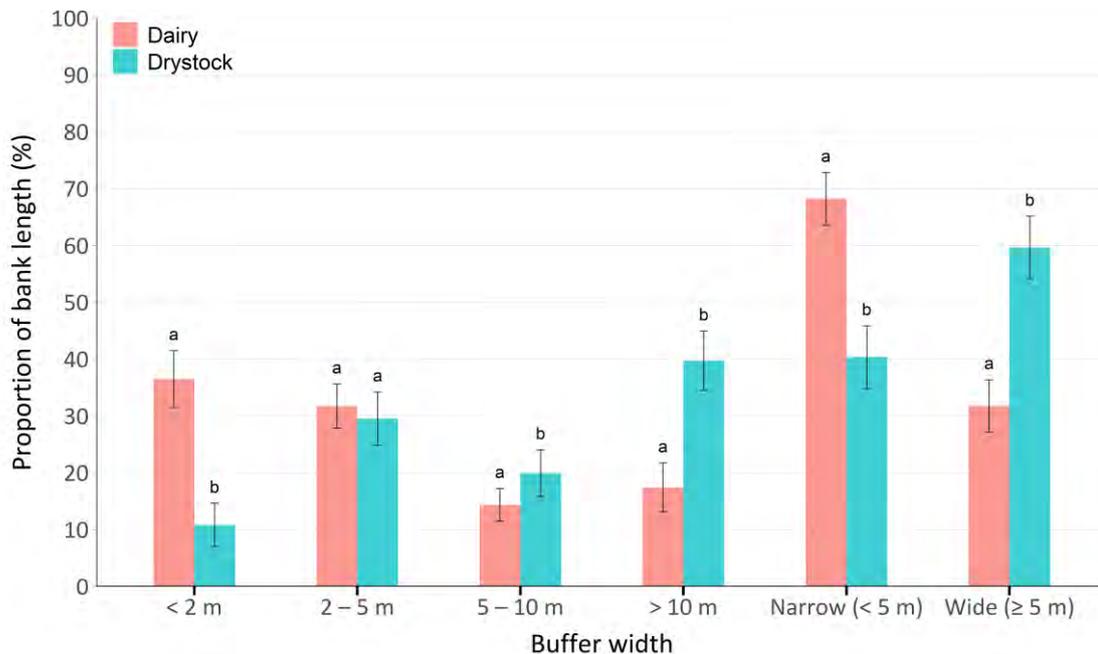
Figure 31. Average proportion of bank length by narrow (< 5 m), wide (≥ 5 m) and individual buffer width categories within land use types across the Waikato region in 2017. Error bars represent the 95% confidence interval about the average. Within each category, averages carrying the same letter are not significantly different ($\alpha = 0.05$).

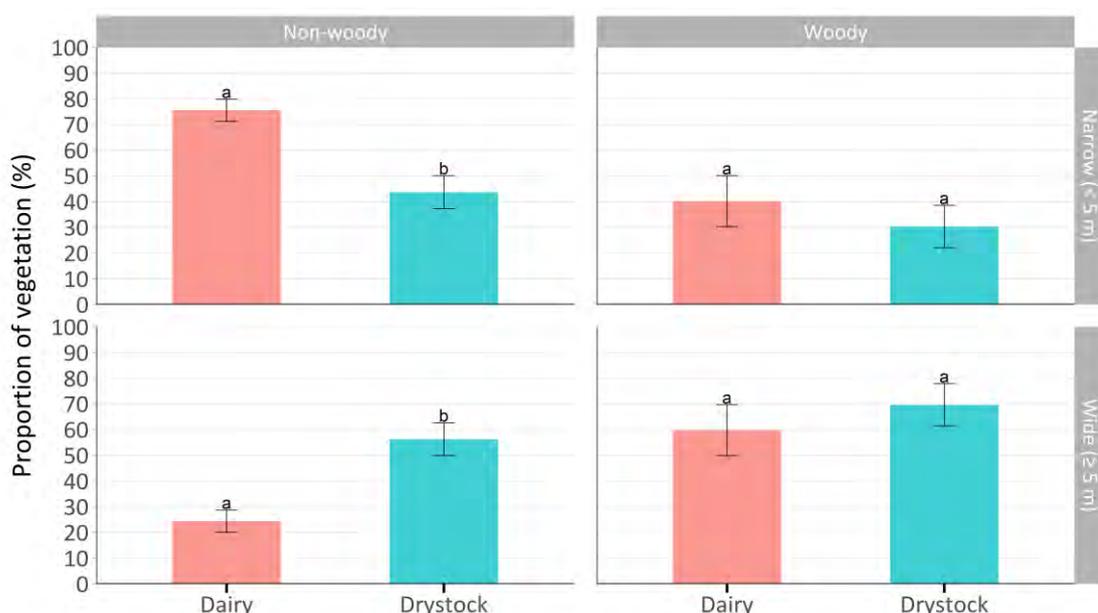
Figure 32. Average proportion of non-woody and woody vegetation within narrow (< 5 m) and wide (≥ 5 m) buffer width categories for dairy and drystock land use types across the Waikato region in 2017. Error bars represent the 95% confidence interval about the average. Within each vegetation x buffer width category, averages carrying the same letter are not significantly different ($\alpha = 0.05$).

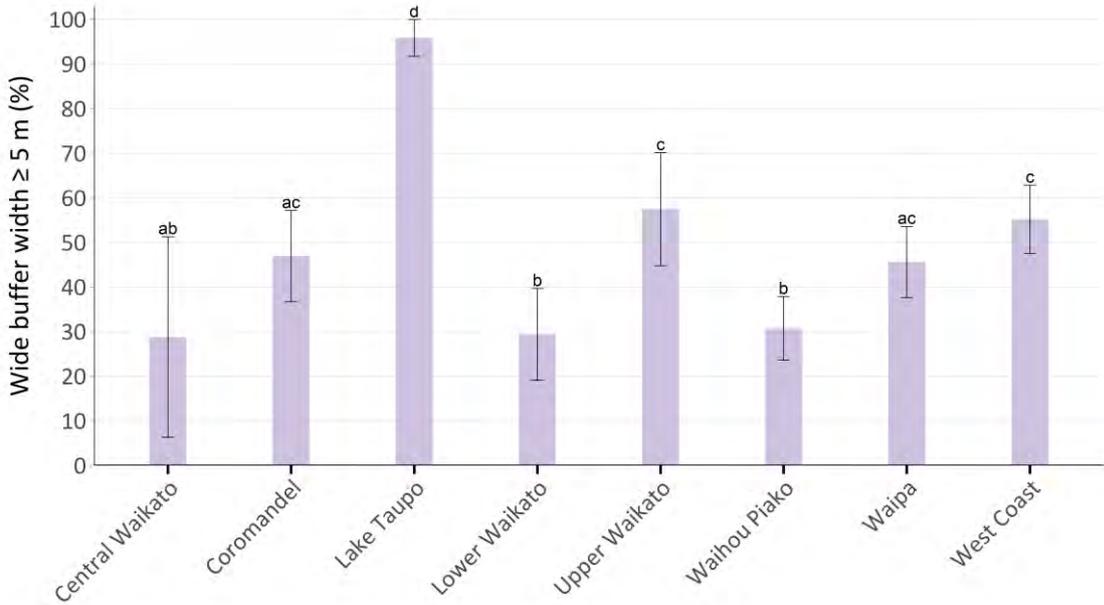
Figure 33. Average proportion of bank length with wide (≥ 5 m) buffer widths within each management zone in 2017. Error bars represent the 95% confidence interval about the average. Averages carrying the same letter are not significantly different ($\alpha = 0.05$).
