Riparian characteristics of pastoral waterways in the Waikato region, 2002-2017

M. Norris¹, H. Jones¹, M. Kimberley², D. Borman¹

November 2020

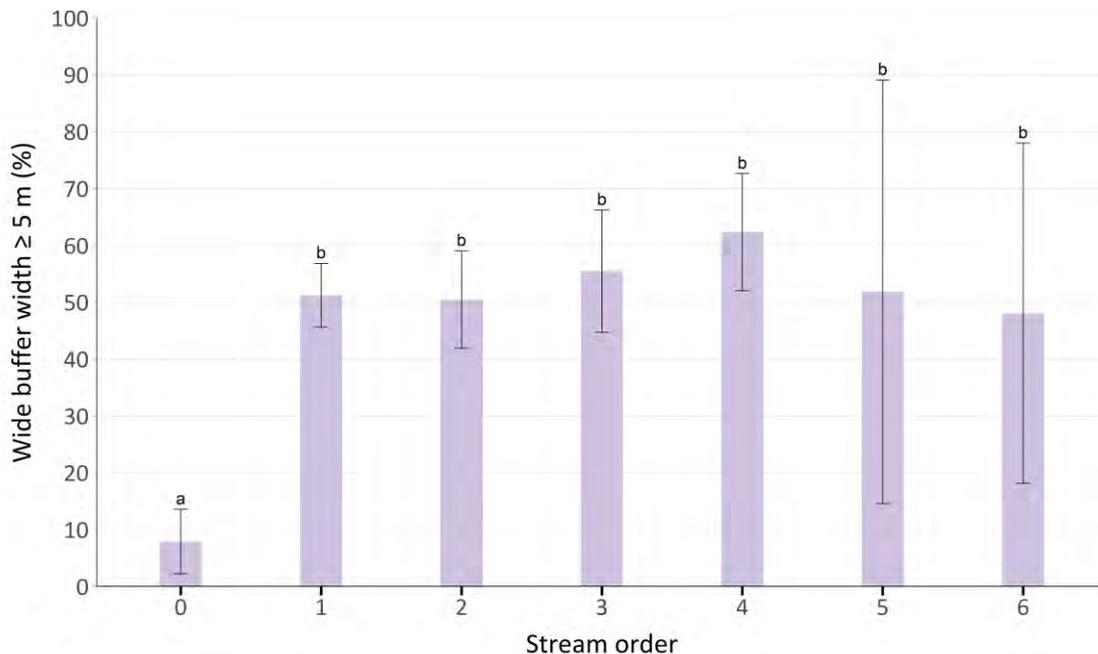
Figure 34. Average proportion of bank length with wide (≥ 5 m) buffer widths within each stream order in 2017. Stream order 0 represents drains. Error bars represent the 95% confidence interval about the average. Averages carrying the same letter are not significantly different ($\alpha = 0.05$).

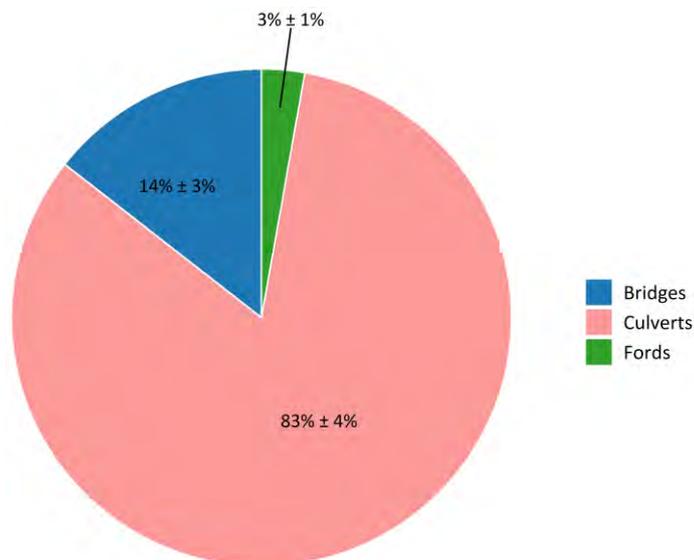
Figure 35. Average proportion of observed waterway crossings that are bridges, culverts or fords across the Waikato region in 2017 (n = 272). Error terms represent the 95% confidence interval about the average.

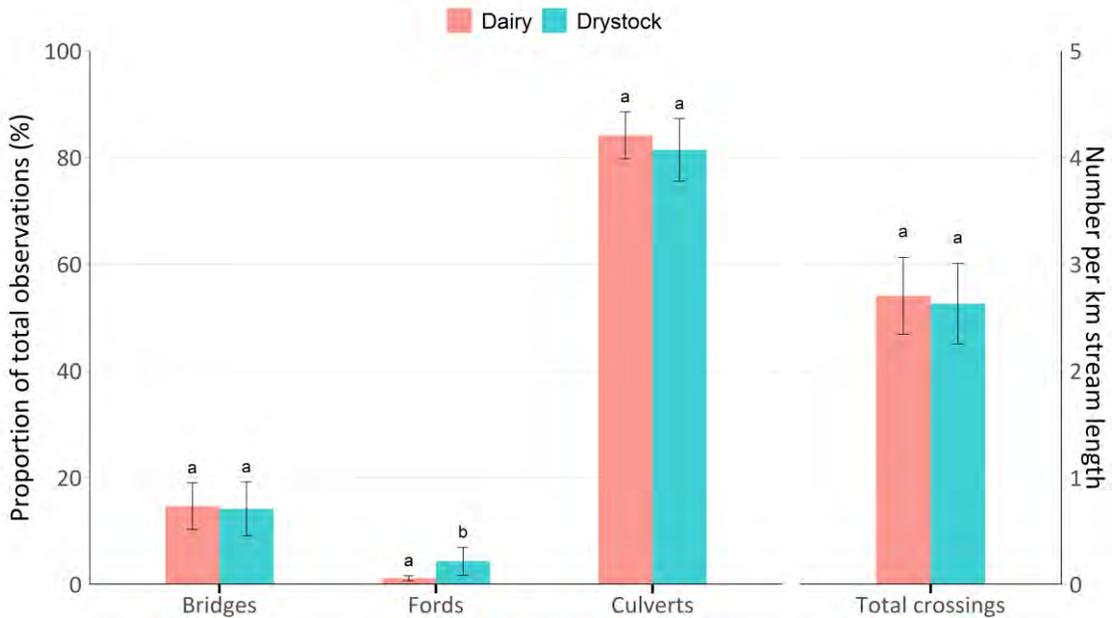
Figure 36. Average proportion of observed waterway crossings that are bridges, fords or culverts (left-hand axis) and total number of crossings per km (right-hand axis) within land use types across the Waikato region in 2017. Error bars represent the 95% confidence interval about the average. Within each category, averages carrying the same letter are not significantly different ($\alpha = 0.05$).

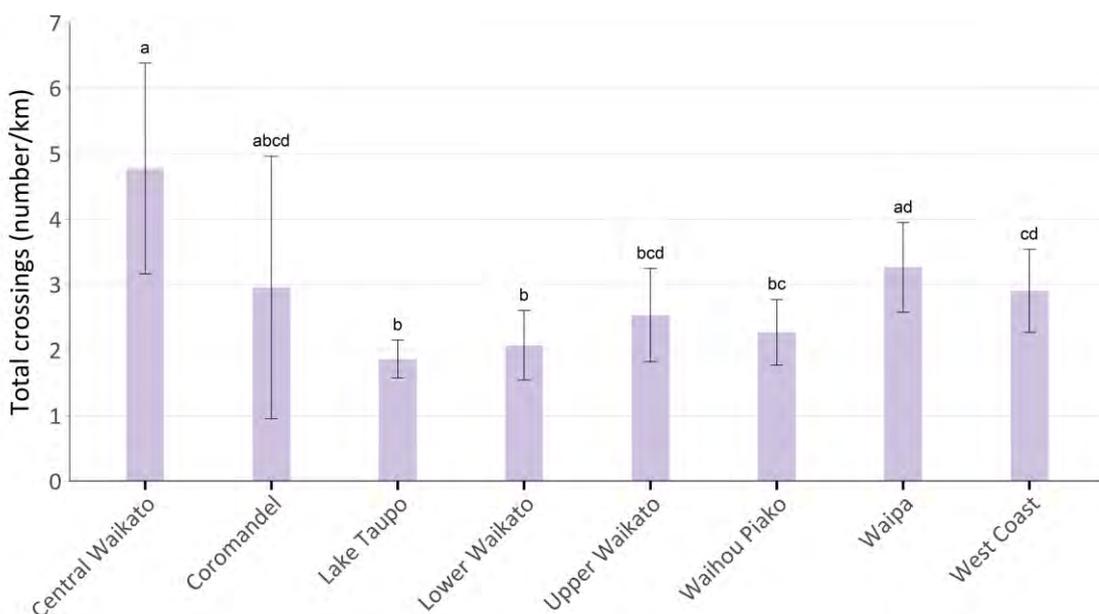
Figure 37. Average number of total waterway crossings observed per km of stream length within each management zone in 2017. Error bars represent the 95% confidence interval about the average. Averages carrying the same letter are not significantly different ($\alpha = 0.05$).

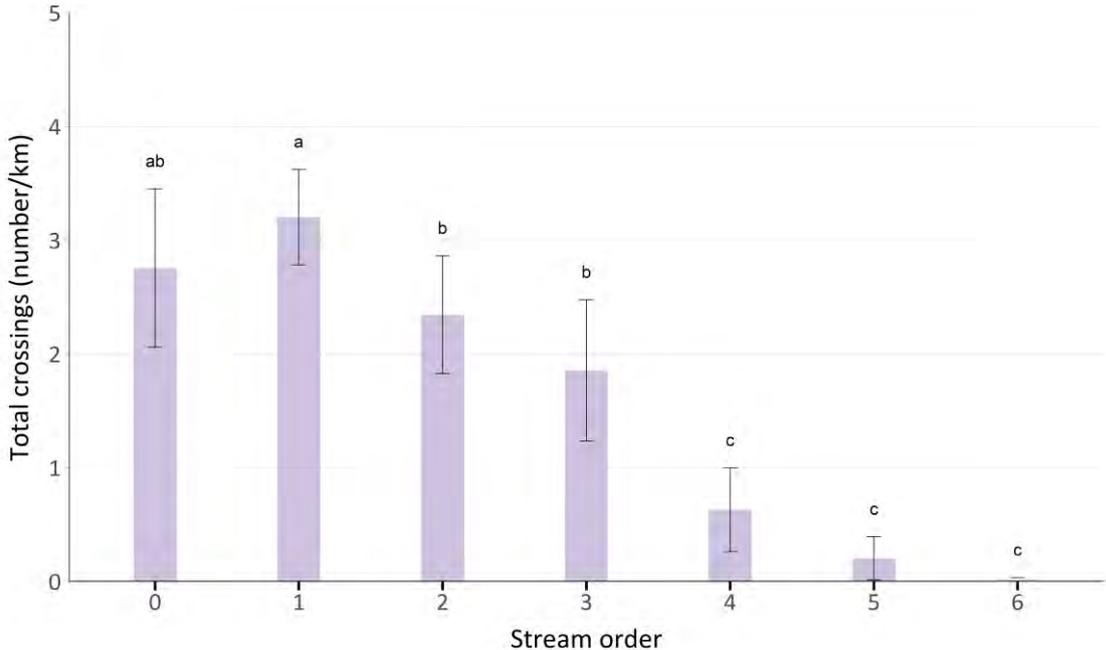
Figure 38. Average number of total waterway crossings observed per km of stream length within each stream order in 2017. Stream order 0 represents drains. Error bars represent the 95% confidence interval about the average. Averages carrying the same letter are not significantly different ($\alpha = 0.05$).

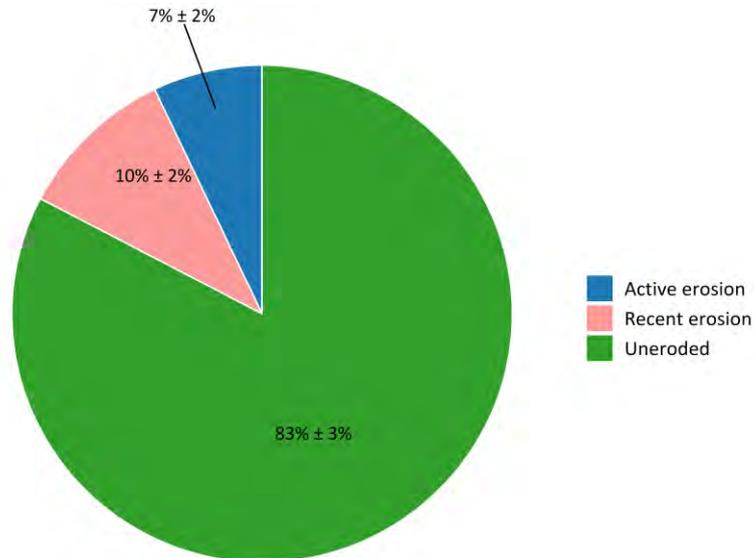
Figure 39. Average proportion of bank length uneroded and with active or recent erosion across the Waikato region in 2017 (n = 418). Error terms represent the 95% confidence interval about the average.

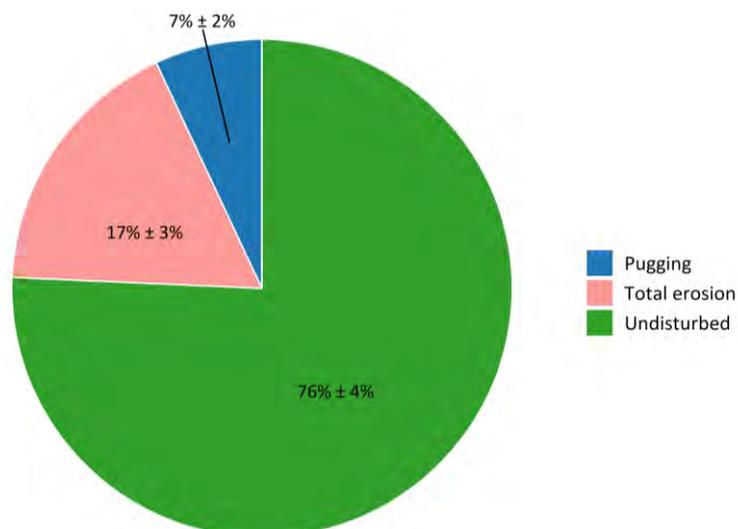
Figure 40. Average proportion of bank length undisturbed and with erosion or pugging disturbance across the Waikato region in 2017 (n = 418). Error terms represent the 95% confidence interval about the average.

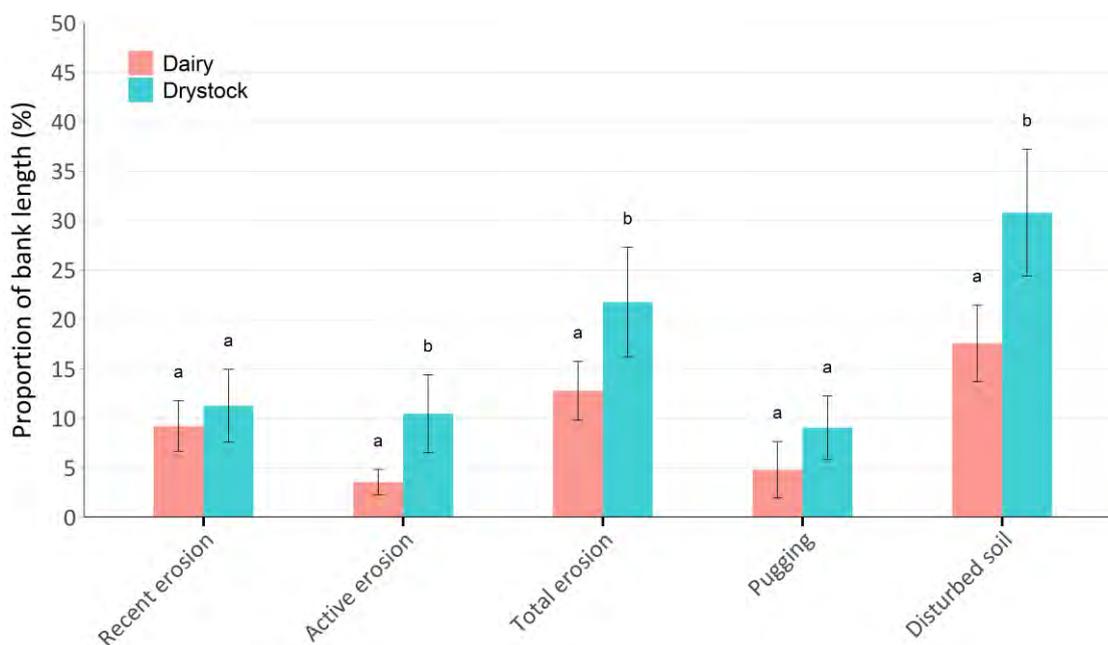
Figure 41. Average proportion of bank length eroded and bank length disturbed (with active and recent erosion components and pugging disturbance) within land use types across the Waikato region in 2017. Error bars represent the 95% confidence interval about the average. Within each category, averages carrying the same letter are not significantly different ($\alpha = 0.05$).

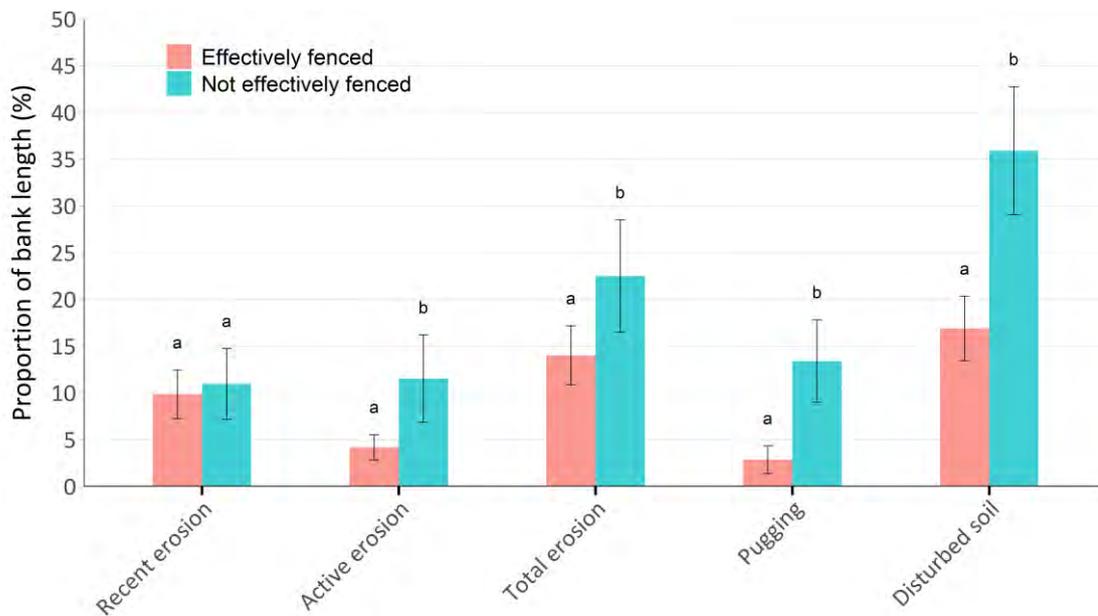
Figure 42. Average proportion of bank length eroded and bank length disturbed (with active and recent erosion components and pugging disturbance) that is effectively fenced or unfenced across the Waikato region in 2017. Error bars represent the 95% confidence interval about the average. Within each category, averages carrying the same letter are not significantly different ($\alpha = 0.05$).

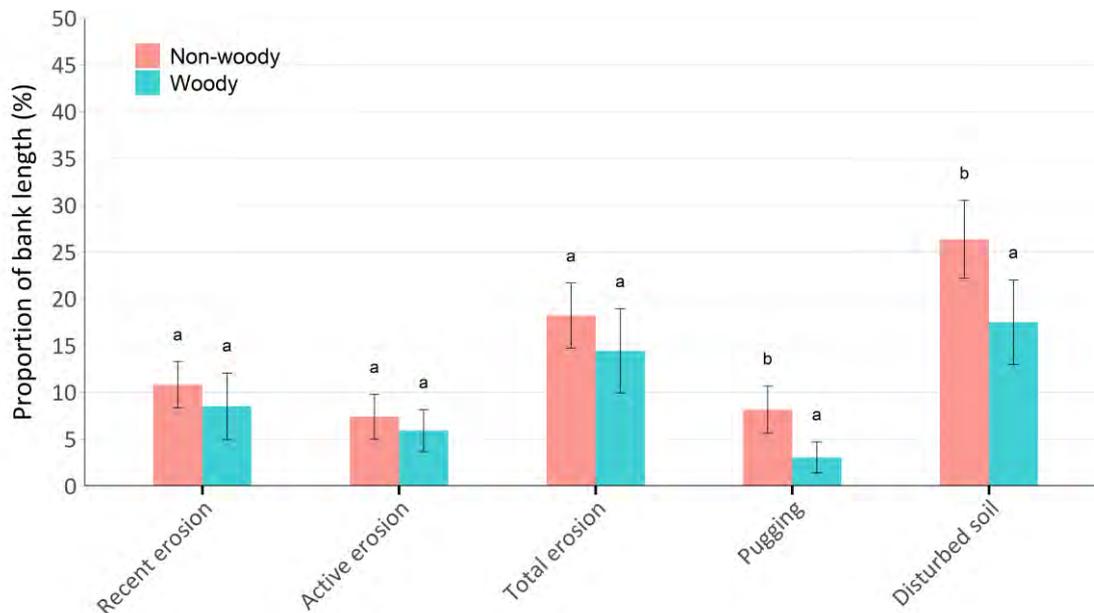
Figure 43. Average proportion of bank length eroded and bank length disturbed (with active and recent erosion components and pugging disturbance) that is occupied by woody or non-woody vegetation across the Waikato region in 2017. Error bars represent the 95% confidence interval about the average. Within each category, averages carrying the same letter are not significantly different ($\alpha = 0.05$).

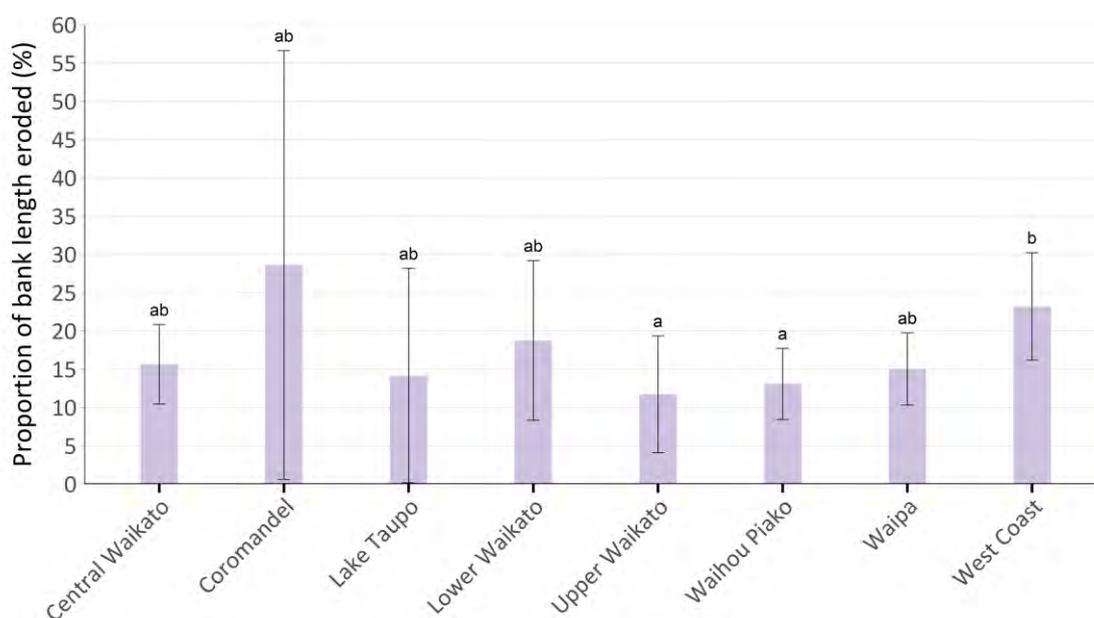
Figure 44. Average proportion of bank length eroded within each management zone in 2017. Error bars represent the 95% confidence interval about the average. Averages carrying the same letter are not significantly different ($\alpha = 0.05$).

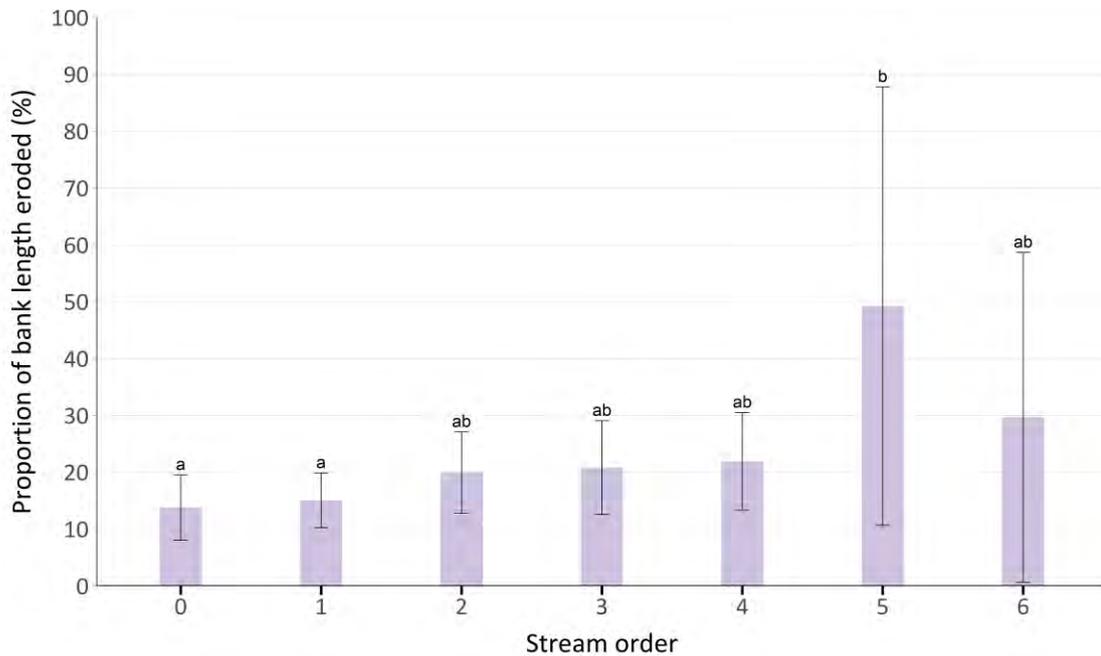
Figure 45. Average proportion of bank length eroded within each stream order in 2017. Stream order 0 represents drains. Error bars represent the 95% confidence interval about the average. Averages carrying the same letter are not significantly different ($\alpha = 0.05$).

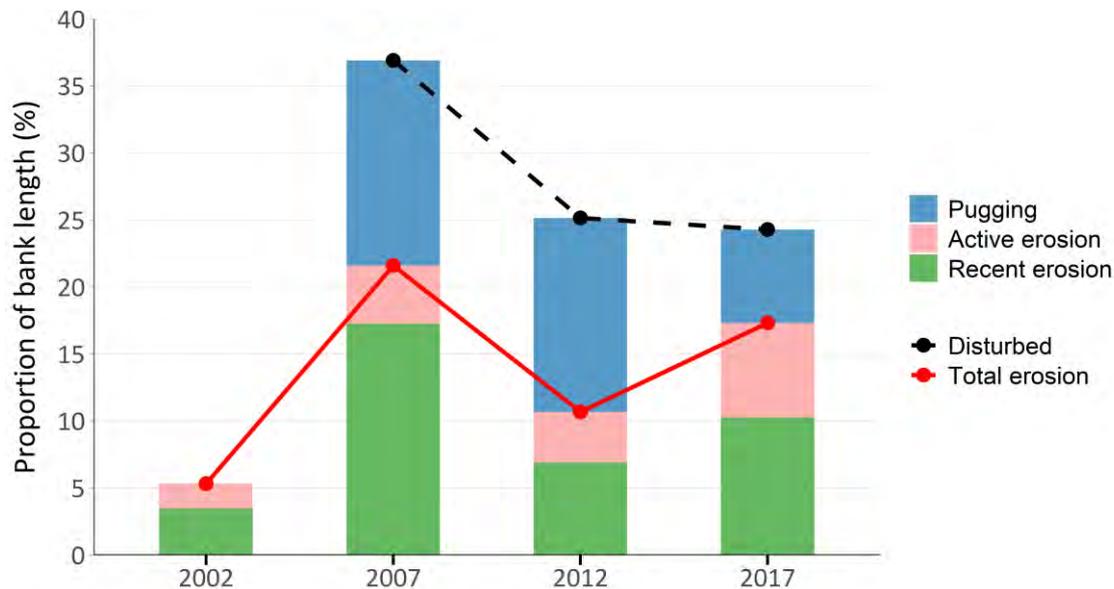
Figure 46. Average proportion of bank length eroded (total) and bank length disturbed (with active and recent components and pugging disturbance) at the four survey periods (2002, 2007, 2012 and 2017). Note that pugging disturbance was not assessed in 2002.

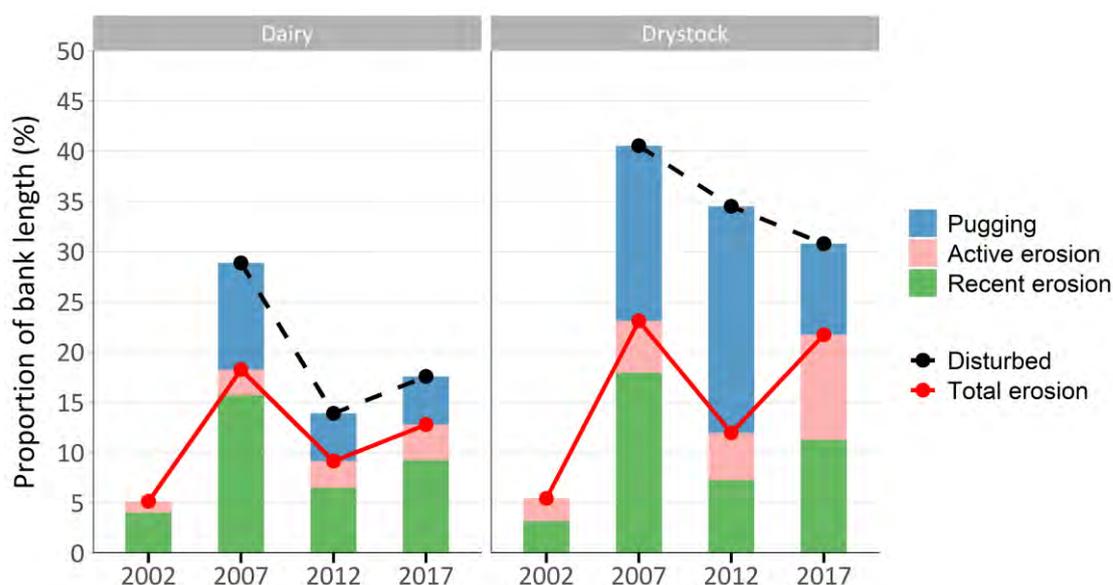
Figure 47. Average proportion of bank length eroded and bank length disturbed (with active and recent components and pugging disturbance) within land use types at the four survey periods (2002, 2007, 2012 and 2017). Note that pugging disturbance was not assessed in 2002.

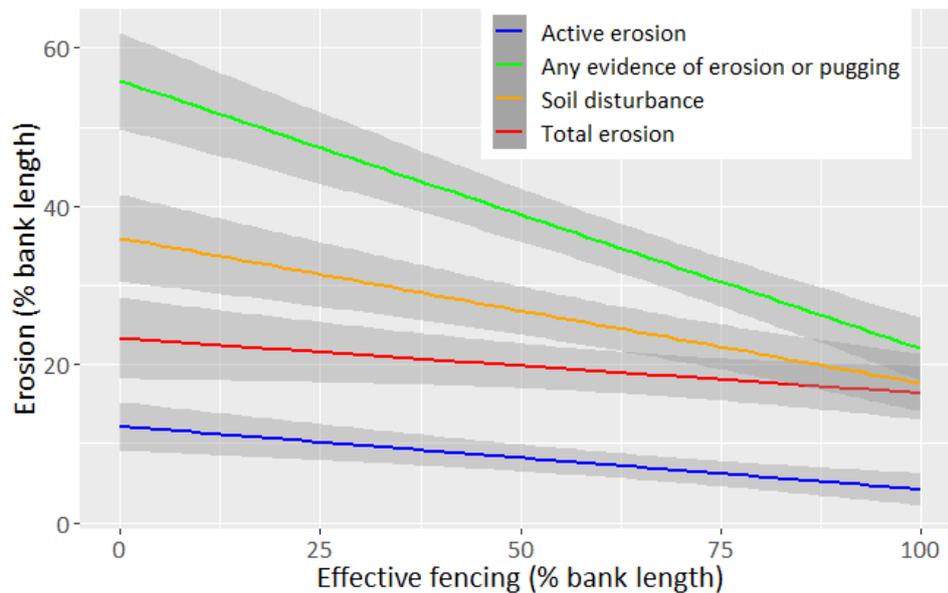
Figure 48. Relationship between four measures of stream bank erosion (y axis) and % bank length effectively fenced (x axis). The lines show predicted erosion using the regression equations given in Table 25 and shaded areas show 95% confidence intervals of the predictions.
