NEW ZEALAND FRESHWATER FISHERIES MISCELLANEOUS REPORT NO. 7

RISK ASSESSMENT REPORT ON THE PROPOSED  
STOCKING OF GRASS CARP INTO NZ STEEL WATER  
INTAKE LAGOON AT WAIKATO NORTH HEADS MINE

RISK ASSESSMENT REPORT ON THE PROPOSED STOCKING OF GRASS CARP  
INTO NZ STEEL WATER INTAKE LAGOON AT WAIKATO NORTH HEADS MINE

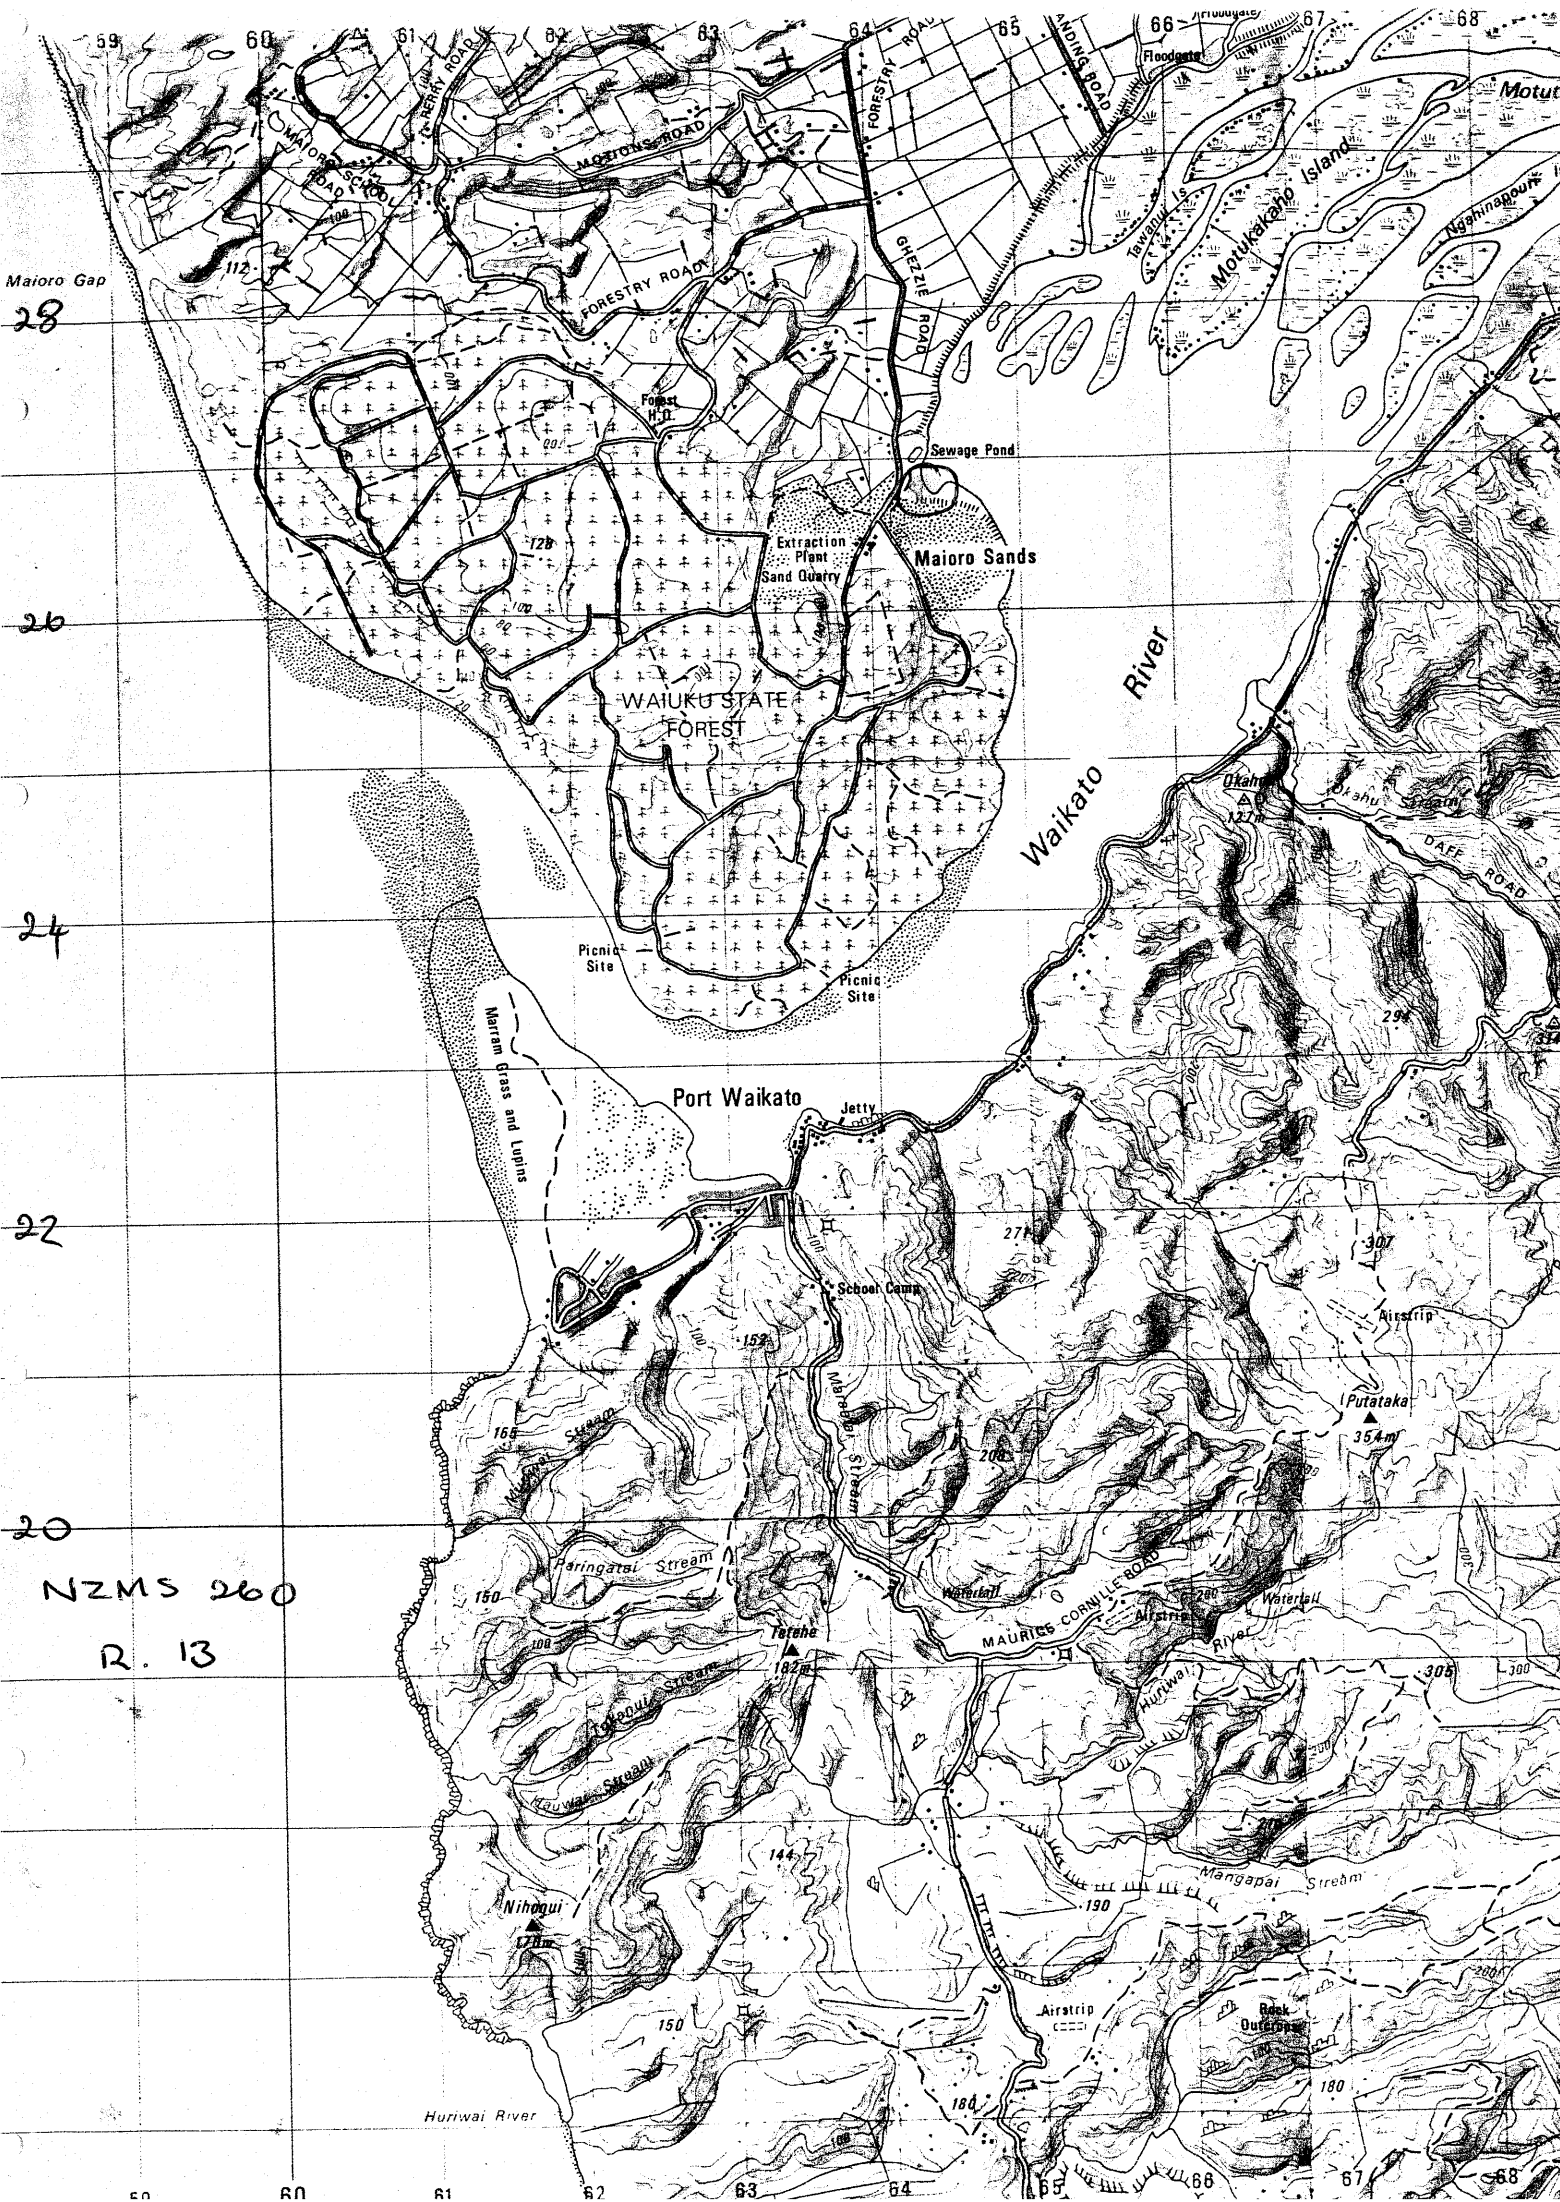
NZMS 260  
R. 13

NZ Steel has applied for a permit to put triploid grass carp in the storage lagoon at the Waikato North Head Mine Site. The lagoon is at NSMS 260, 642268 (Map 1), adjacent to the Waikato River.

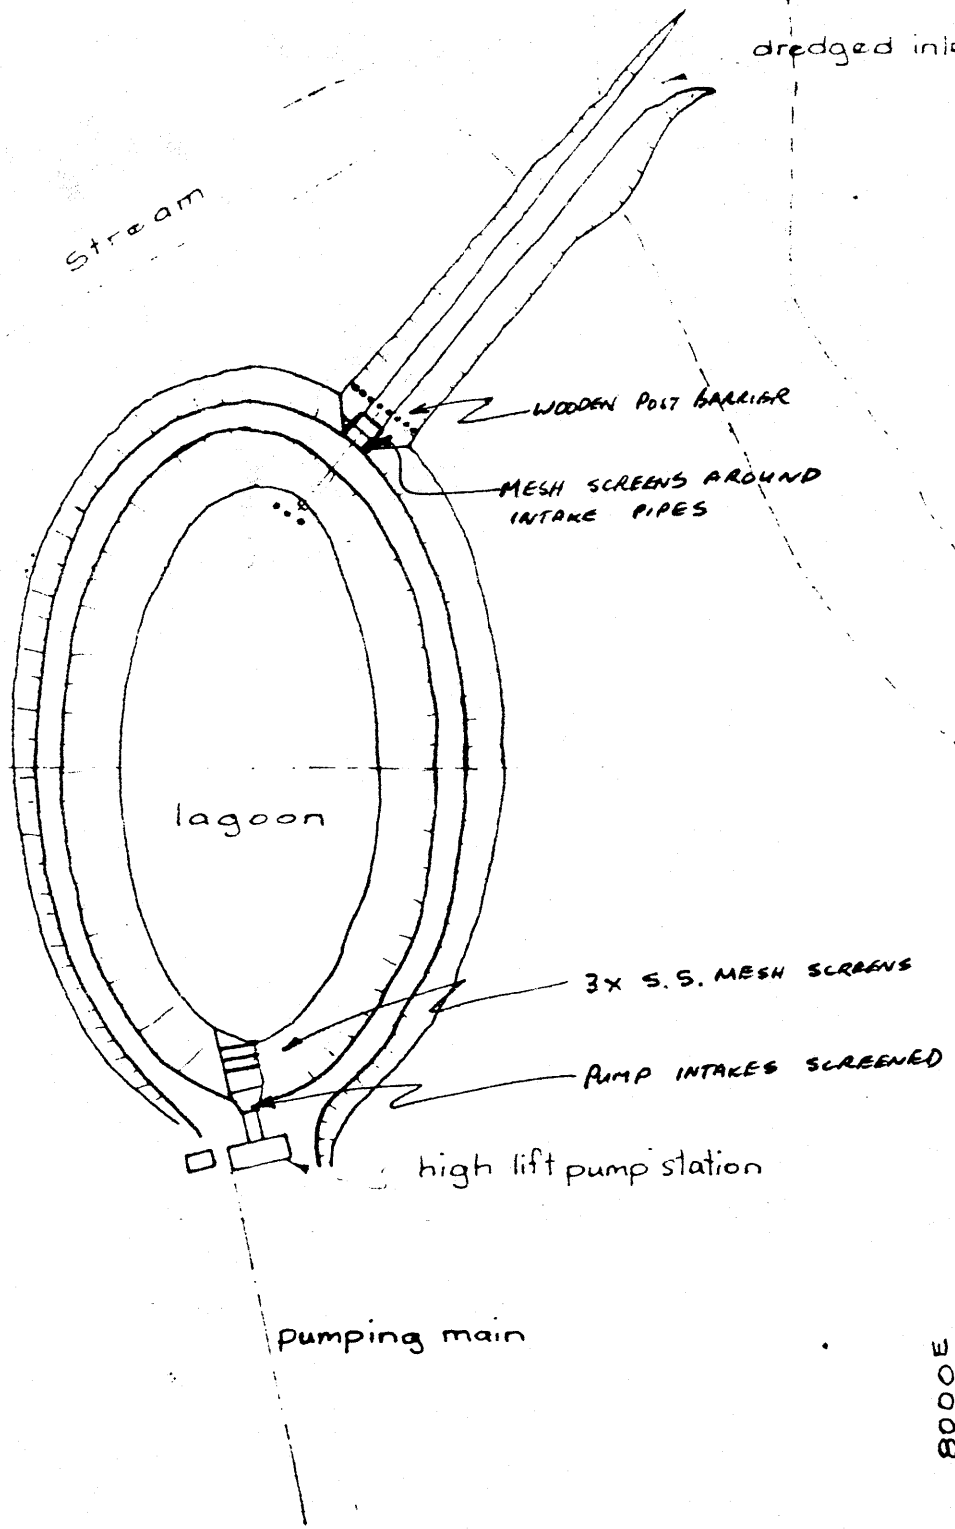
N.Z. STEEL MINING LTD  
RIVER WATER INTAKE

Three stainless steel mesh screens (Map 2) protect the pumps. The screens are not effective and need to be cleaned frequently.

dredged inlet channel

MESH SCREENS AROUND INTAKE PIPES

3x S.S. MESH SCREENS

PUMP INTAKES SCREENED

high lift pump station

NZ Steel should undertake regular patrols to prevent unauthorised removal of the carp. The intake to the lagoon should be screened with a minimum of 3 cm mesh or screen permanently fixed to the intake pipes.

The entire site is fenced and regularly patrolled. Human interference with stock is unlikely. If the whitebait screens on the intake were damaged, it is conceivable that large fish could get to the Waikato river. This can be prevented by screening the culverts where these enter the lagoon. Provided the screens are well made, the probability of the fish escaping to the Waikato River is low. There is a small population of grass carp already present in the Waikato.
